The September 18-20 2020 Medicane Ianos Impact on Greece

Phase I Reconnaissance Report

Geotechnical Extreme Events Reconnaissance Association

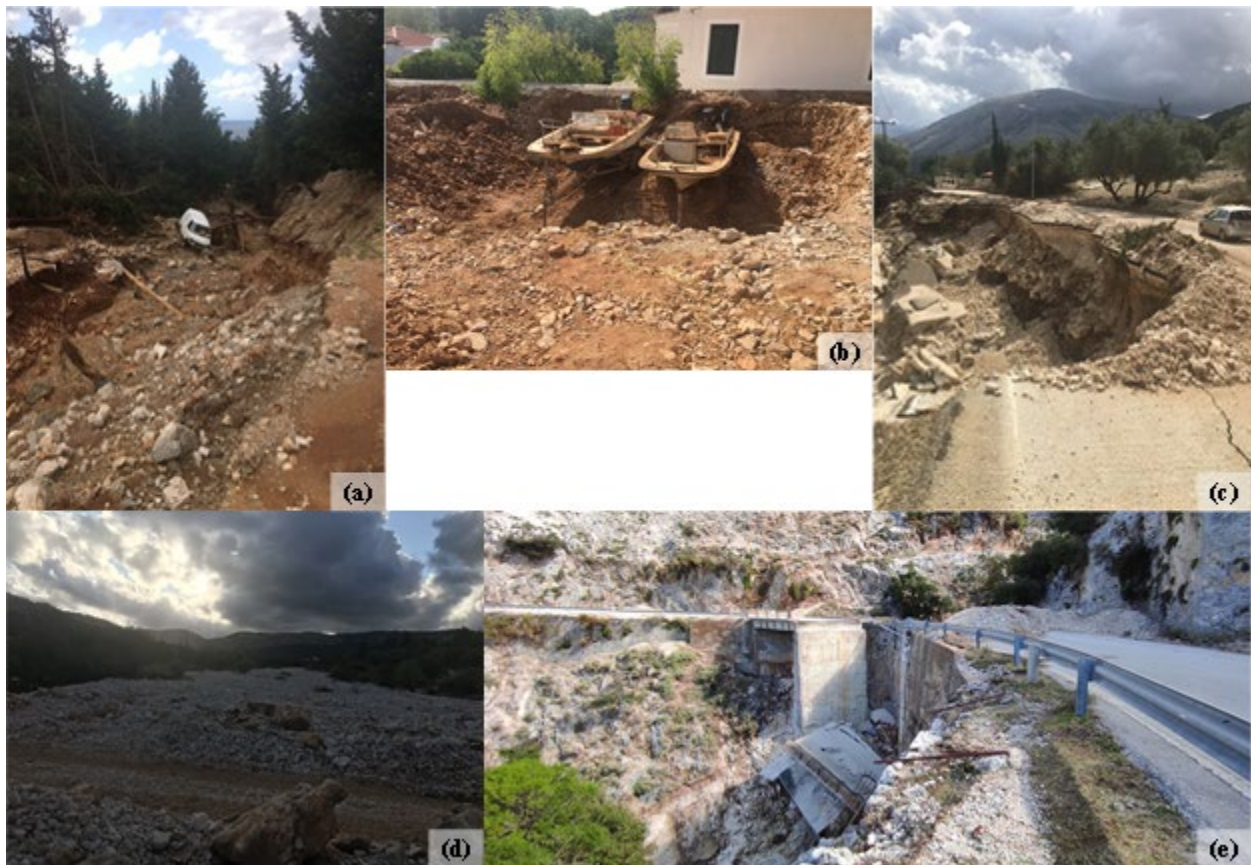
Cephalonia island was heavily impacted by Medicane Ianos. In particular, the northern part of the island towards Erissos peninsula, was the hardest hit. Flooding was extensive with the towns of Ag. Efimia and Fiskardo being partially inundated. Debris flows occurred in several locations across the island. Often the debris flows covered wide areas (~40-70 m in width), while typically the average size of the pebbles/debris reached 20-50 cm (Figure 4.6d). The small, coastal village of Assos was covered by approximately 1.5 m of earth/debris material (Figures 4.6a and 4.6b). Moreover, the earth flows were often associated with road embankment failures (Figure 4.6c). The latter was also observed in cases of severe riverbank erosion/scour. The road network of the island was damaged and/or obstructed in several locations due to landslides, while a critical simple-span reinforced concrete bridge near the village of Agkonas collapsed (Figure 4.6e), heavily impacting the transportation network of the island.

Figure 4.6. Characteristic damages in Cephalonia island following Medicane Ianos: a) Riverbank Erosion, b) debris flow within a rural community, c) road embankment failure, d) extensive debris flow, e) bridge collapse.

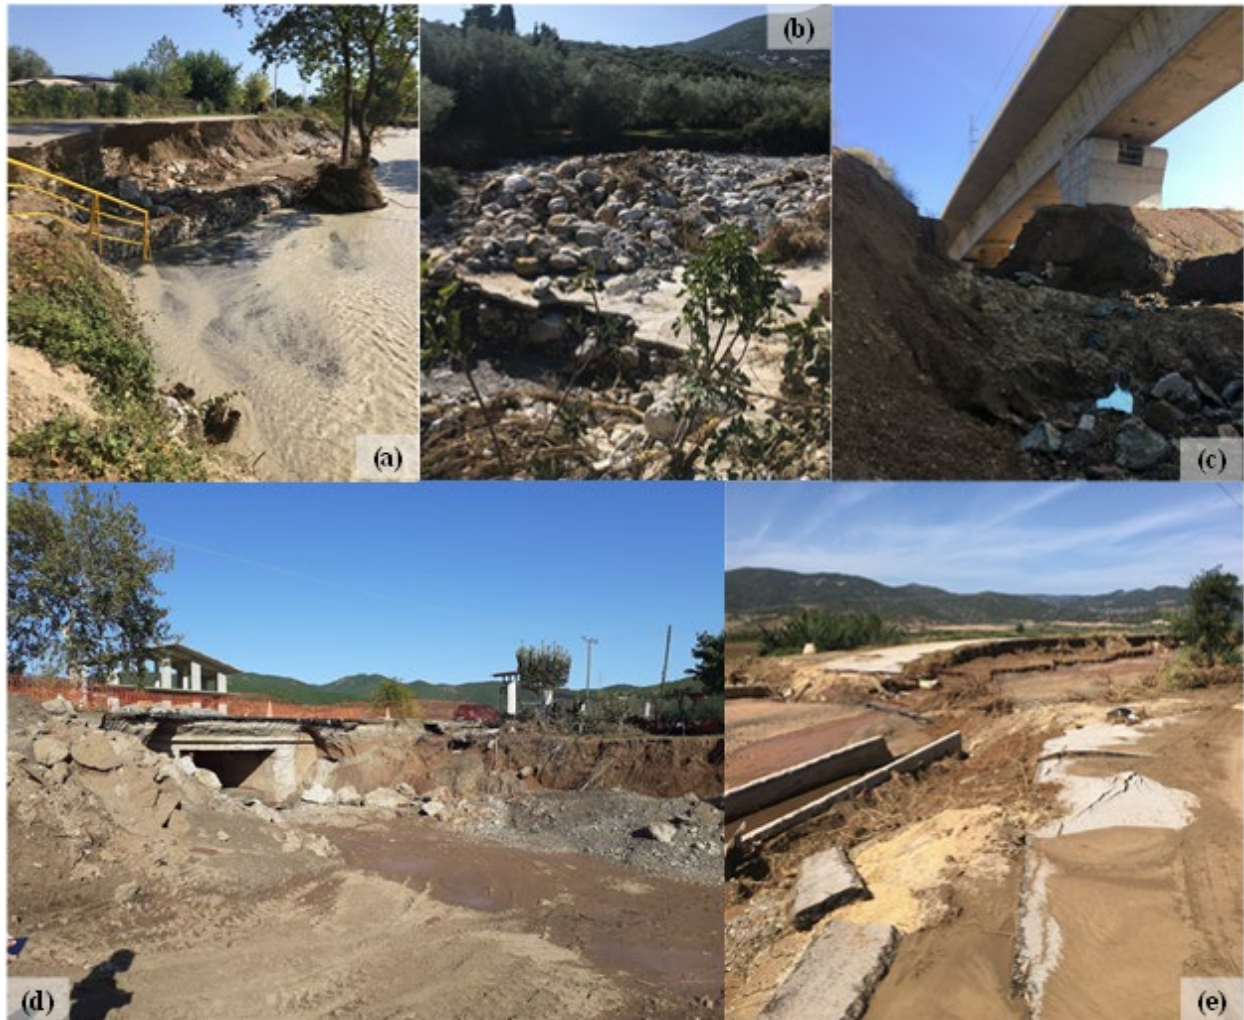
Figure 4.14. Characteristic damages in the region of Lamia following Medicanne Ianos: a) riverbank erosion and road embankment failure, b) extensive debris flow, c) bridge foundation scour, d) riverbank erosion, and e) road embankment failure

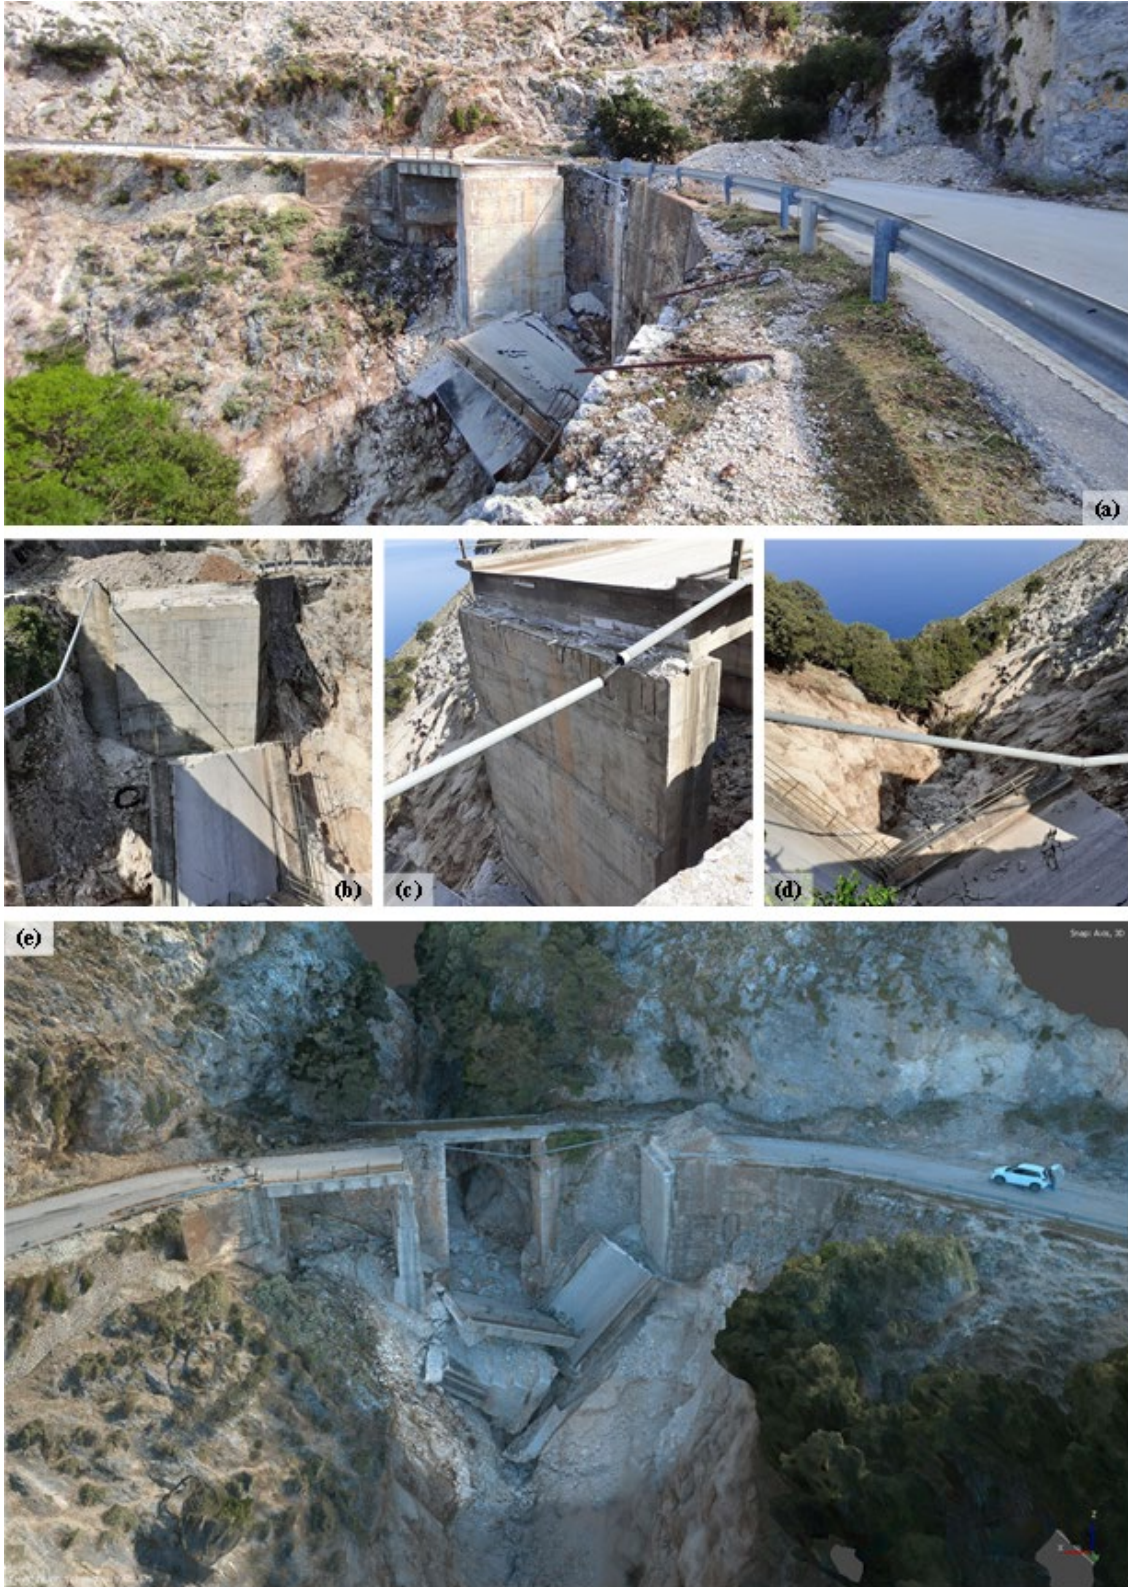
Figure 5.1. Collapsed multi-span RC bridge on E.O. Argostoliou-Fiskardou ($38.319506^{\circ}\text{N}$, $20.508197^{\circ}\text{E}$): a-d) roadside photos, e) UAV-enabled 3D texture mesh - perspective view (view 3D model at: <https://skfb.ly/6WyYT>)

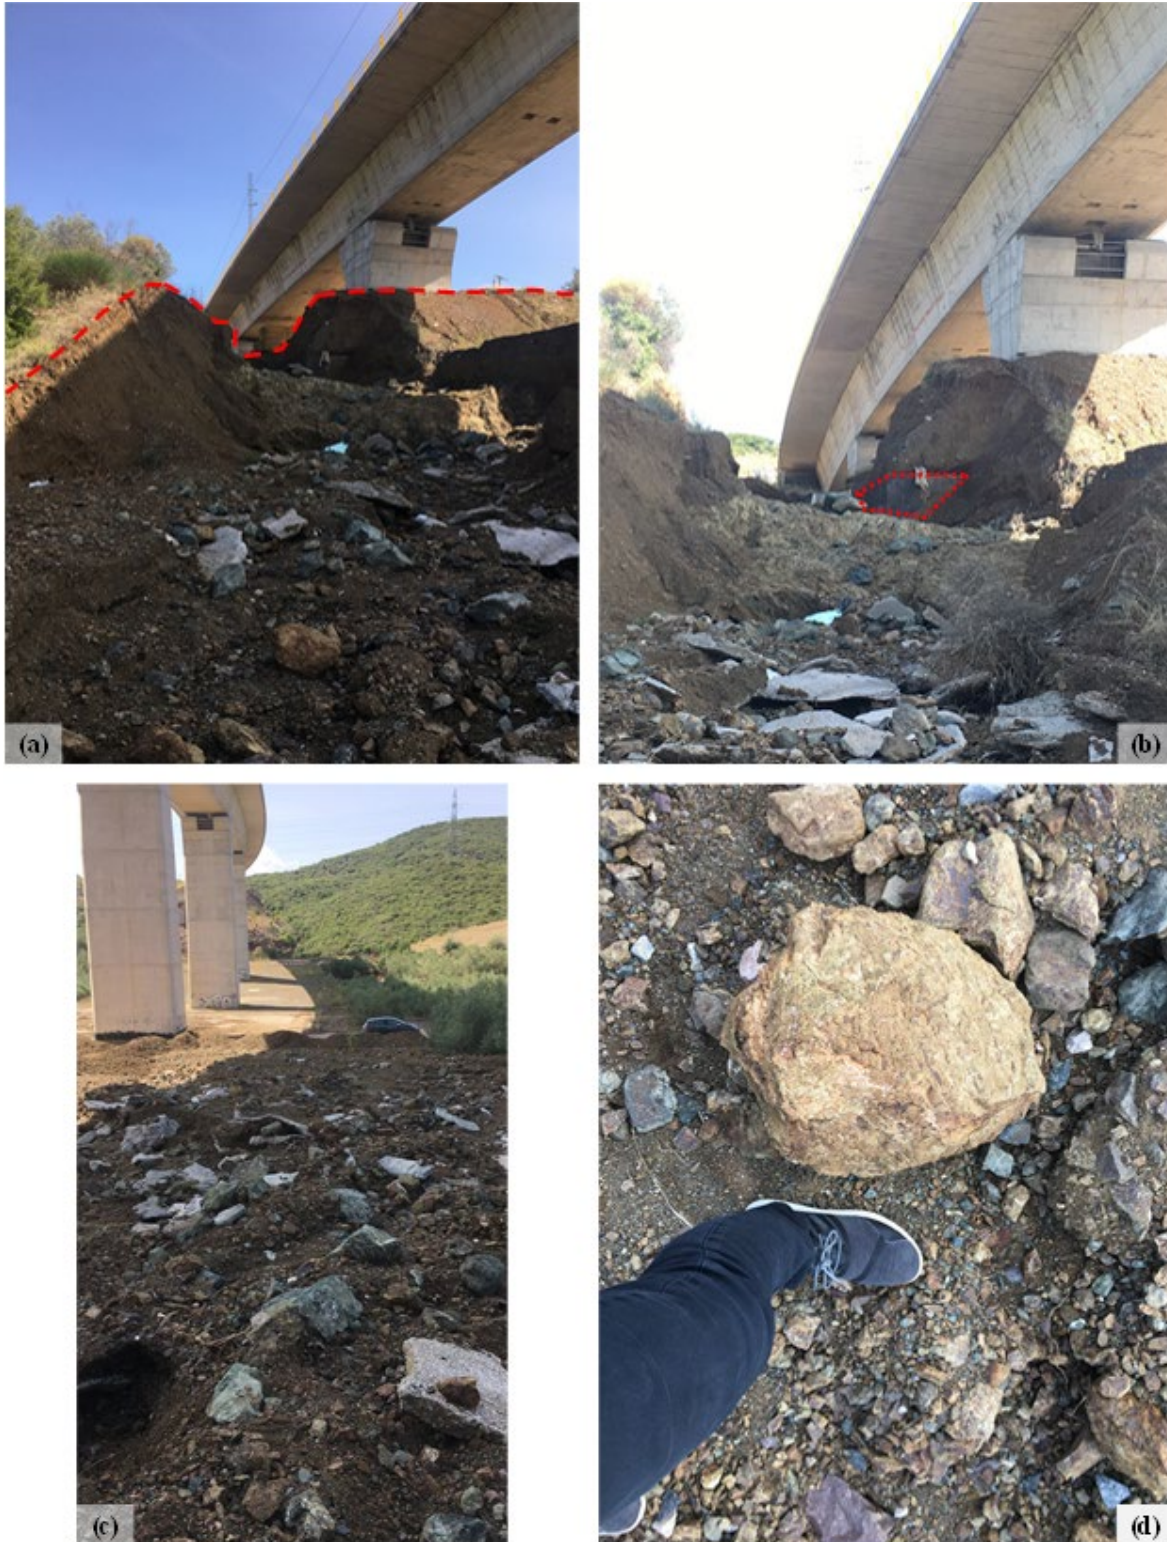
Figure 5.4. Railway bridge foundation scour (38.9609999722°N, 22.3005999722°E): a) eroded scar of bridge foundation embankment, b) exposed pier foundation, c) view of bridge and eroded embankment, and d) indicative size of debris on site

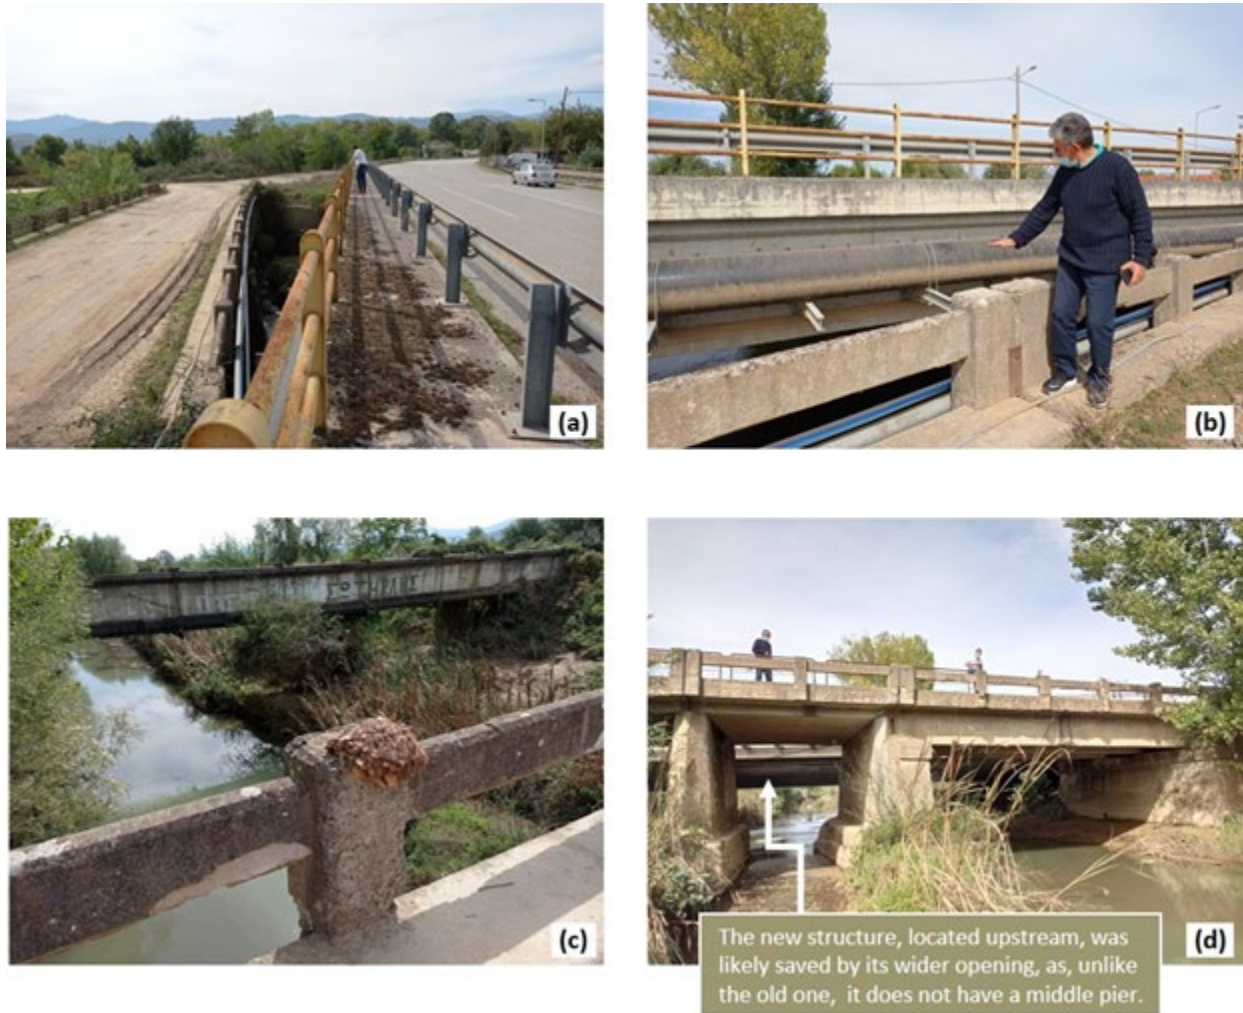
Figure 5.6. Photos of Bridge No. 3: a pair of RC bridges crossing the Gavria Rema along the Karditsa – Kastania provincial road (39.344589222°N; 21.894189833°E): (a) evidence of overflow over the older bridge, which is located a few meters downstream of the younger structure; (b) level of water height; (c) debris remains at the deck; and (d) side view of the structure showing no structural damage.

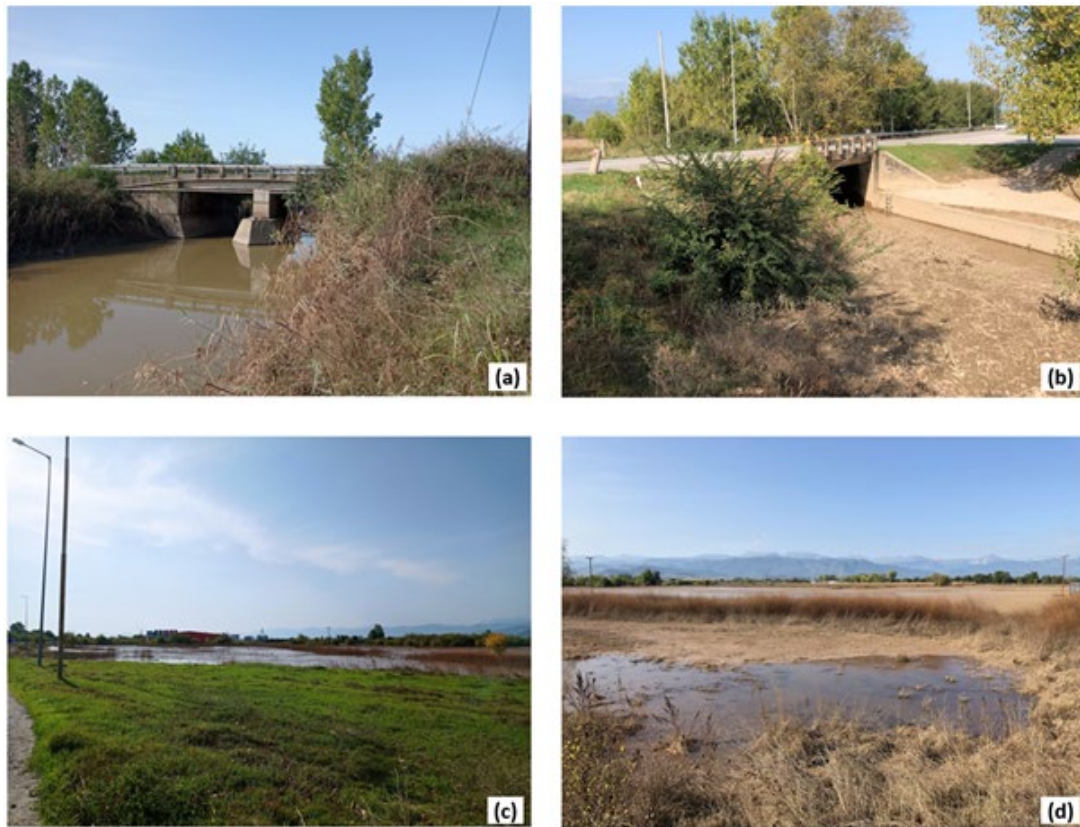
Figure 5.10. Photos of (a) Bridge No.14 (39.097792474°N; 21.878223628°E) and (b) Bridge No. 15 (39.47911111° N; 21.84343611° E) which suffered negligible damage despite being reportedly flooded, with water heights in the (c) – (d) nearby fields exceeding 1.5 m (according to communication with local people).

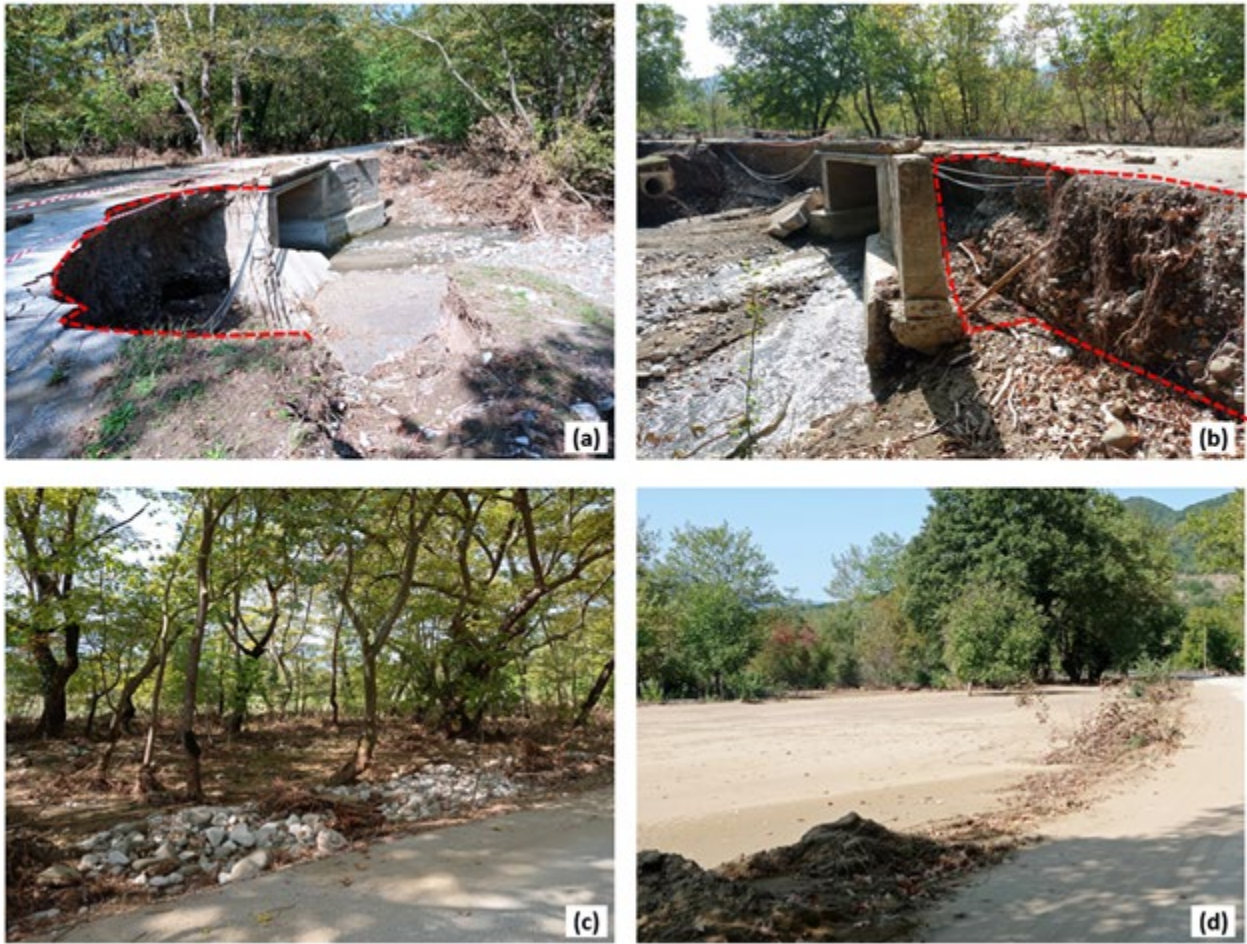
Figure 5.13. Bridge No. 10 crossing a secondary gully on the way from Mouzaki to Ellinokastro (39.401844000° N; 21.668420778° E): (a) western abutment; (b) eastern abutment; and (c) – (d) photos of surrounding fields indicating widespread flooding.

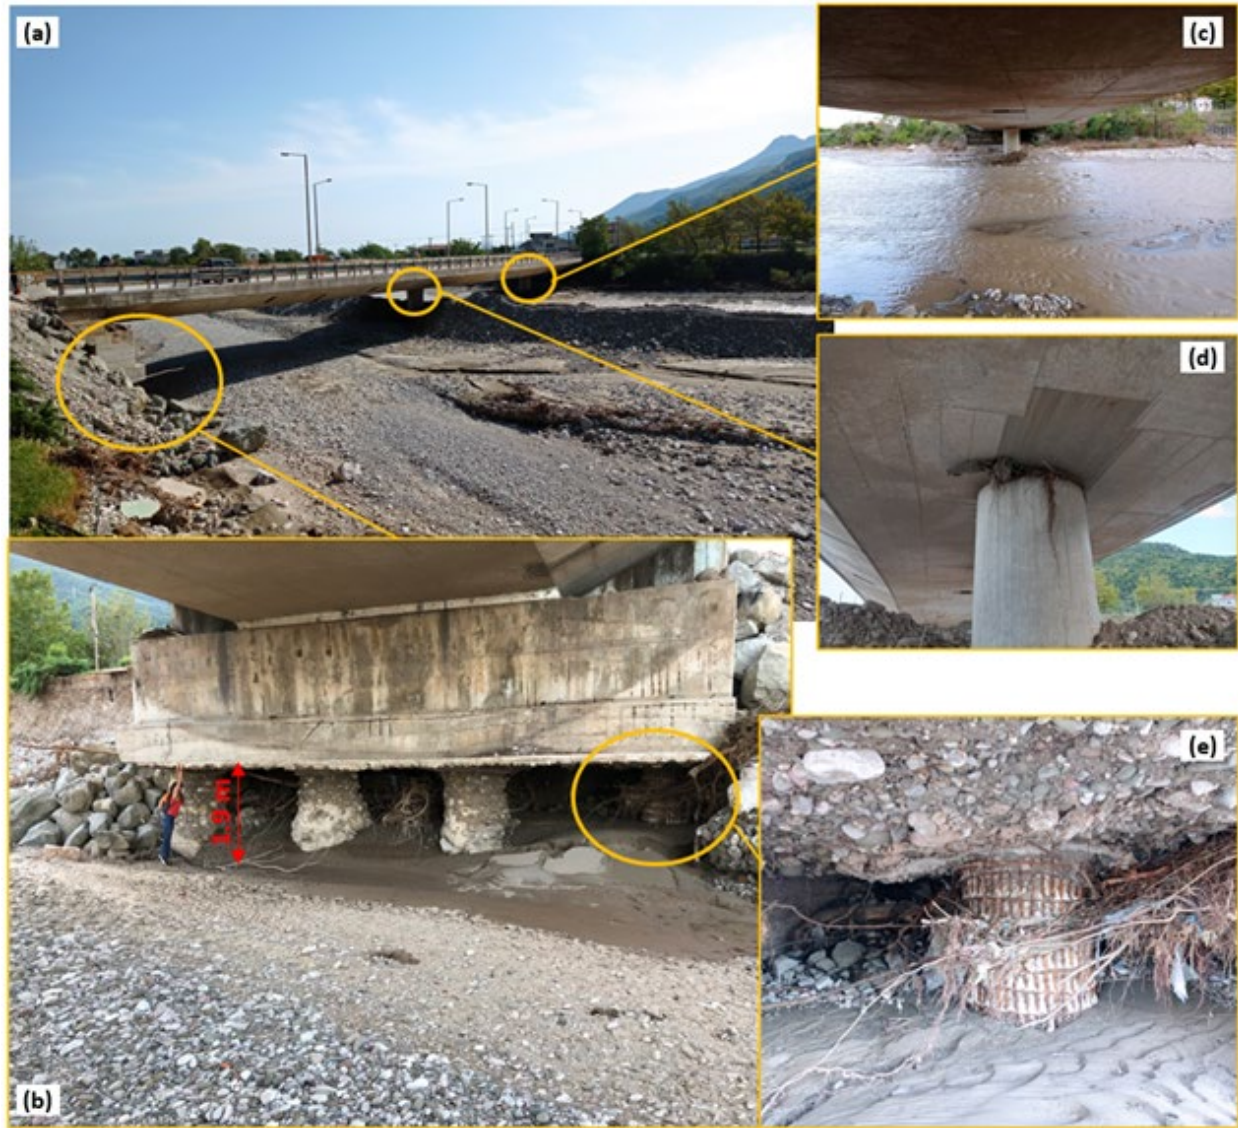
Figure 5.15. Photos of Bridge No. 7, the road bridge crossing Pamissos river in the center of Mouzaki (39.427341667°N; 21.667275000°E): (a) side view; (b) abutment scour; (c) unaffected, opposite (SE) side; (d) debris stuck within the connection between pier and deck indicating flood water height.

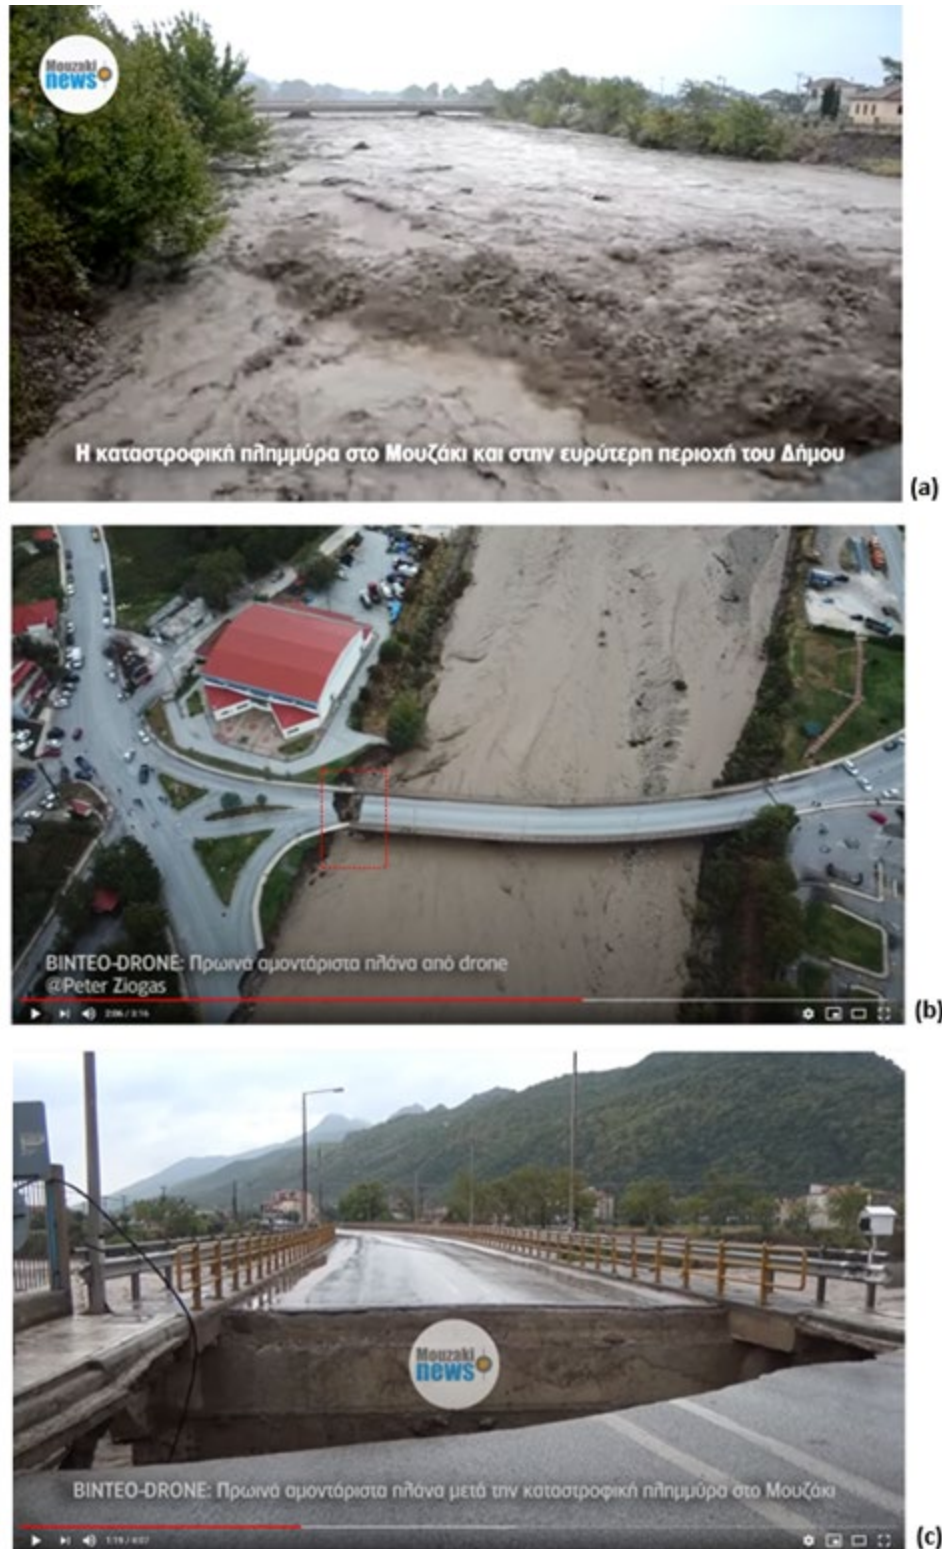
Figure 5.16. Footage of Bridge No. 7, in local news showing: (a) the water height on September 18, 2020 (<https://www.youtube.com/watch?v=7TzUZh3YgxY>); and (b) – (c) the abutment failure and associated roadway collapse (<https://www.youtube.com/watch?v=hLP3NdMF9SI>).

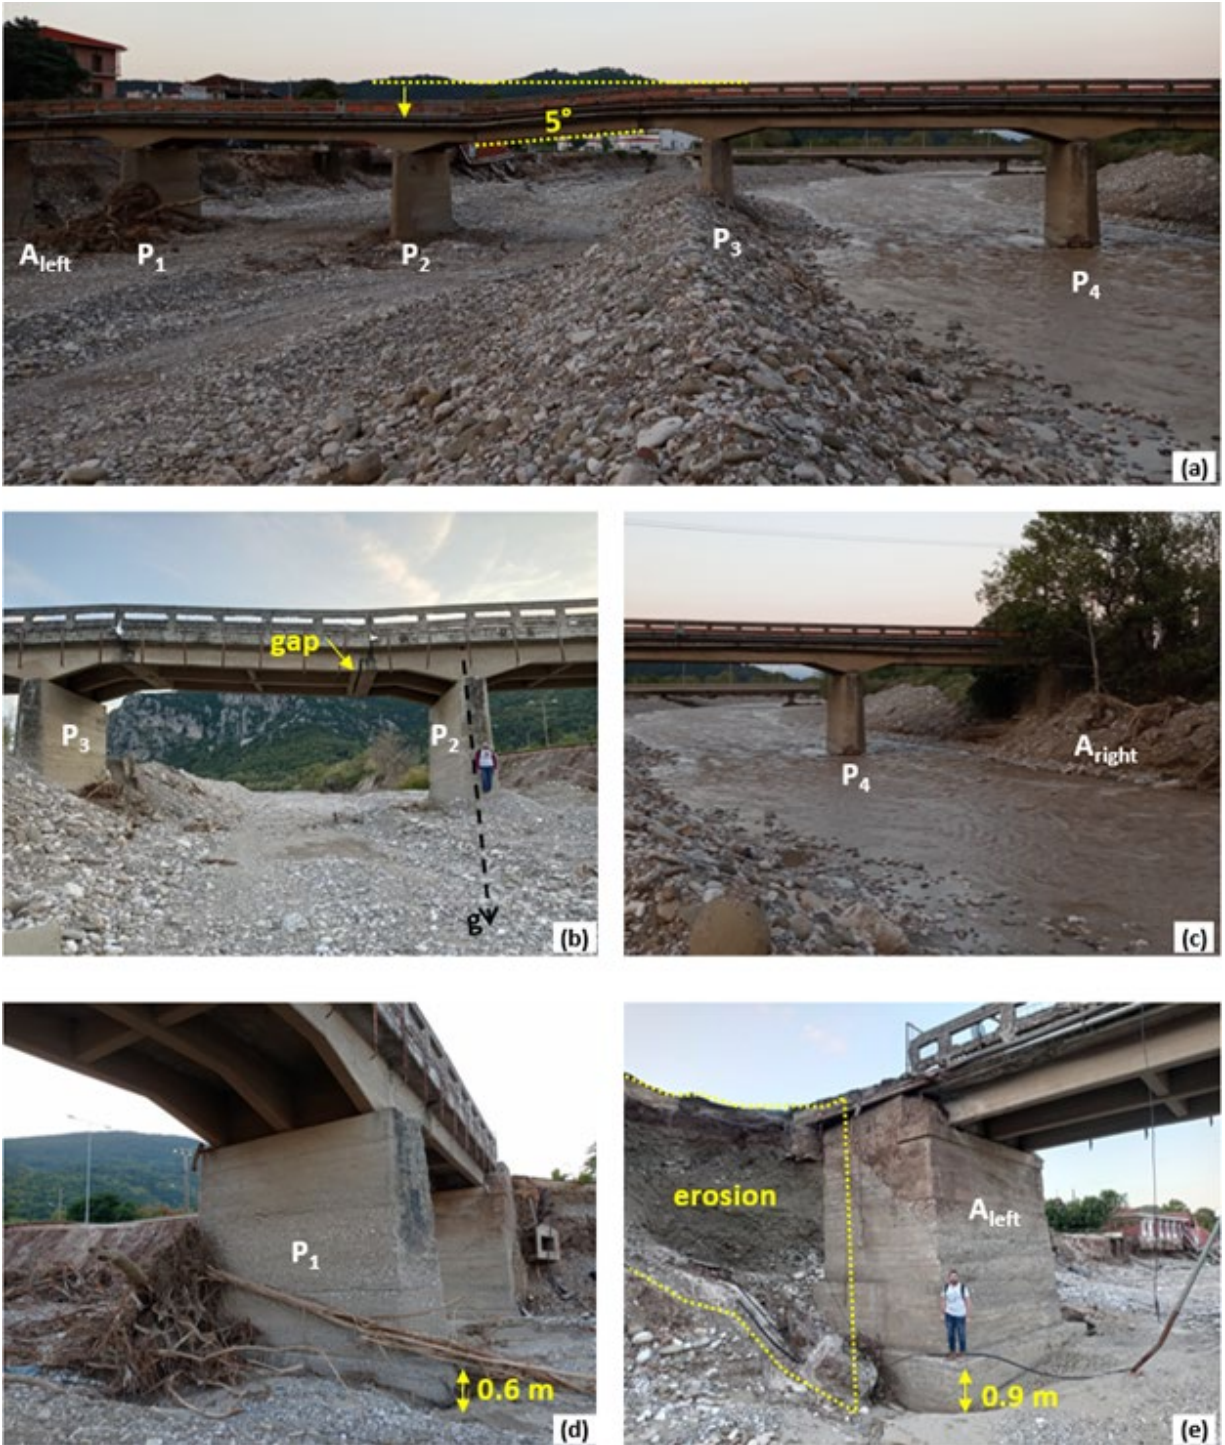
Figure 5.17. Photos of the severely damaged pedestrian bridge in Mouzaki, i.e. Bridge No. 8 (39.425804111°N; 21.666233056°E): (a) longitudinal direction indicating the substantial settlement of the left side (Pier 2) and the associated rotation of the deck; (b) closer view of piers 2 and 3; (c) the evidently unaffected right side; (d) scour at P1; and (e) abutment scour and backfill erosion.

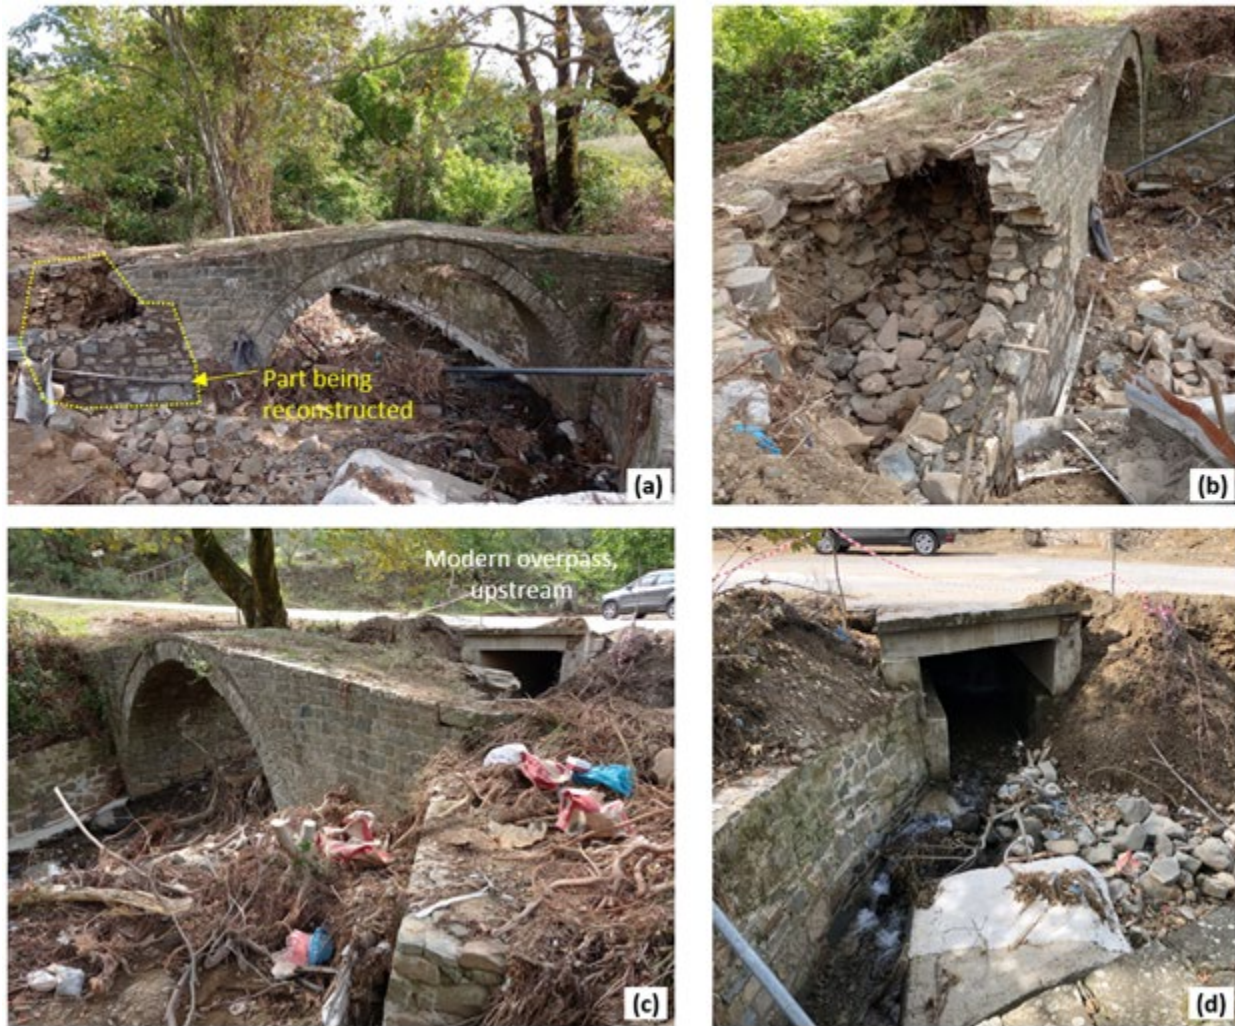
Figure 5.25. Photos of Bridge No.2, a masonry arch near Moschato (39.32248333°N; 21.79625000°E): (a) – (b) part of it was being reconstructed on 2/10/2020, while (c) there was a significant amount of debris upstream, especially in the (d) modern (RC) overpass.

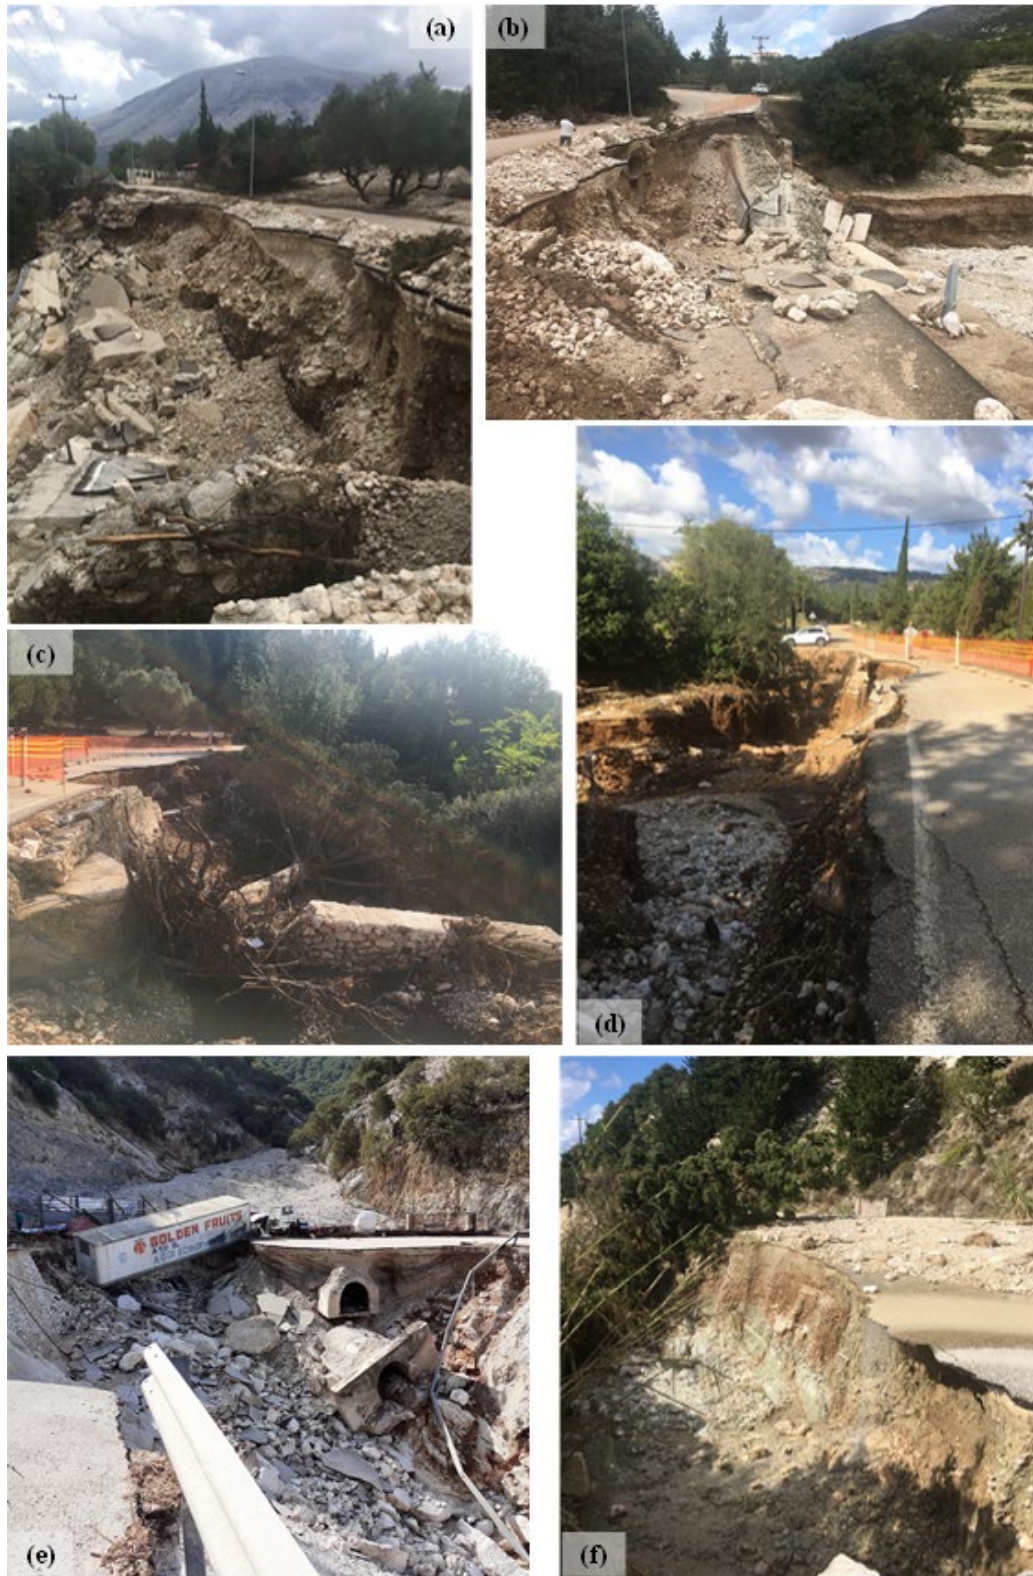
Figure 5.27. Road embankment failures across Cephalonia due to flood/debris related erosion:
a,b) 38.325680556°N, 20.551658333°E, c,d) 38.310936111°N, 20.576272222°E, e)
38.326667°N, 20.518333°E, and f) 38.335719444°N, 20.543761111°E

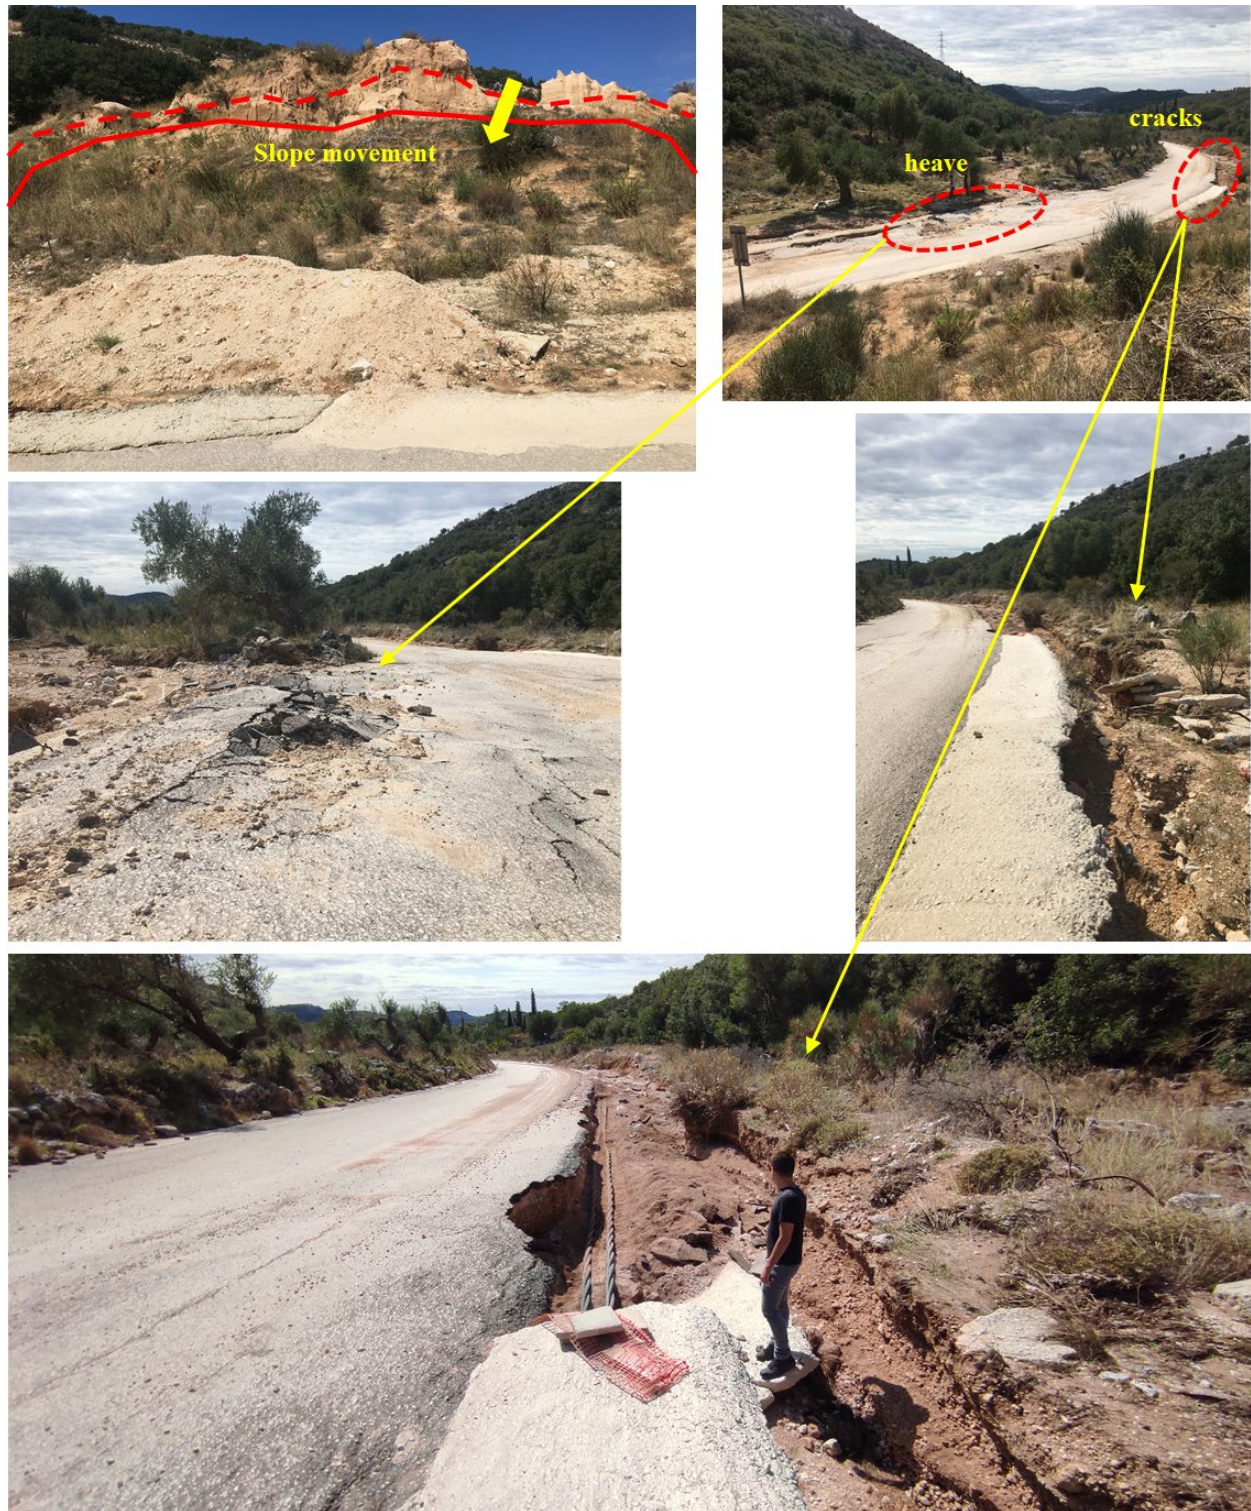
Figure 5.28. Roadside slope failure that led to road heave and cracks along a 150 m stretch (38.201636111°N, 20.502291667°E)

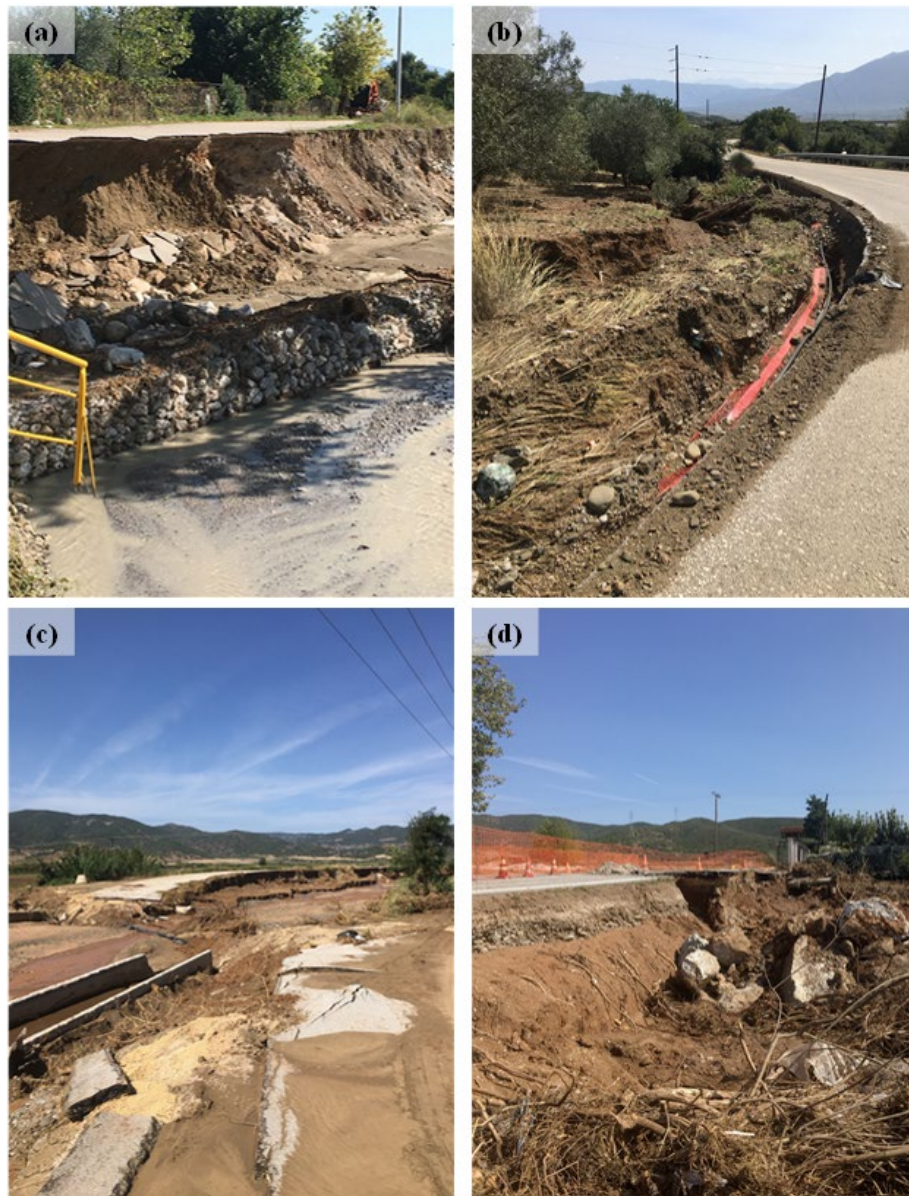
Figure 5.29. Road embankment failures in the region of Lamia: a) at Gorgopotamos (38.83451944°N, 22.39527499°E); b) north of Stirfaka (38.96918055°N, 22.29513611°E); c) along the E.O. Lamia Karpenisi (38.92455°N, 22.27771944°E); d) near Paliouri (38.94233611°N, 22.21619722°E)

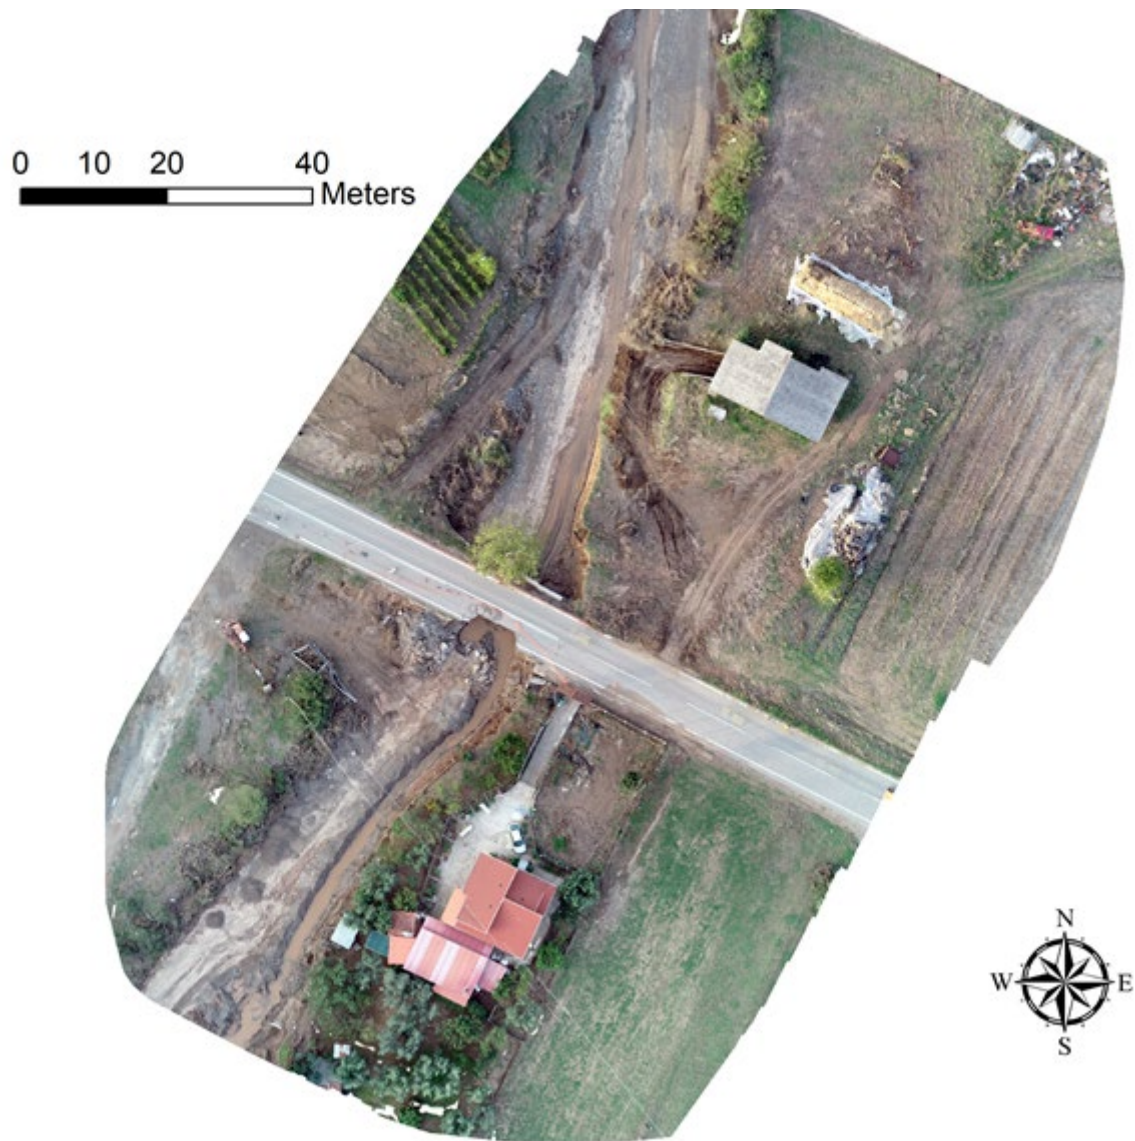
Figure 5.30. UAV-enabled orthophoto of road failure on E.O. Lamia-Karpenisi ($38.94233611^{\circ}\text{N}$, $22.21619722^{\circ}\text{E}$)
