The September 18-20 2020 Medicane Ianos Impact on Greece

Phase I Reconnaissance Report

Geotechnical Extreme Events Reconnaissance Association

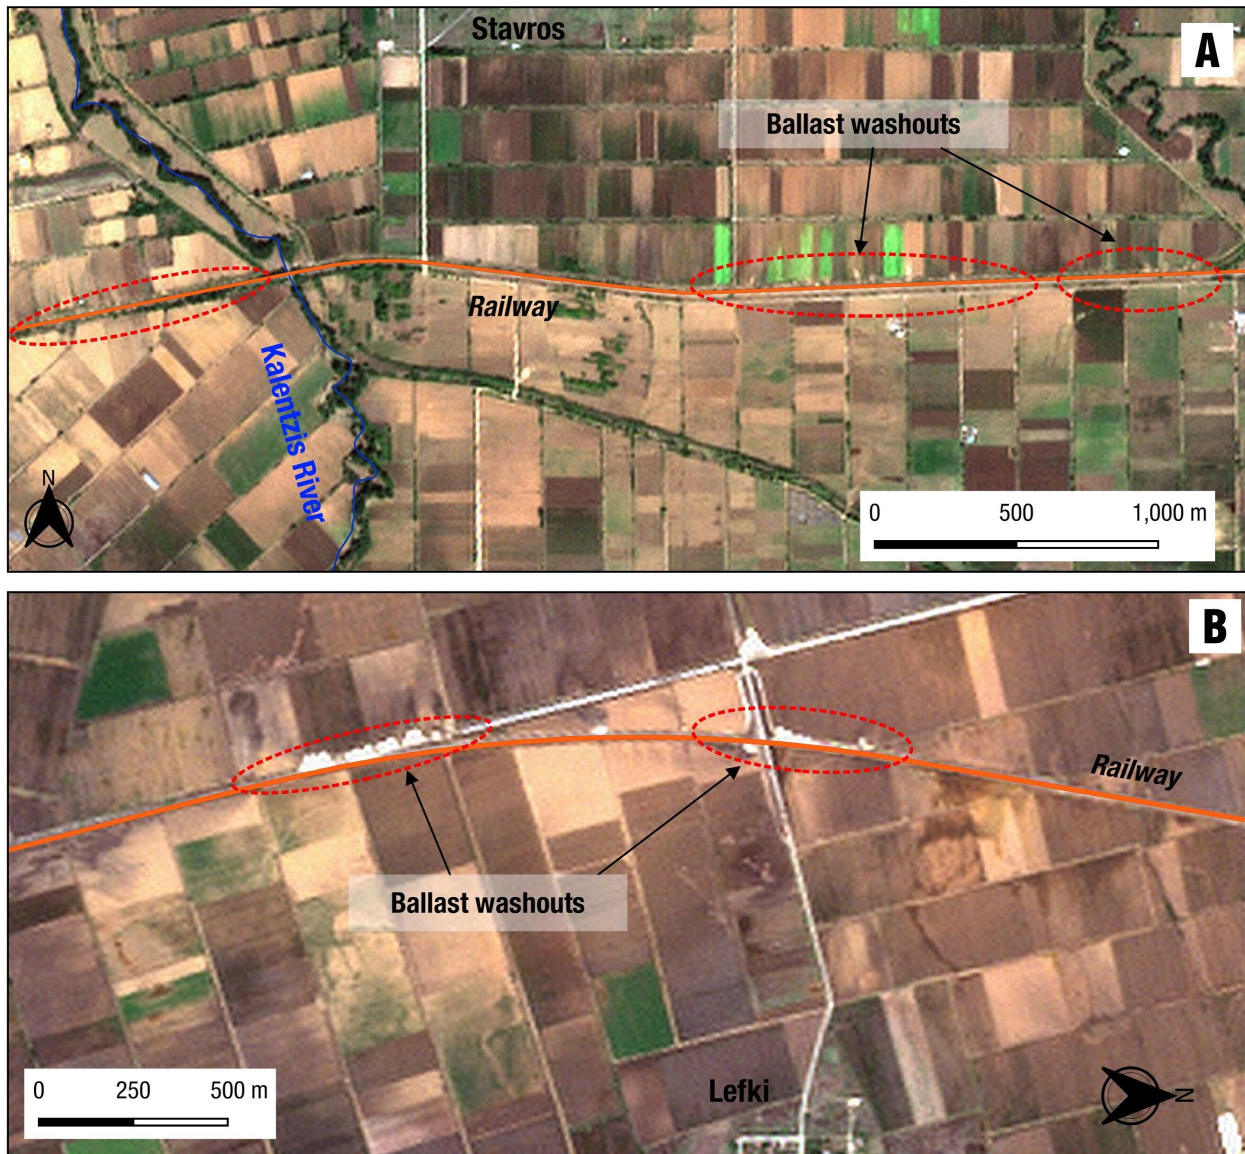
Figure 5.36. Locations of significant washout along the railway line embankment, distinguished by the lateral flow of eroded material (ballast washouts). A) Railway line Kalabaka-Paleofarsalos, east of Karditsa (map center location 39.34951°N , 21.9852°E). B) Railway line Paleofarsalos-Larisa, north of Paleofarsalos (Stavros) (map center location 39.3800°N , 22.2234°E). Sentinel-2 true color imagery (RGB432) acquired in September 25 2020, enhanced using Sub-Pixel Convolutional Neural Network (super-resolution).

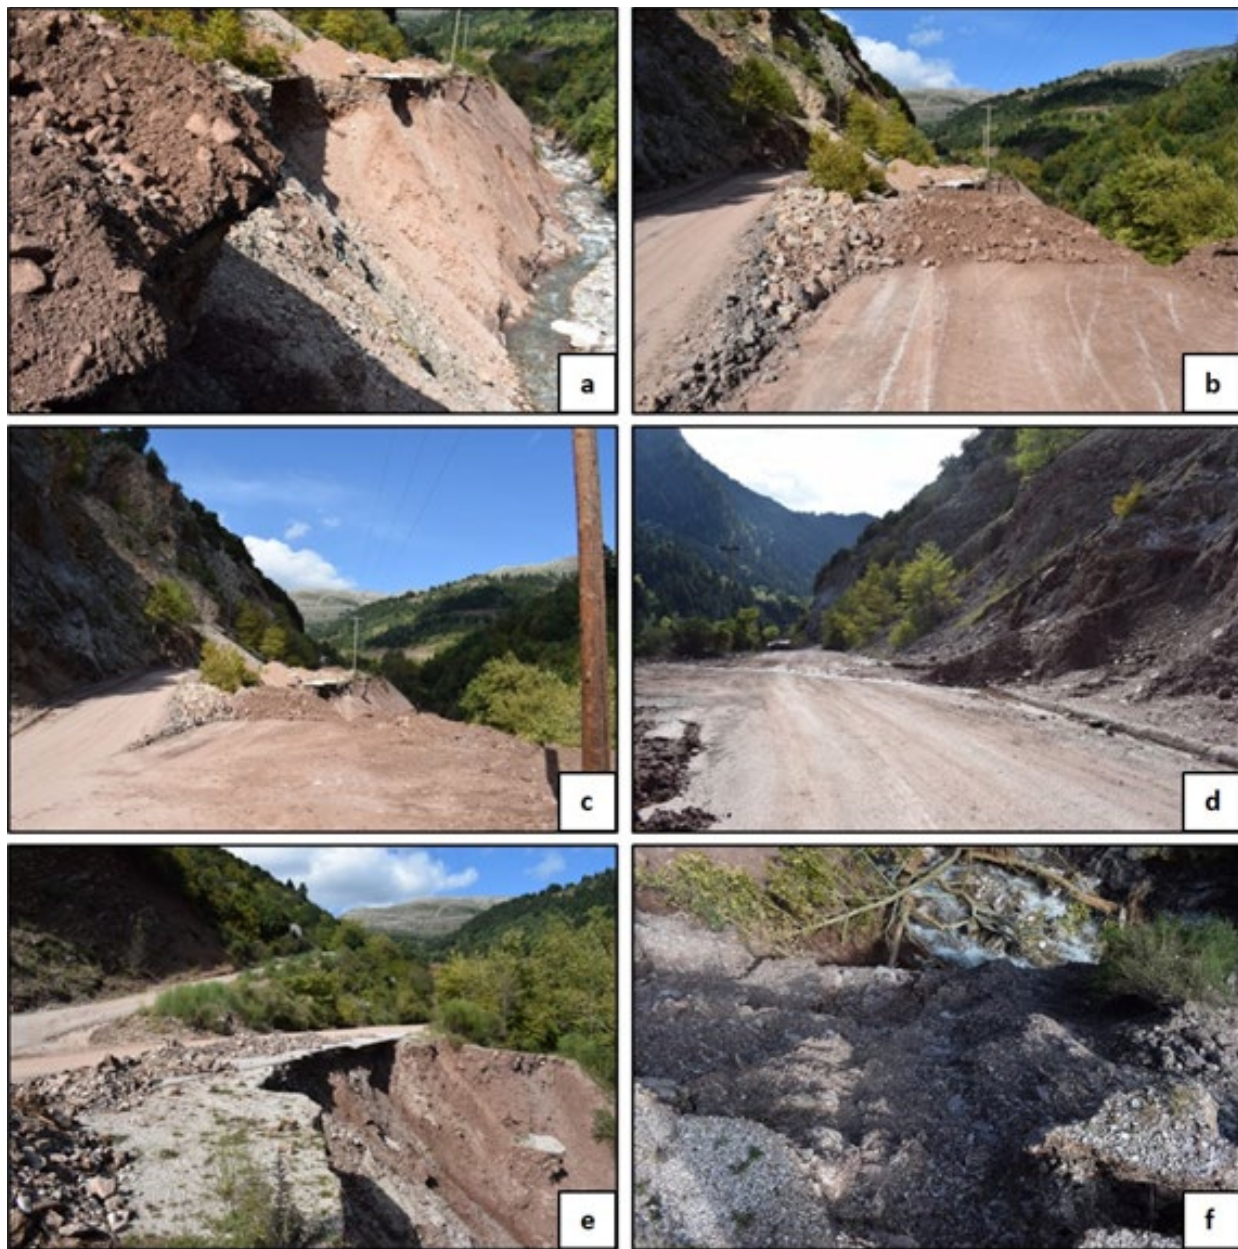
Figure 6.10. Rotational slide that caused road damage next to Argithea village (39.356111°N, 21.535556°E).

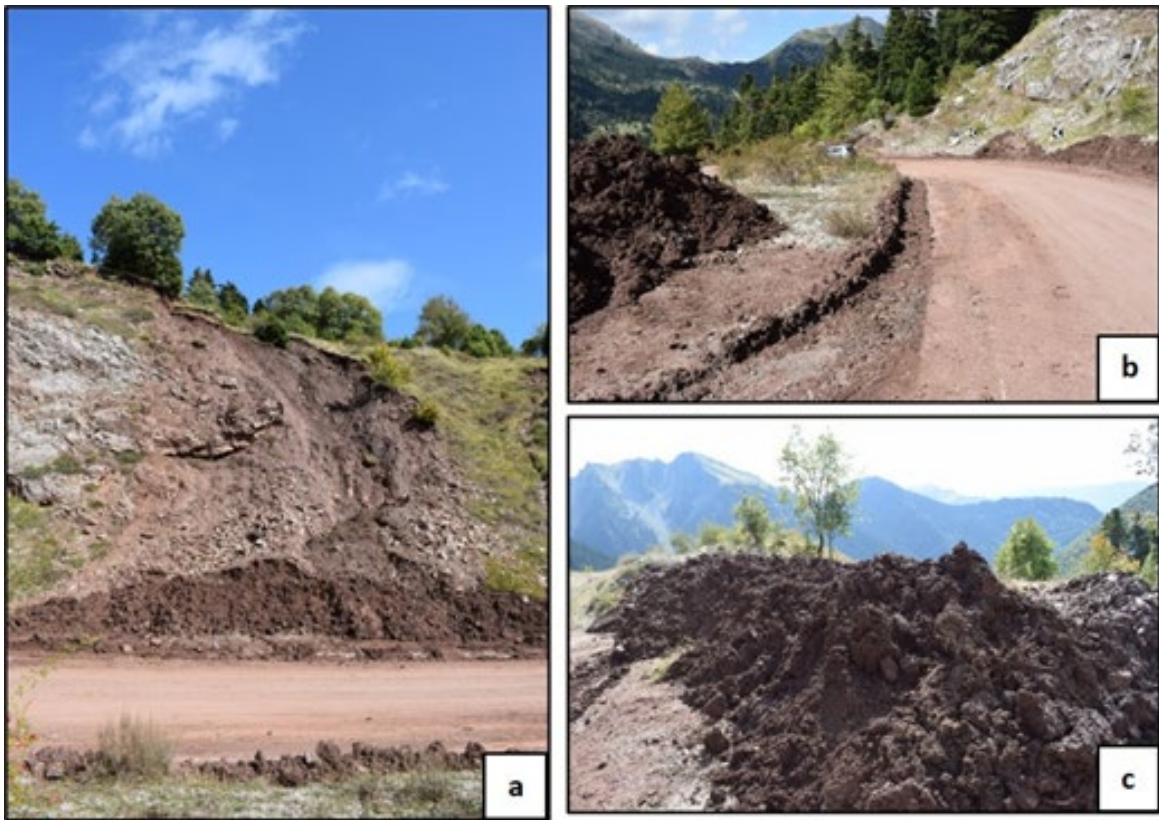
Figure 6.11. Rotational slide in Eastern Argithea area (39.364444°N, 21.541111°E)

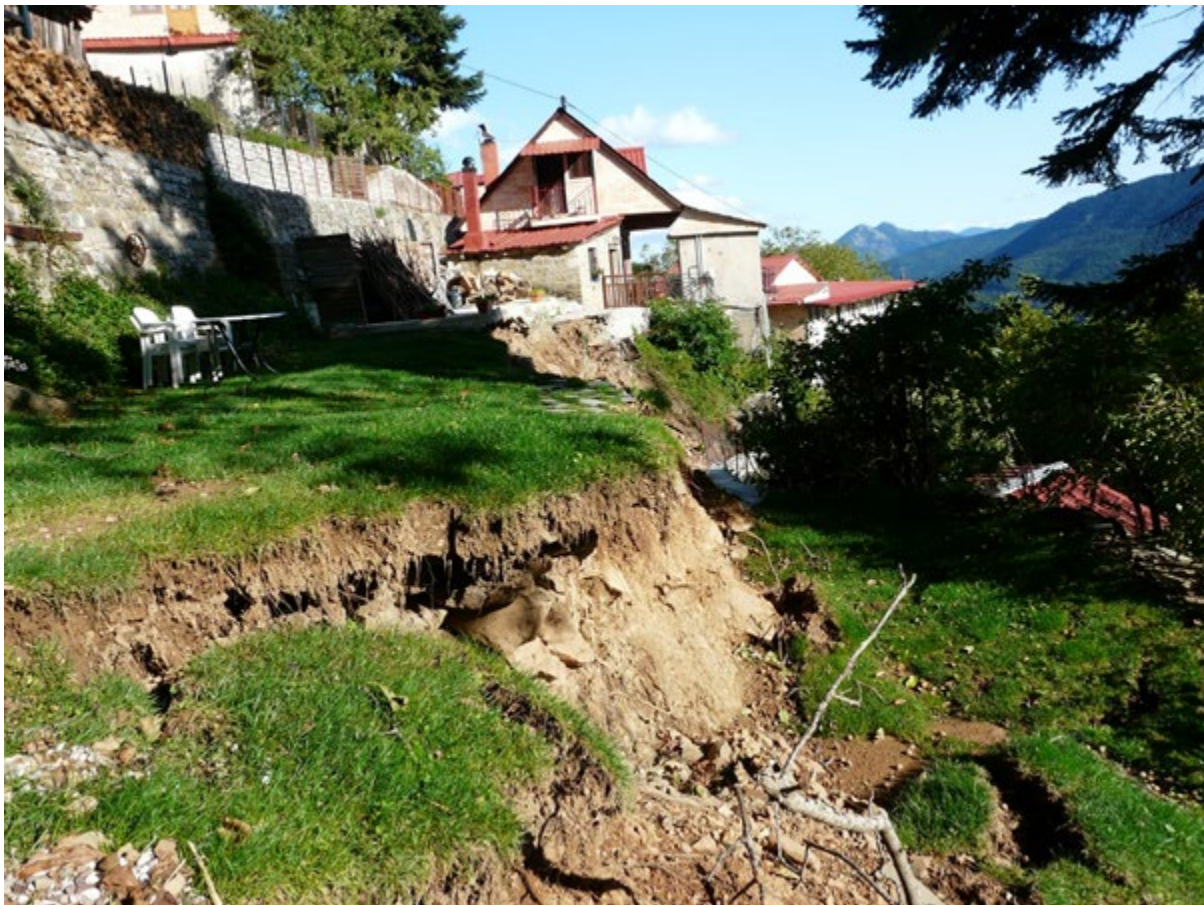
Figure 6.18. Rotational slide causing structural damage at the village of Rafina (39.27172°N, 21.69607° E)

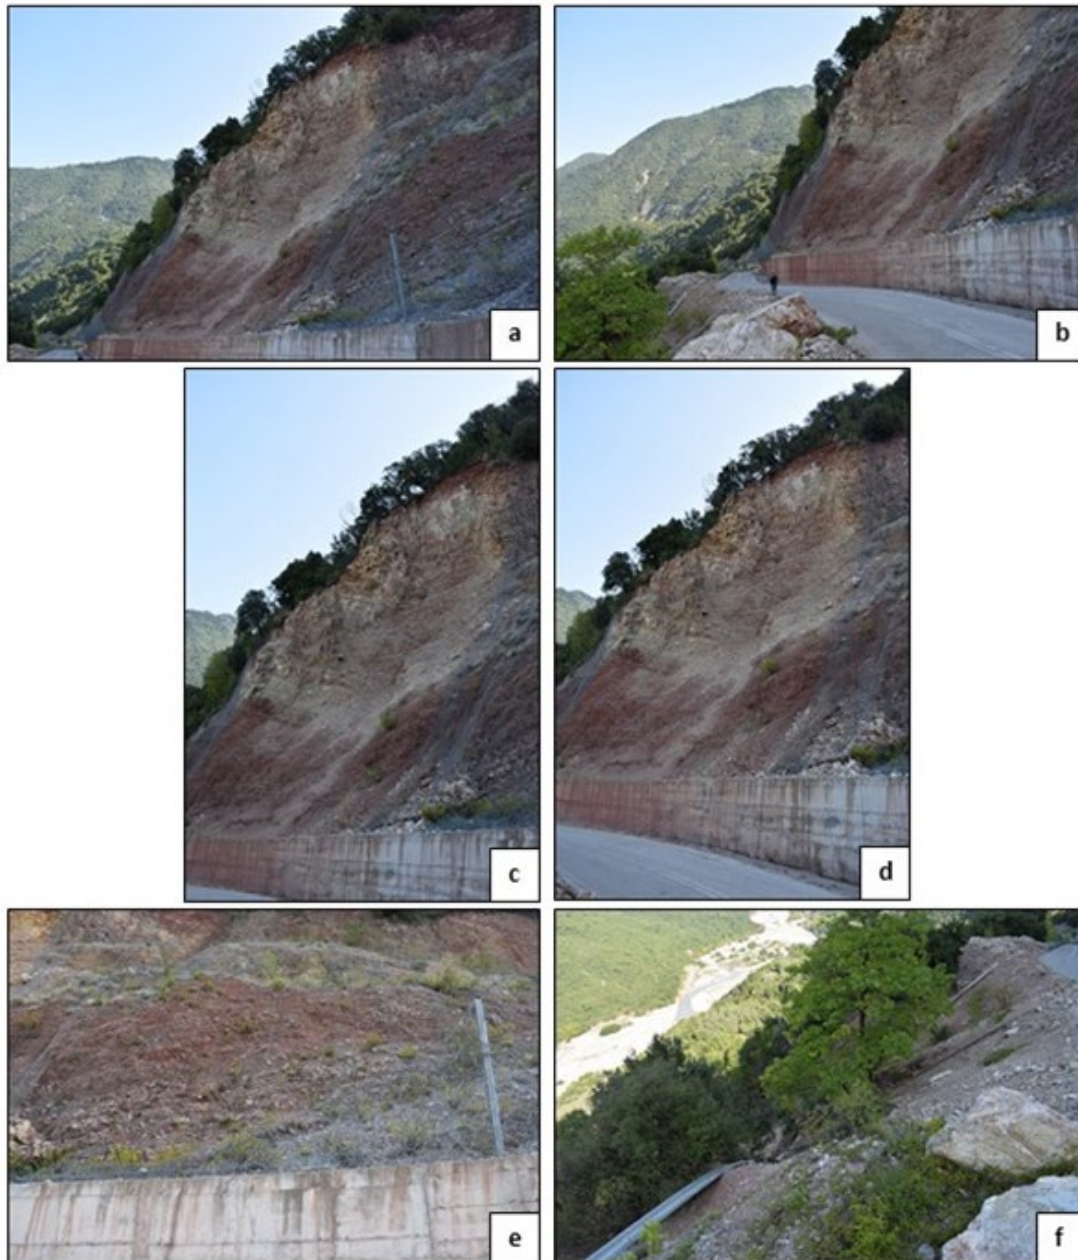
Figure 6.26. Rockfall failure at the area of Karpenisi - Agrafa

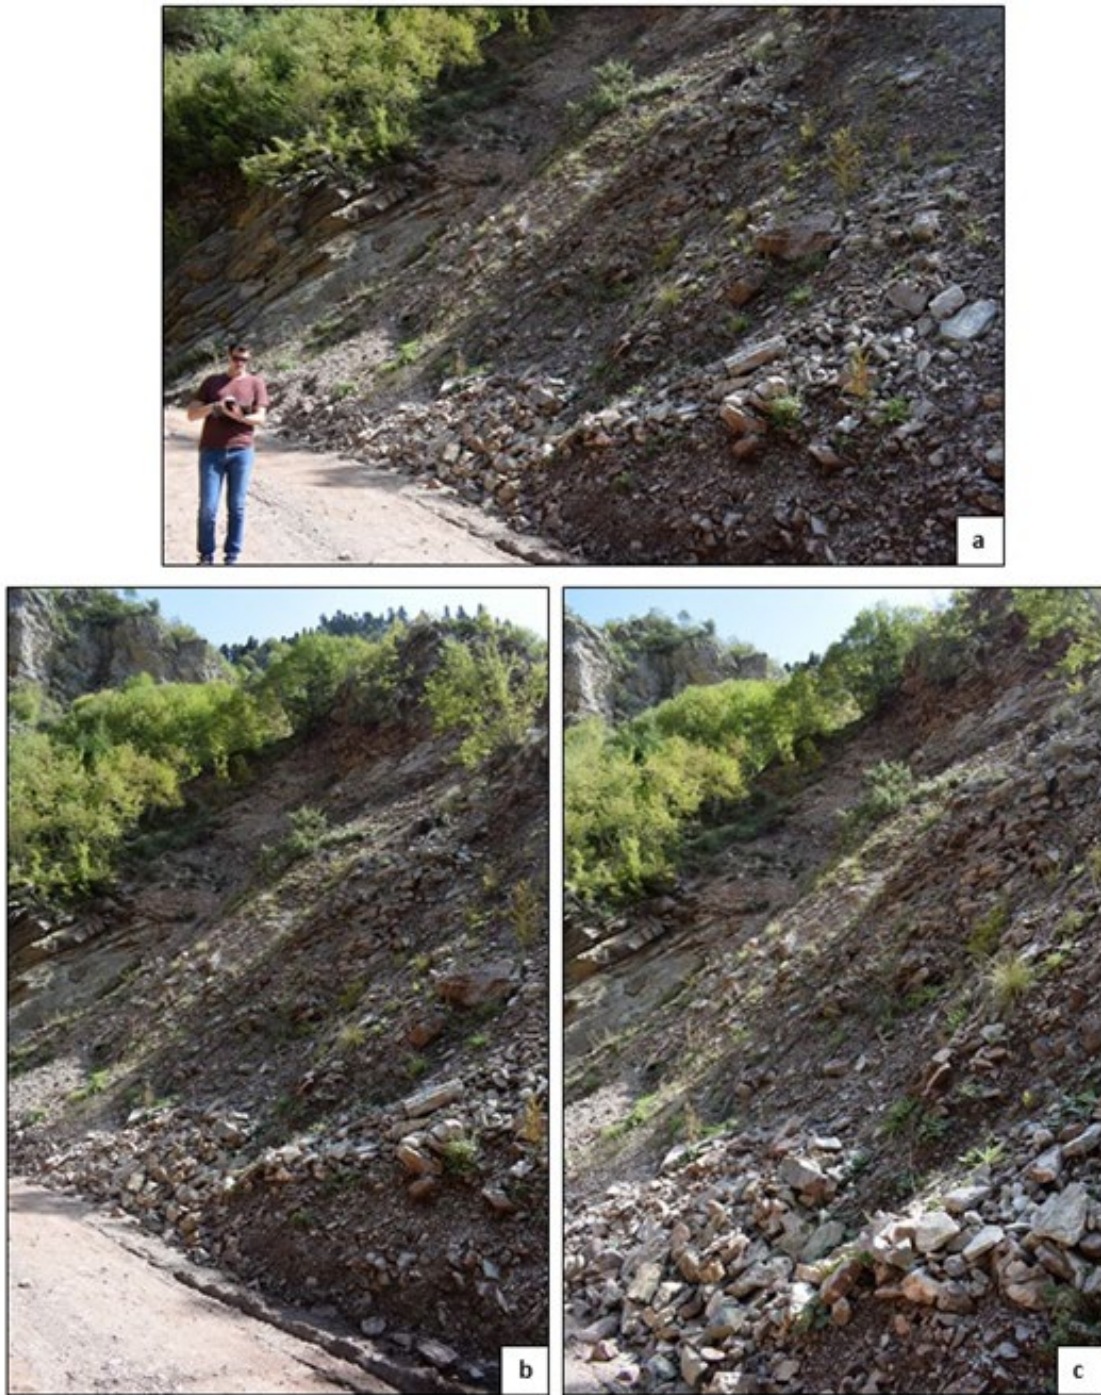
Figure 6.28. Rockslide along the road network of Karpenisi - Vraggiana

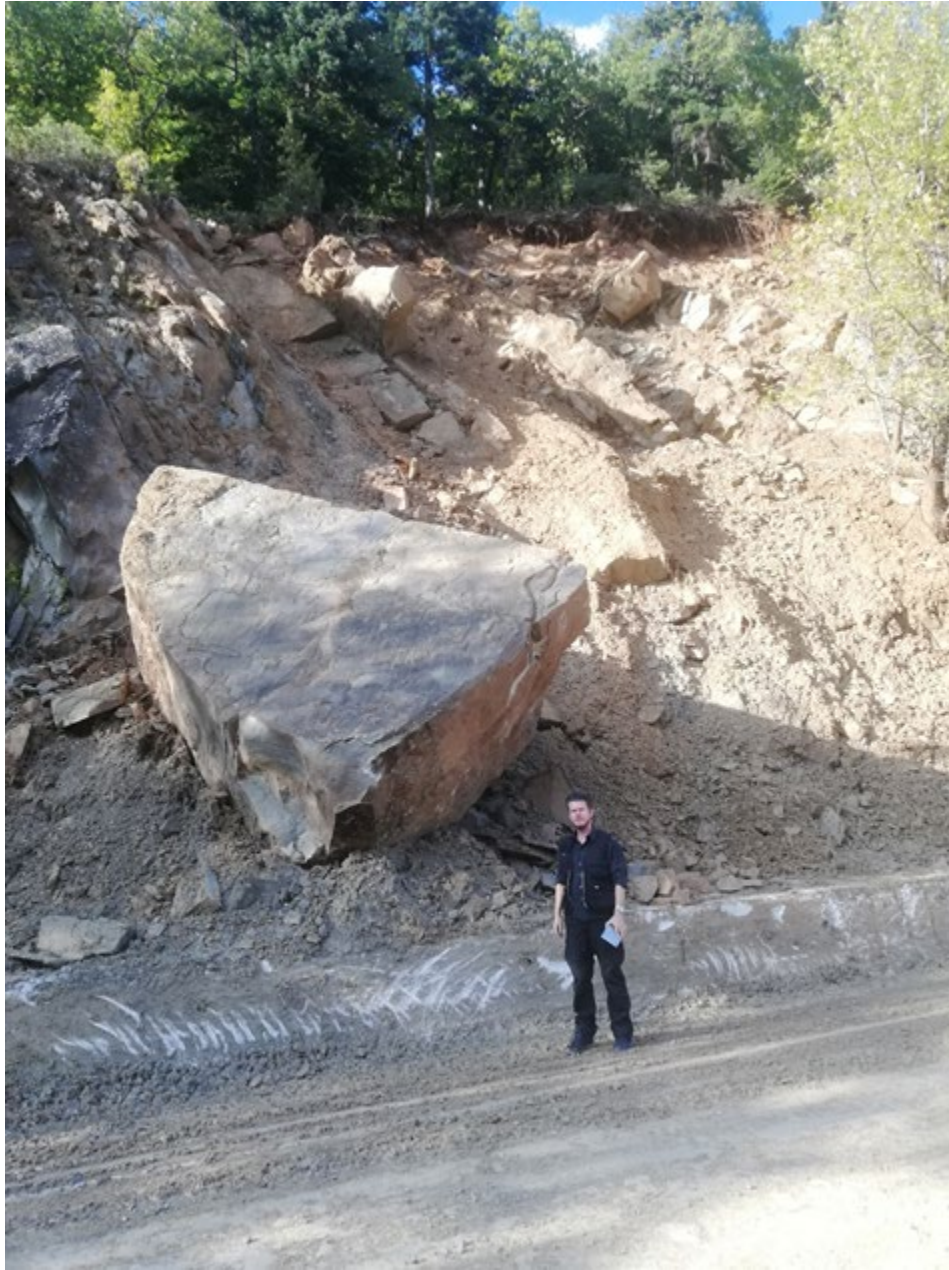
Figure 6.33. Wedge failure mechanism at the area of Belokomiti. (39.25325°N, 21.72192°E)

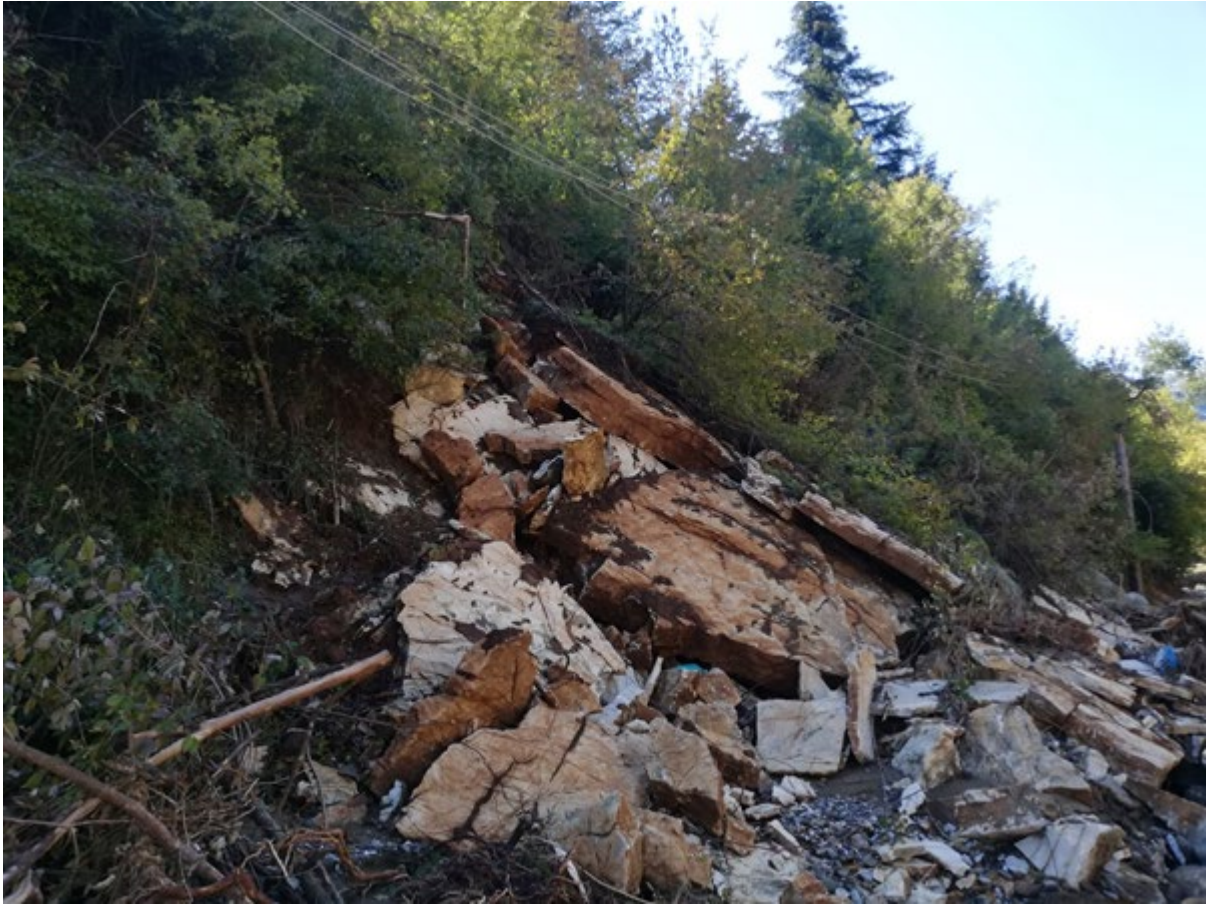
Figure 6.34. Planar sliding at the village Pezoula. (39.30406°N, 21.69014°E)

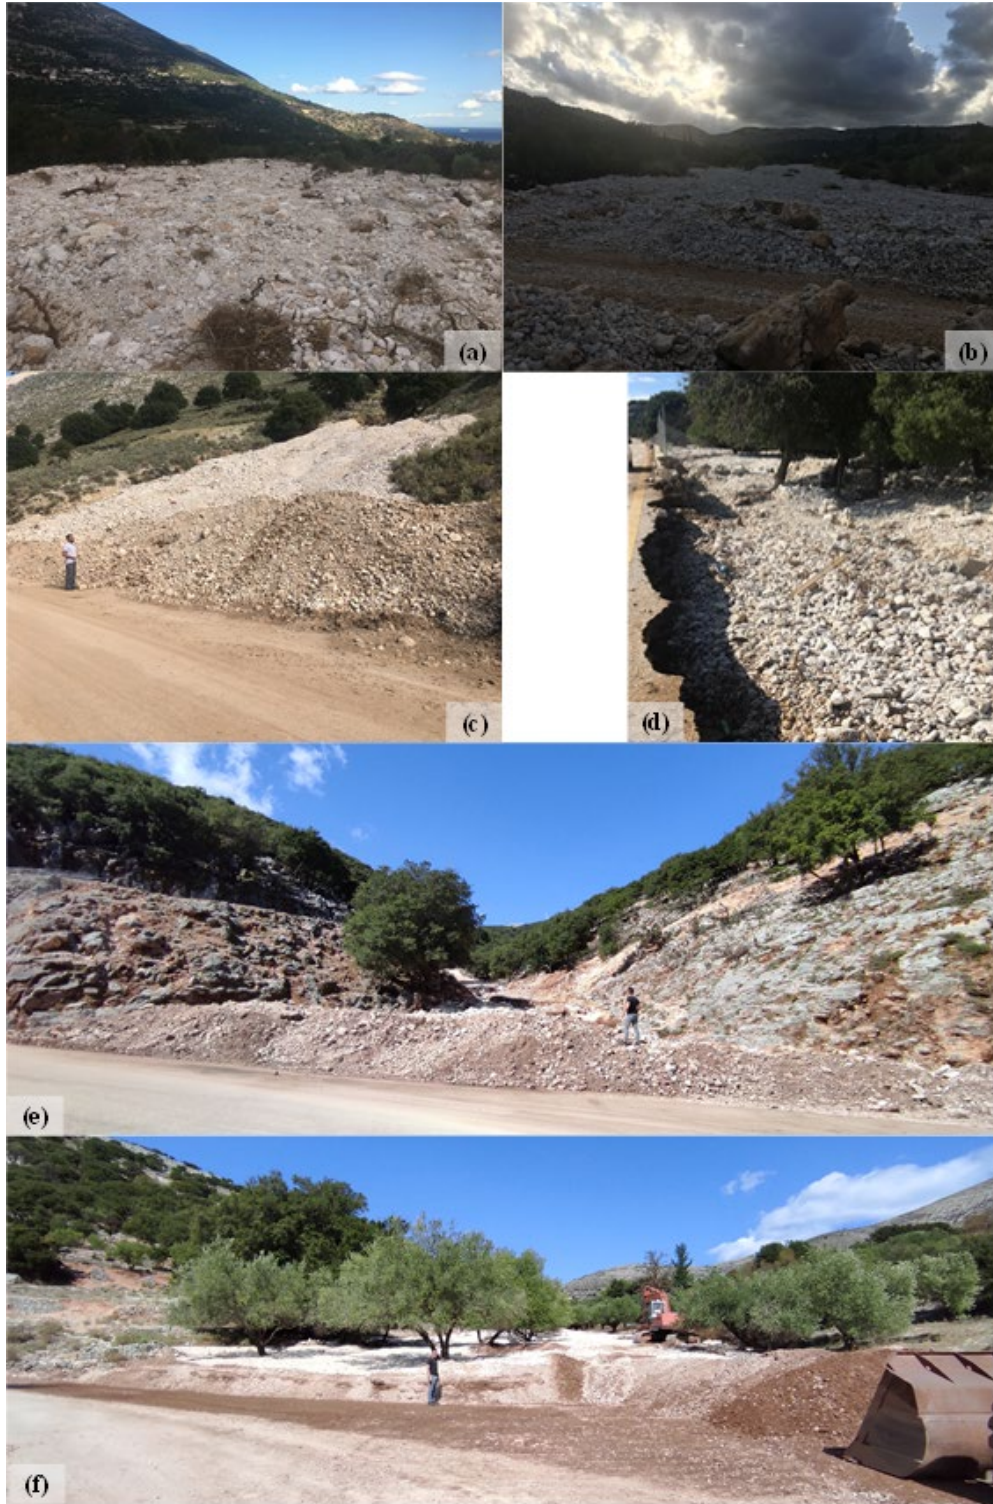
Figure 6.36. Debris flow manifestations across Cephalonia island: a) 38.309422222°N, 20.570208333°E, b) 38.309383333°N, 20.570166667°E, c) 38.307786111°N, 20.495036111°E, d) 38.291980556°N, 20.528944444°E, e) 38.306109972°N, 20.534586972°E, f) 38.231639972°N, 20.506282972°E

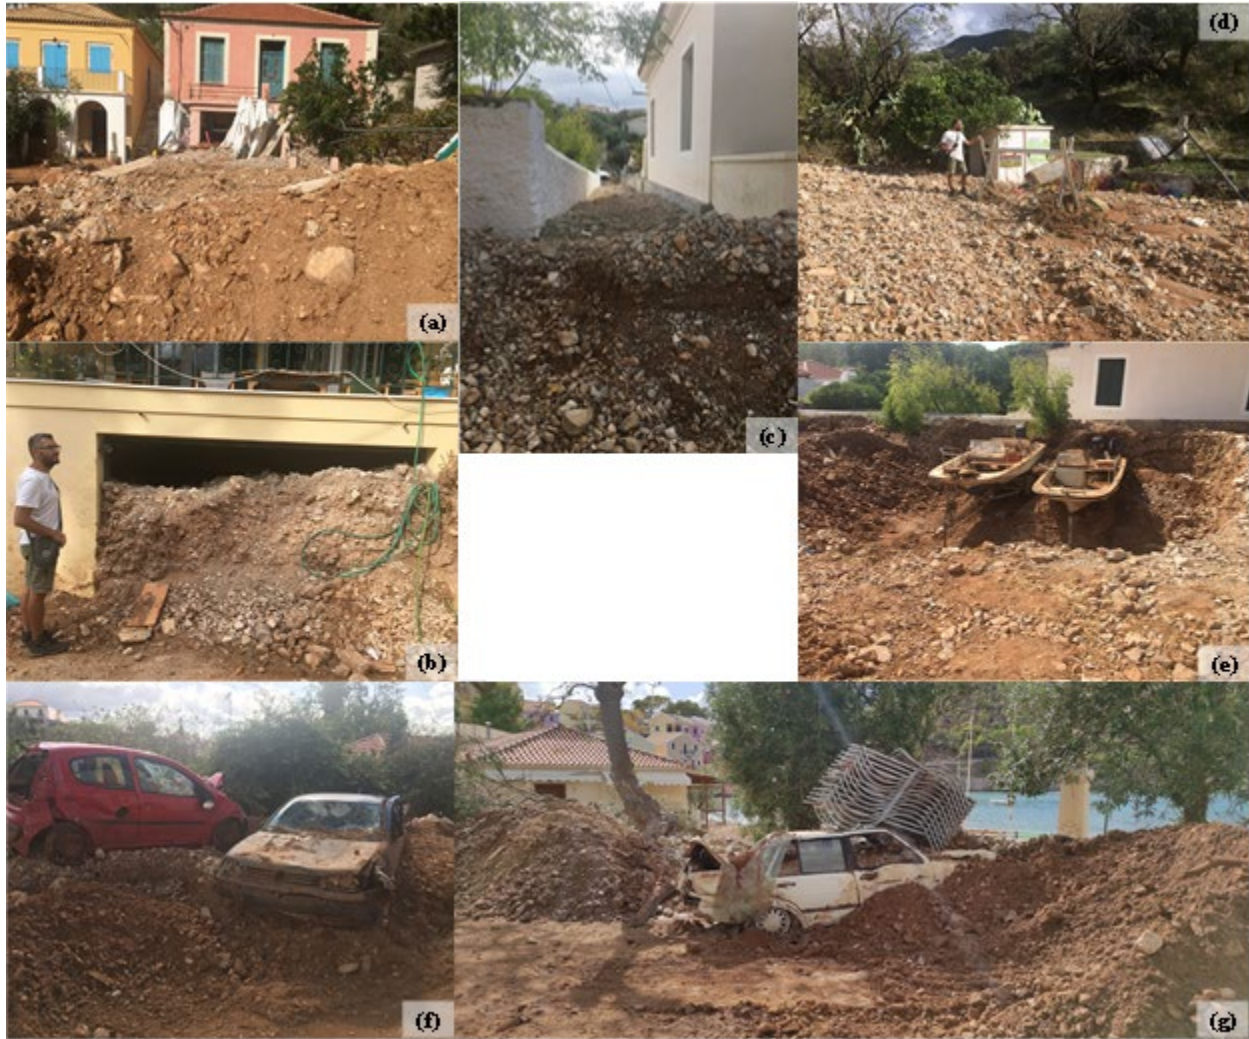
Figure 6.38. Debris flow within the village of Assos (38.319506°N, 20.508197°E), as of 9/29/2020

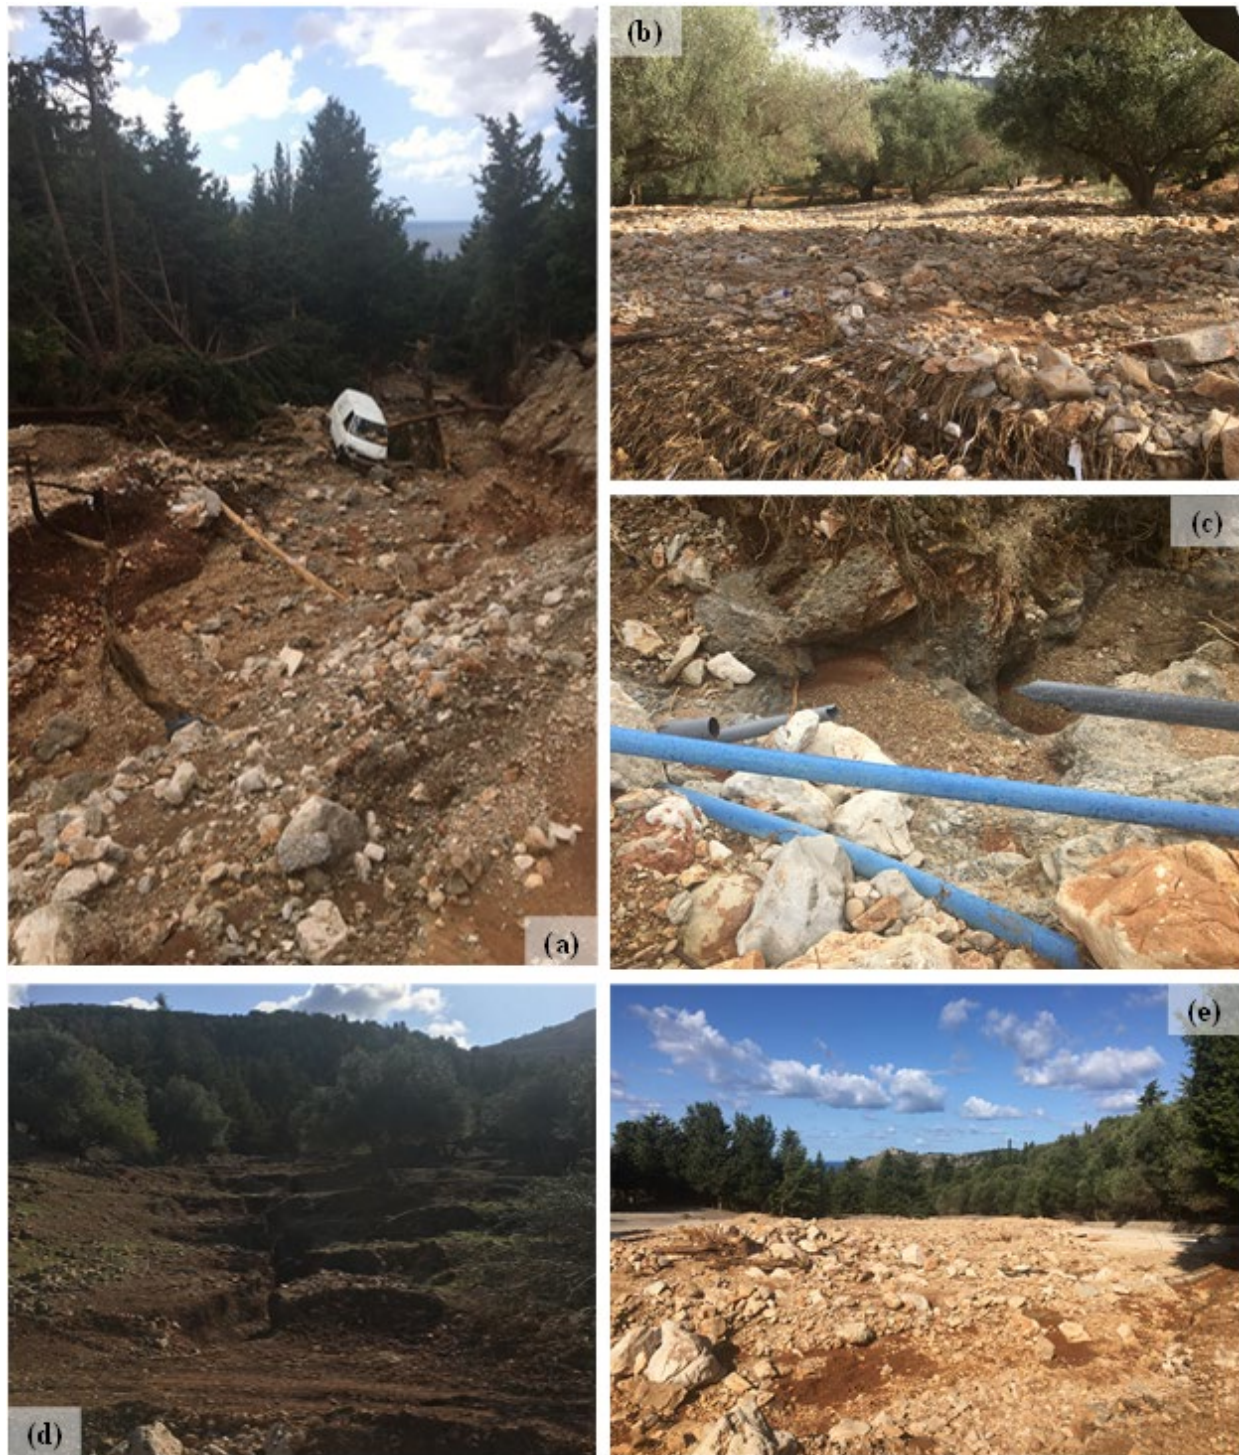
Figure 6.39. Debris flow manifestations outside of Assos village (view 3D model at: <https://skfb.ly/6WyTT>): a) severe surface erosion and debris (38.376281°N, 20.548333°E); b) olive tree field covered by debris (38.378158°N, 20.543012°E); c) broken utility lines (38.37639166°N, 20.549125°E); d) extensive ground cracking (38.376112°N, 20.551870°E) and e) indicative debris extent and size (38.376112°N, 20.551870°E)

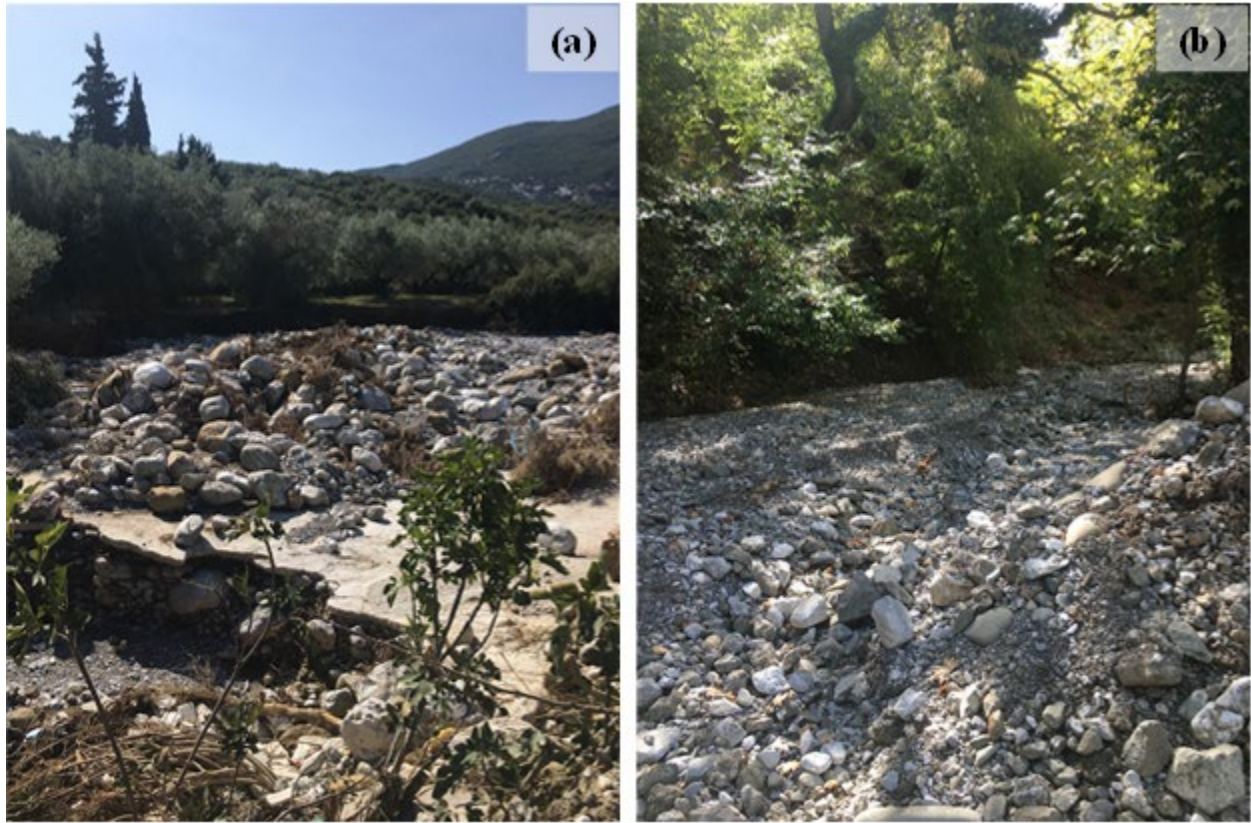
Figure 6.48. Manifestations of debris flow in the south side of Spercheios river valley: a) 38.85976388°N, 22.36969722°E; b) 38.874°N, 22.2538055°E

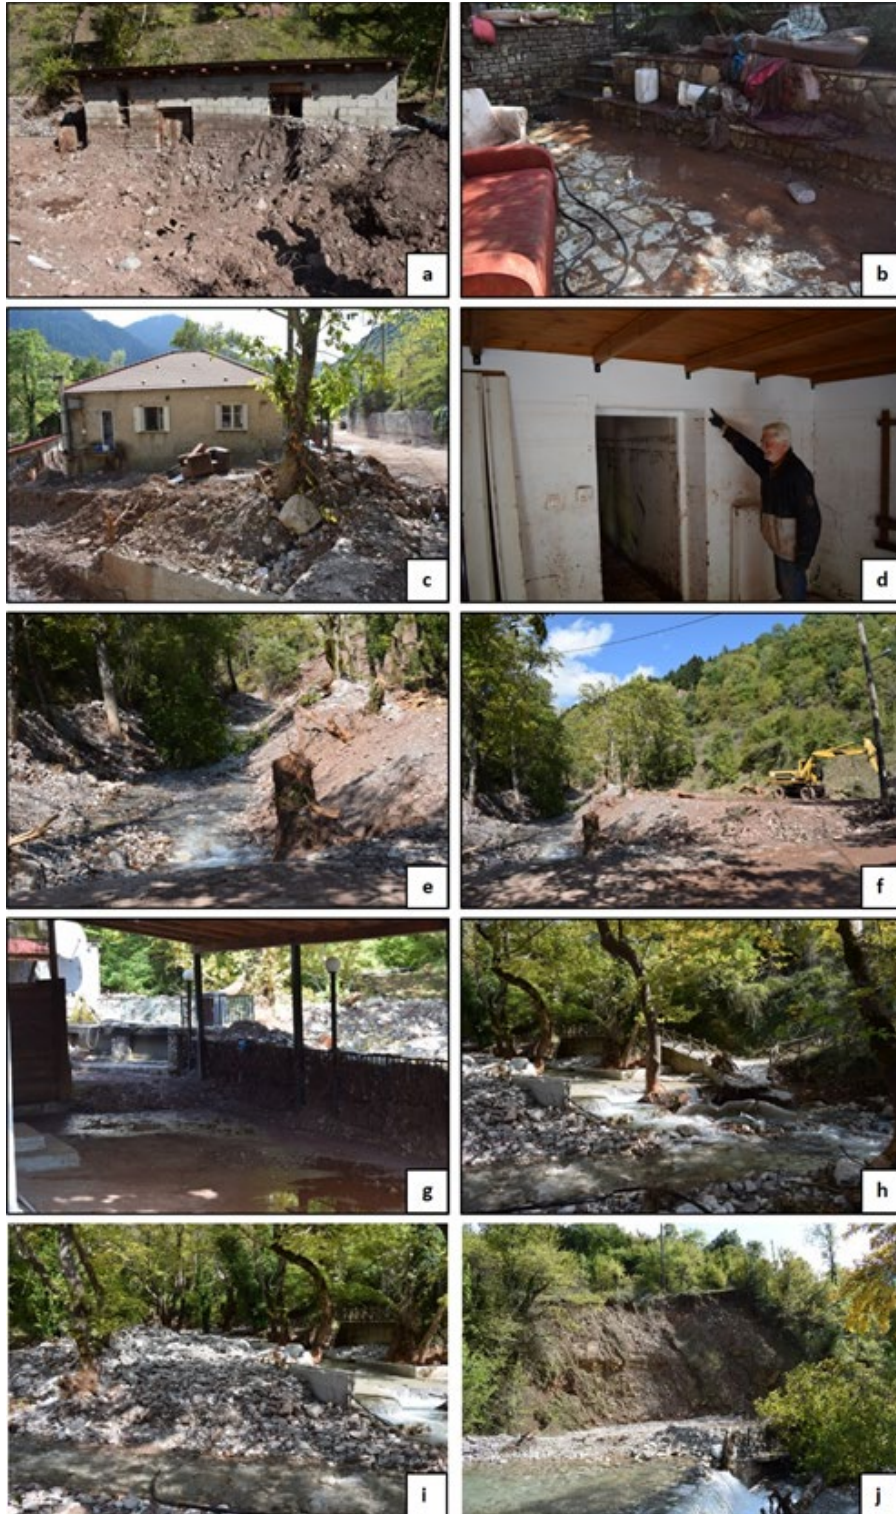
Figure 6.53. Complete destruction of Argithea village due to a debris flow. Structural damage on infrastructure has been observed (39.359444°N, 21.538056°E).

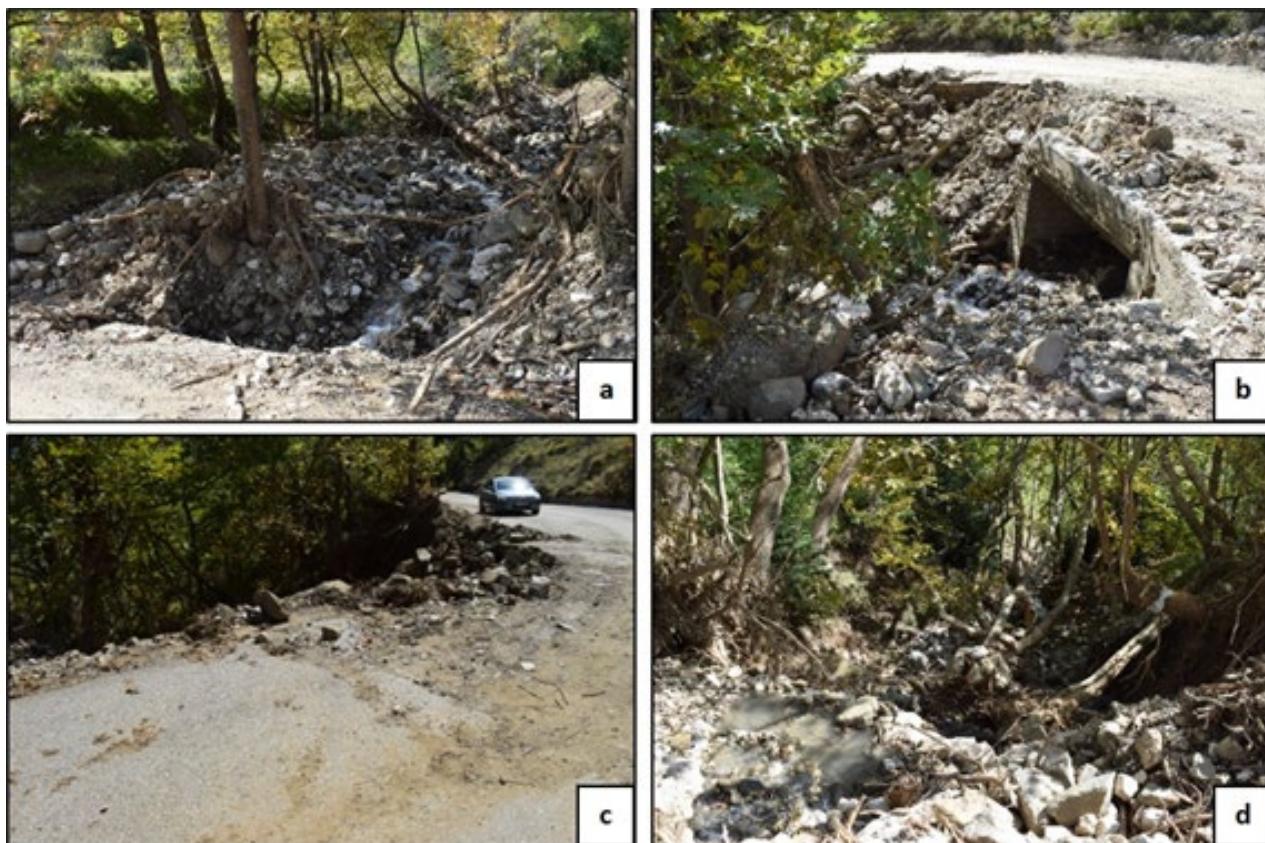
Figure 6.54. Debris flow towards Oxya village (39.366667°N, 21.592222°E).

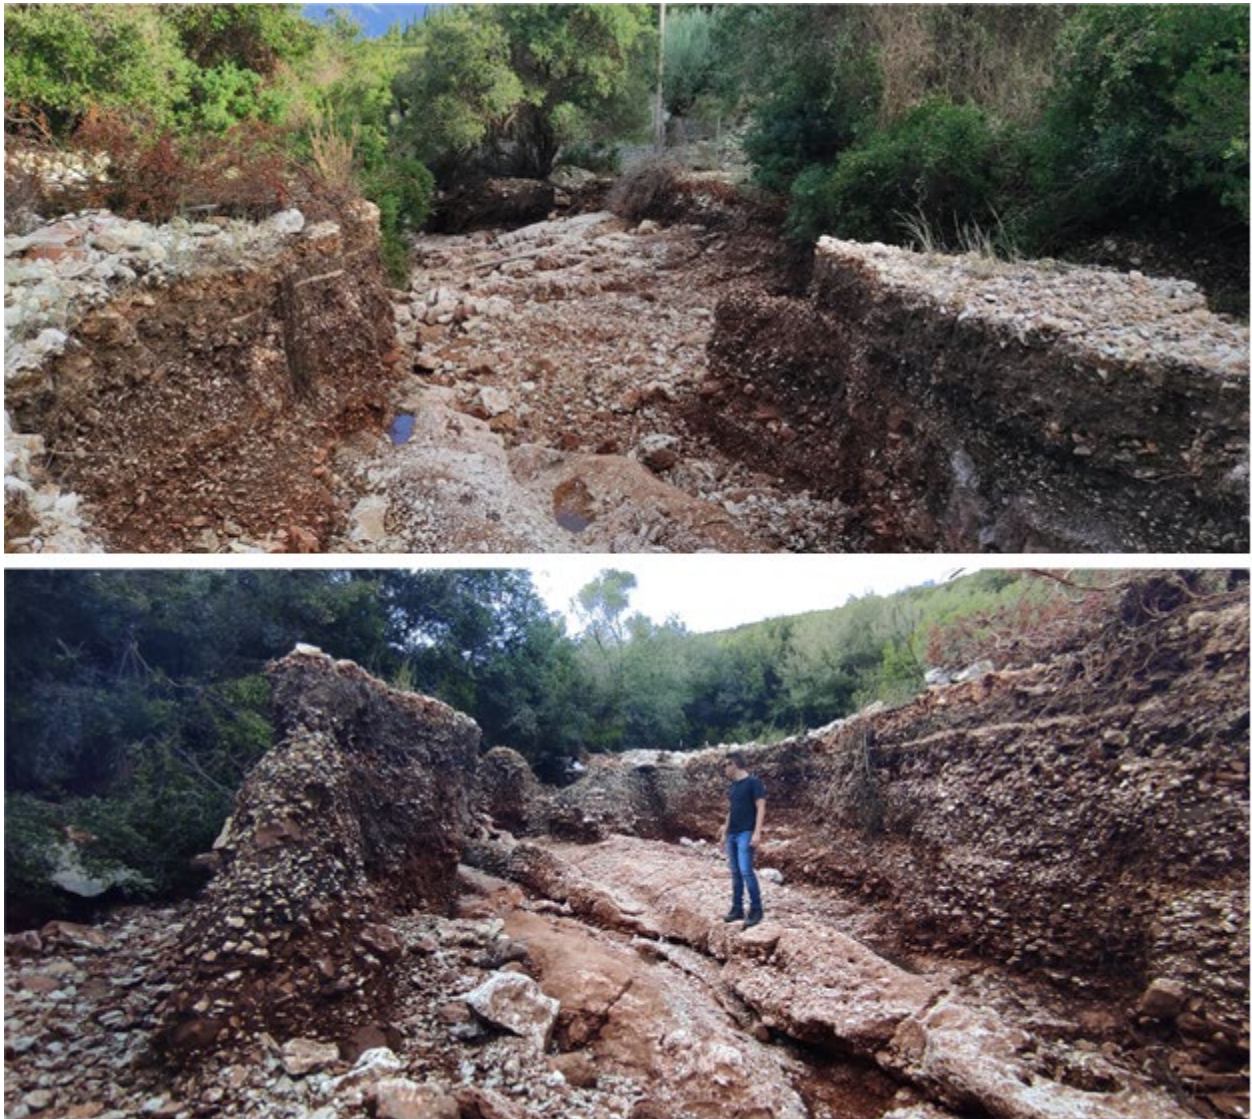
Figure 7.1. Surface erosion outside of Fiskardo village (38.459501°N, 20.57179499°E)

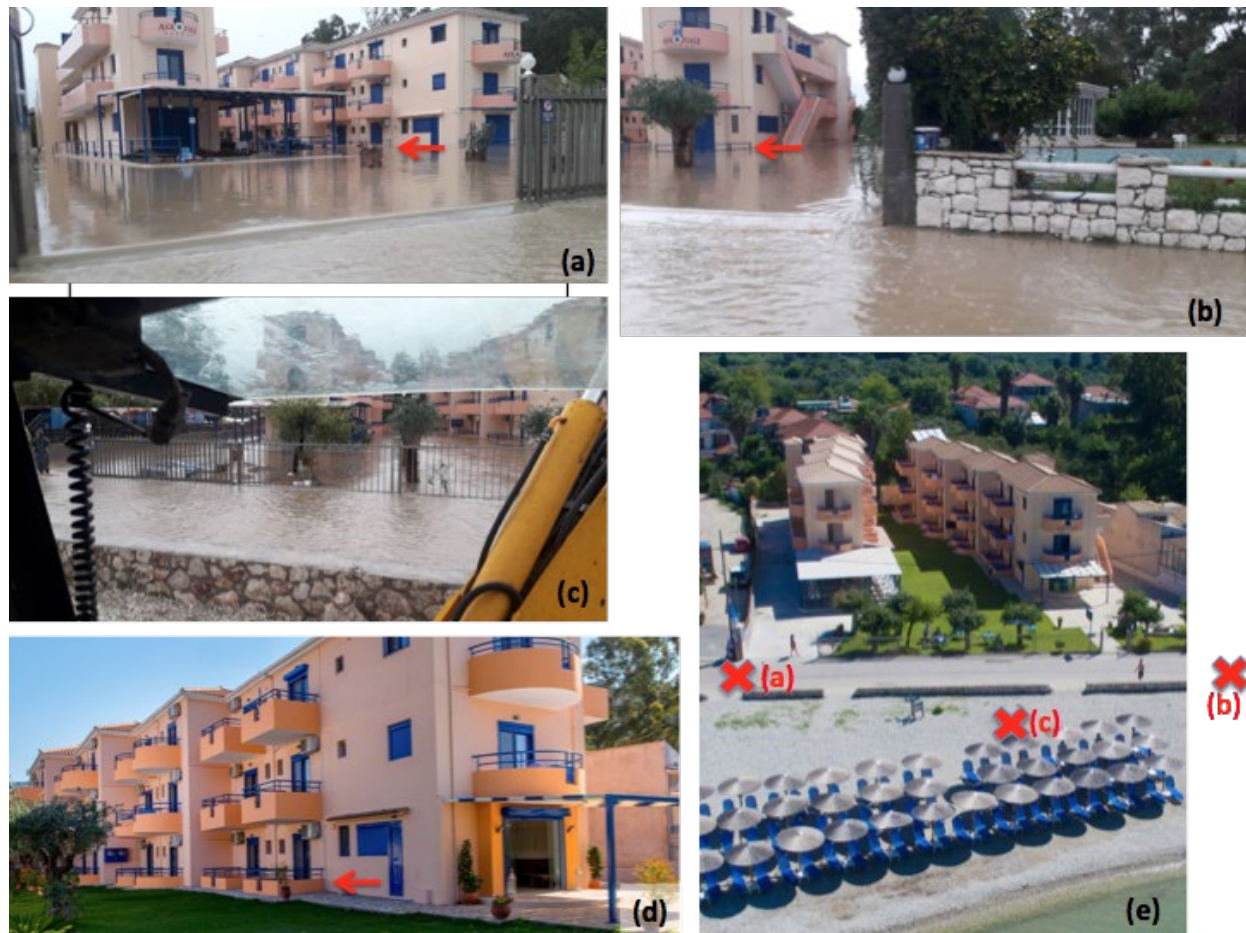
Figure 7.3. a,b,c) Flooding along the seaside at Vasiliki village, Lefkada, as photographed by an eye witness on the day vs. d,e) reference photos from GoogleMaps, indicating the view points for photos in a,b,c. Horizontal arrows indicate water level with respect to balcony railings (38.628758°N, 20.606678°E).

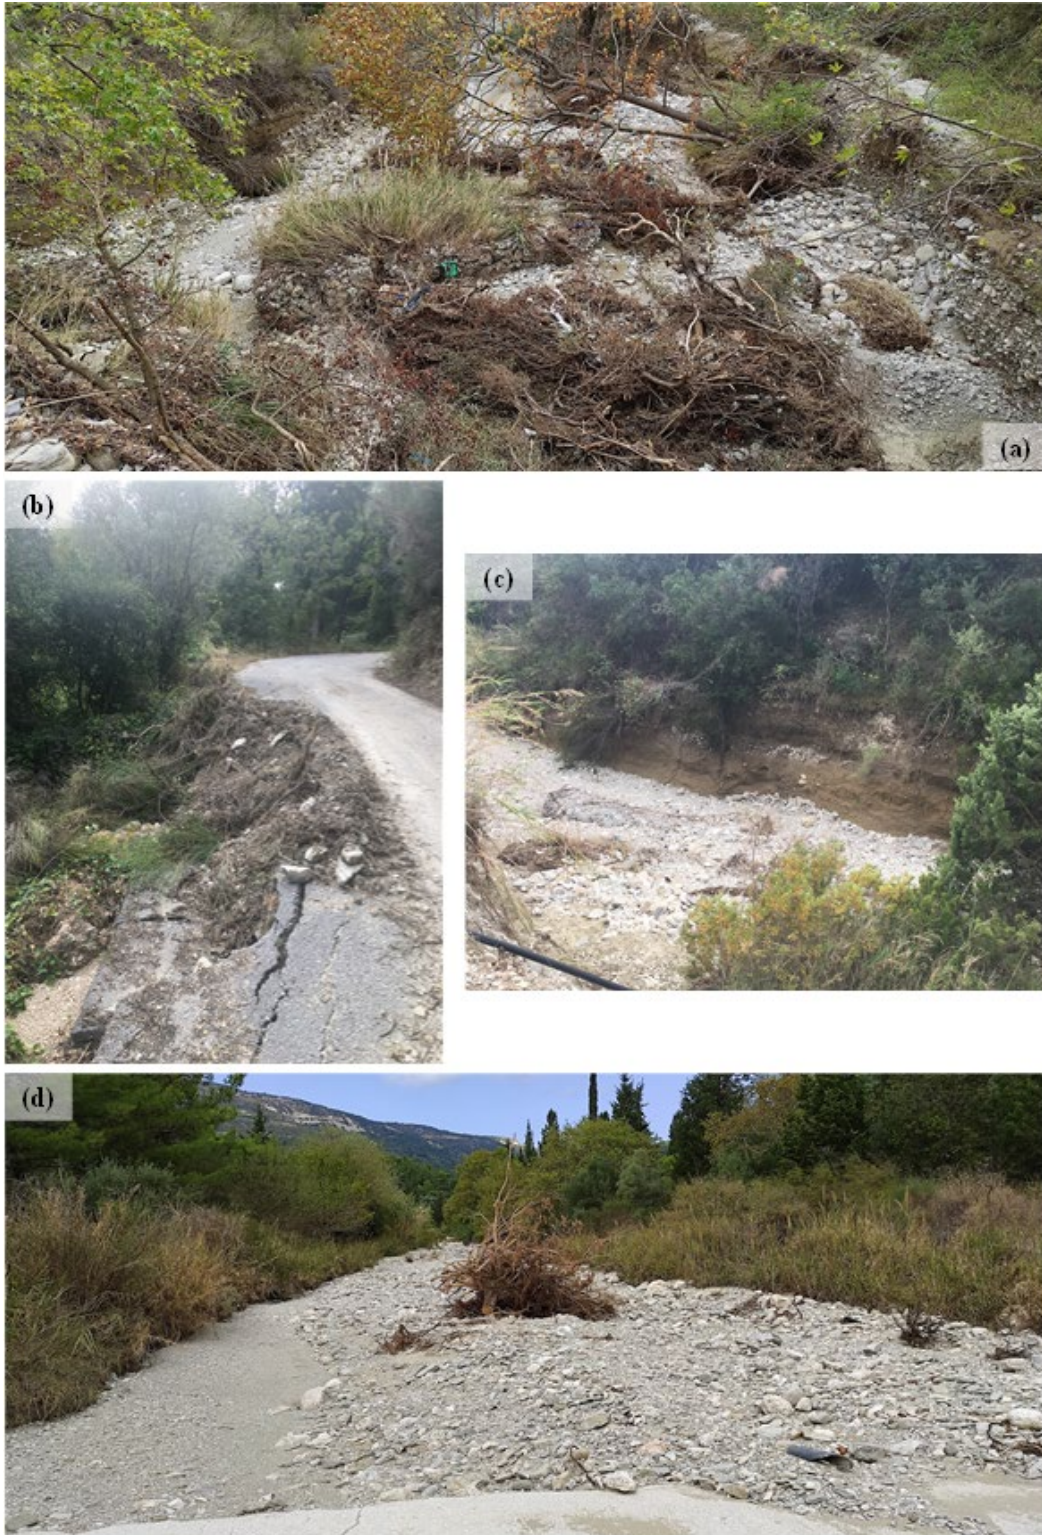
Figure 7.4. Typical features observed in Lefkada island: a) eroded material from flood protection levee (38.665858972°N, 20.620208°E); b) road embankment damage (38.67684167°N, 20.6093056°E); c) riverbank erosion (38.6646278°N, 20.623711°E); d) debris on riverbed (38.665858972°N, 20.620208°E).
