The September 18-20 2020 Medicane Ianos Impact on Greece

Phase I Reconnaissance Report

Geotechnical Extreme Events Reconnaissance Association

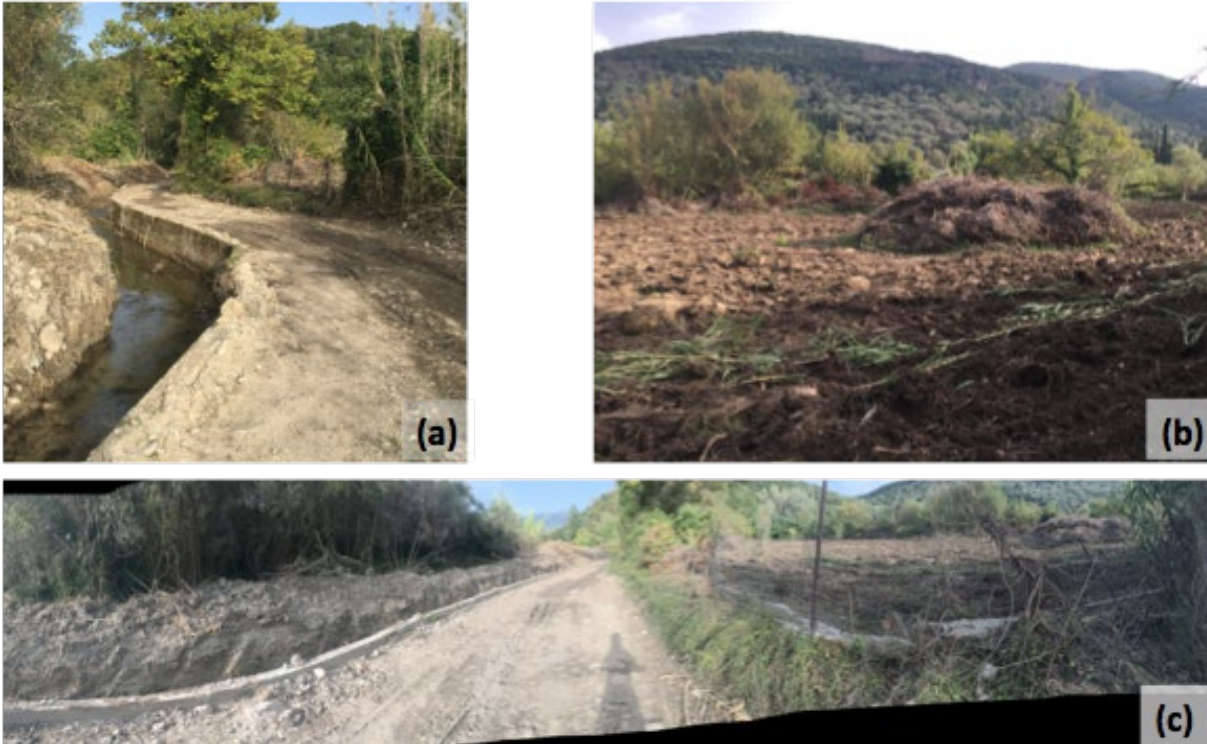
Figure 7.5. Location of severe flooding (1 m from ground level) outside of Vasiliki village, Lefkada (38.637388°N, 20.617512°E).

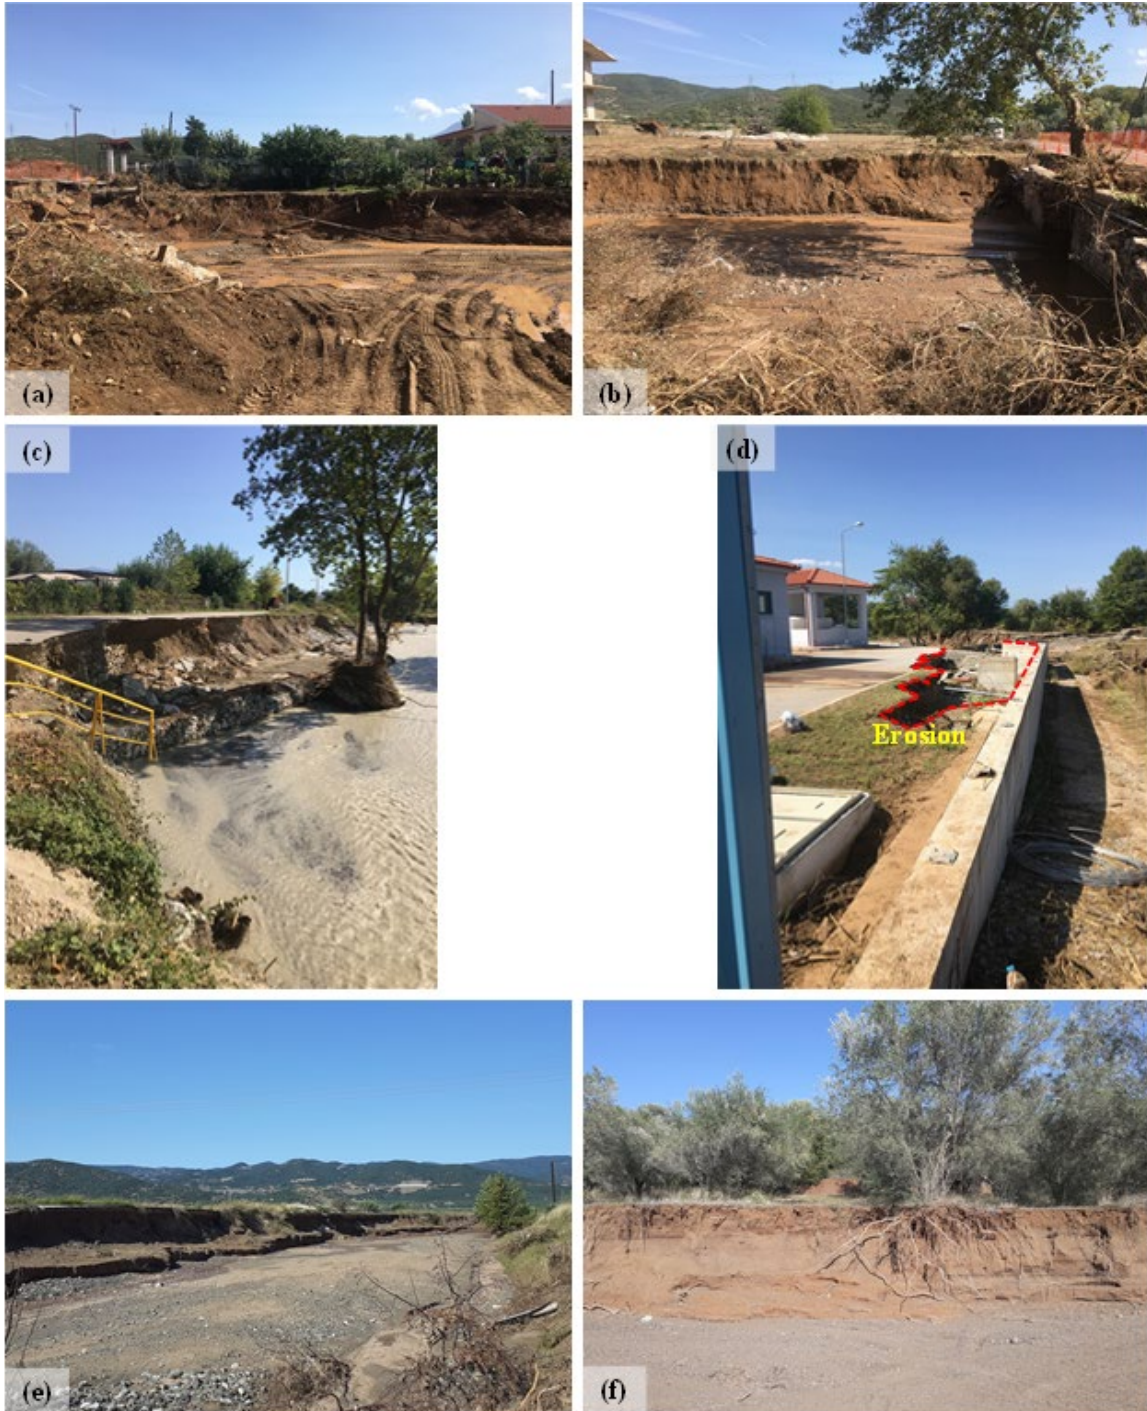
Figure 7.7. Riverbank erosion in Spercheios river valley: a and b) 38.94233611°N, 22.21619722°E; c) 38.83451944°N, 22.39527499°E; d) 38.90973611°N, 22.28436944°E; e) 38.92455°N, 22.27771944°E; f) 38.946288833°N, 22.270412388°E.

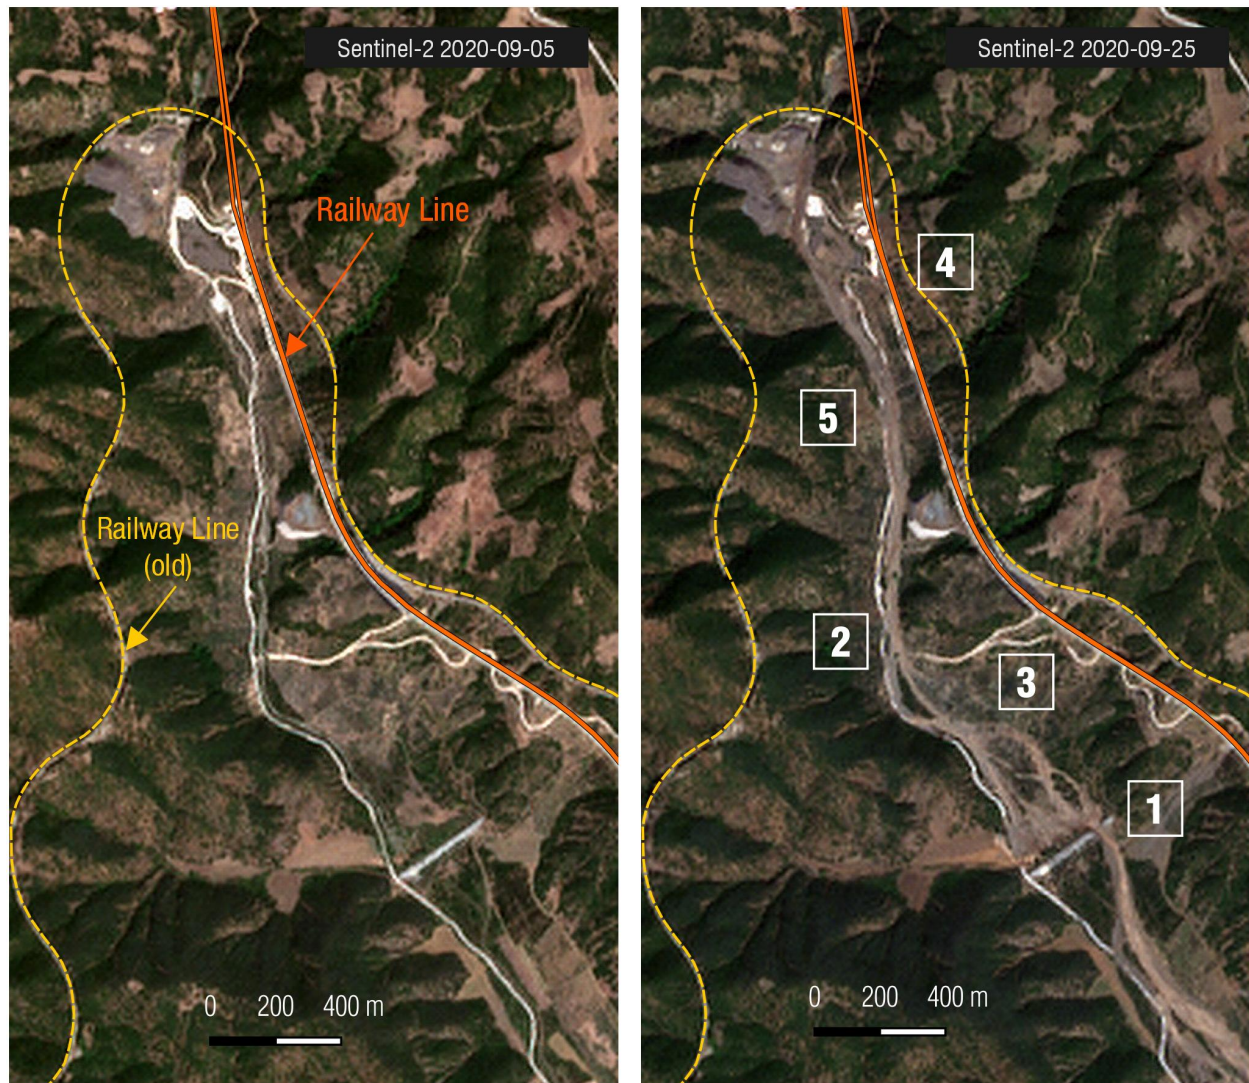
Figure 7.9. Flooding and debris effects on the streams northwest of Stirfaka, Lamia. Left: Sentinel-2 (super-resolution) image of September 5 2020. Right: Sentinel-2 (super-resolution) image of September 25 2020. Deposition of debris & flood sediments downstream along the torrent. Significant damages downstream that include breach of a flood-protection dam [1] (Location 38.9598°N, 22.27405°E), landslides along the old and new railway line (3,4) and service road damage (2,5).

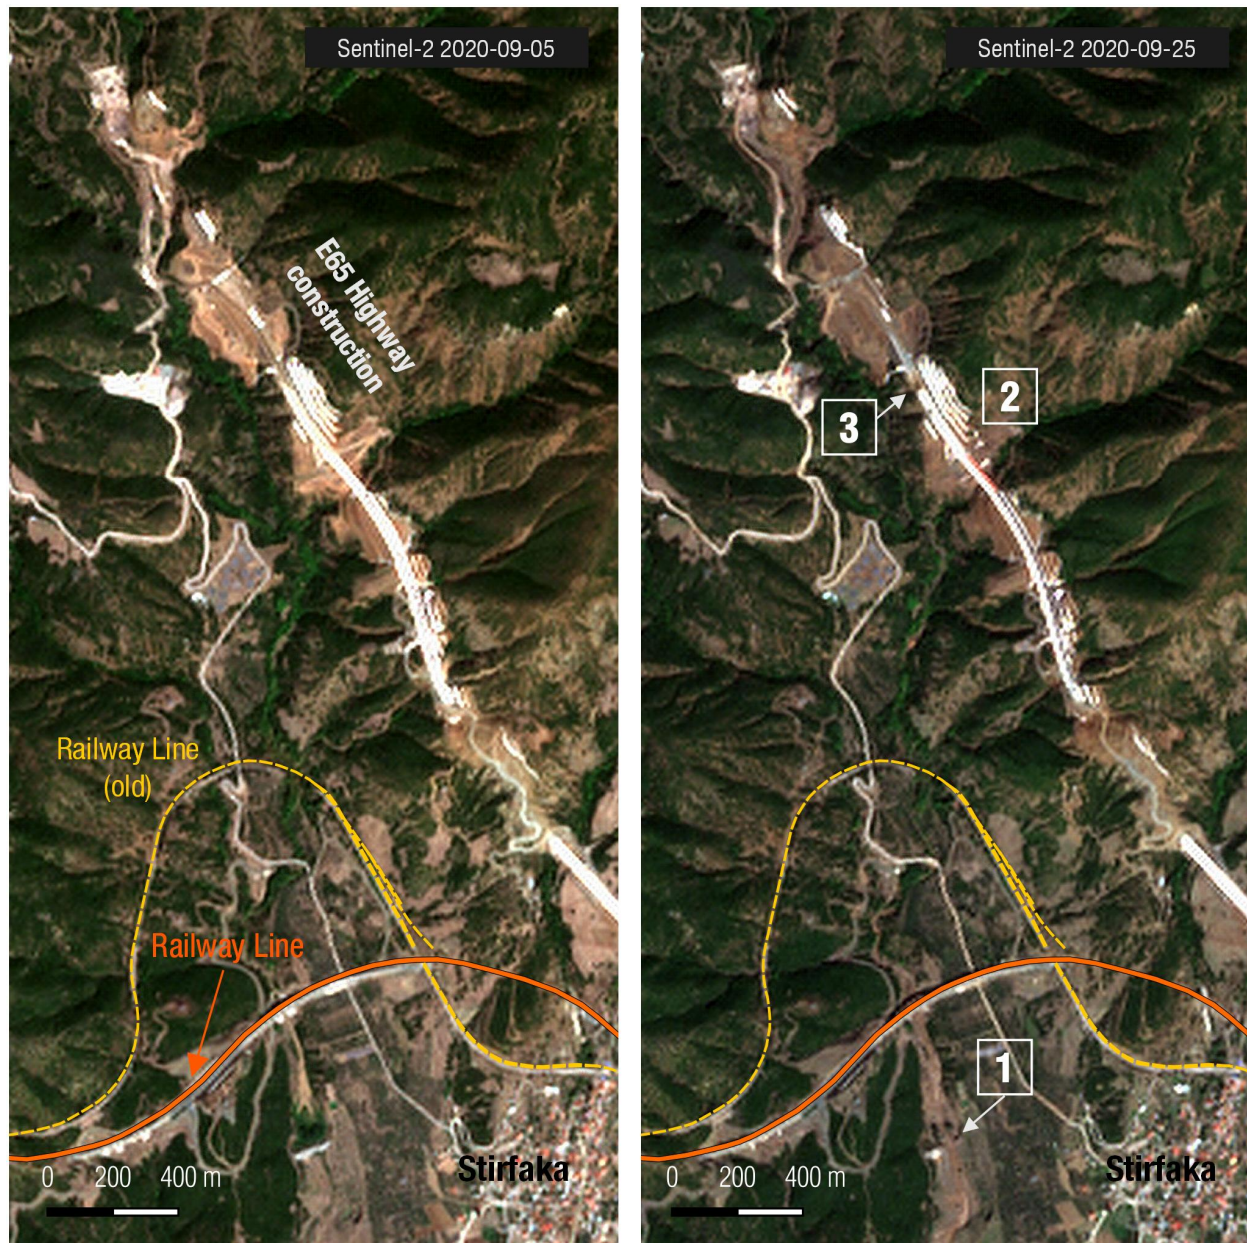
Figure 7.10. Flooding and debris effects on the streams and along the E65 highway construction site northwest of Stirfaka, Lamia. Left: Sentinel-2 (super-resolution) image of September 5 2020. Right: Sentinel-2 (super-resolution) image of September 25 2020. Deposition of debris & flood sediments downstream along the torrent. Significant damages downstream that include breach of a small flood-protection dam [1] (Location 38.9562°N, 22.29896°E), and landslides/failures along the E65 construction site (2,3).

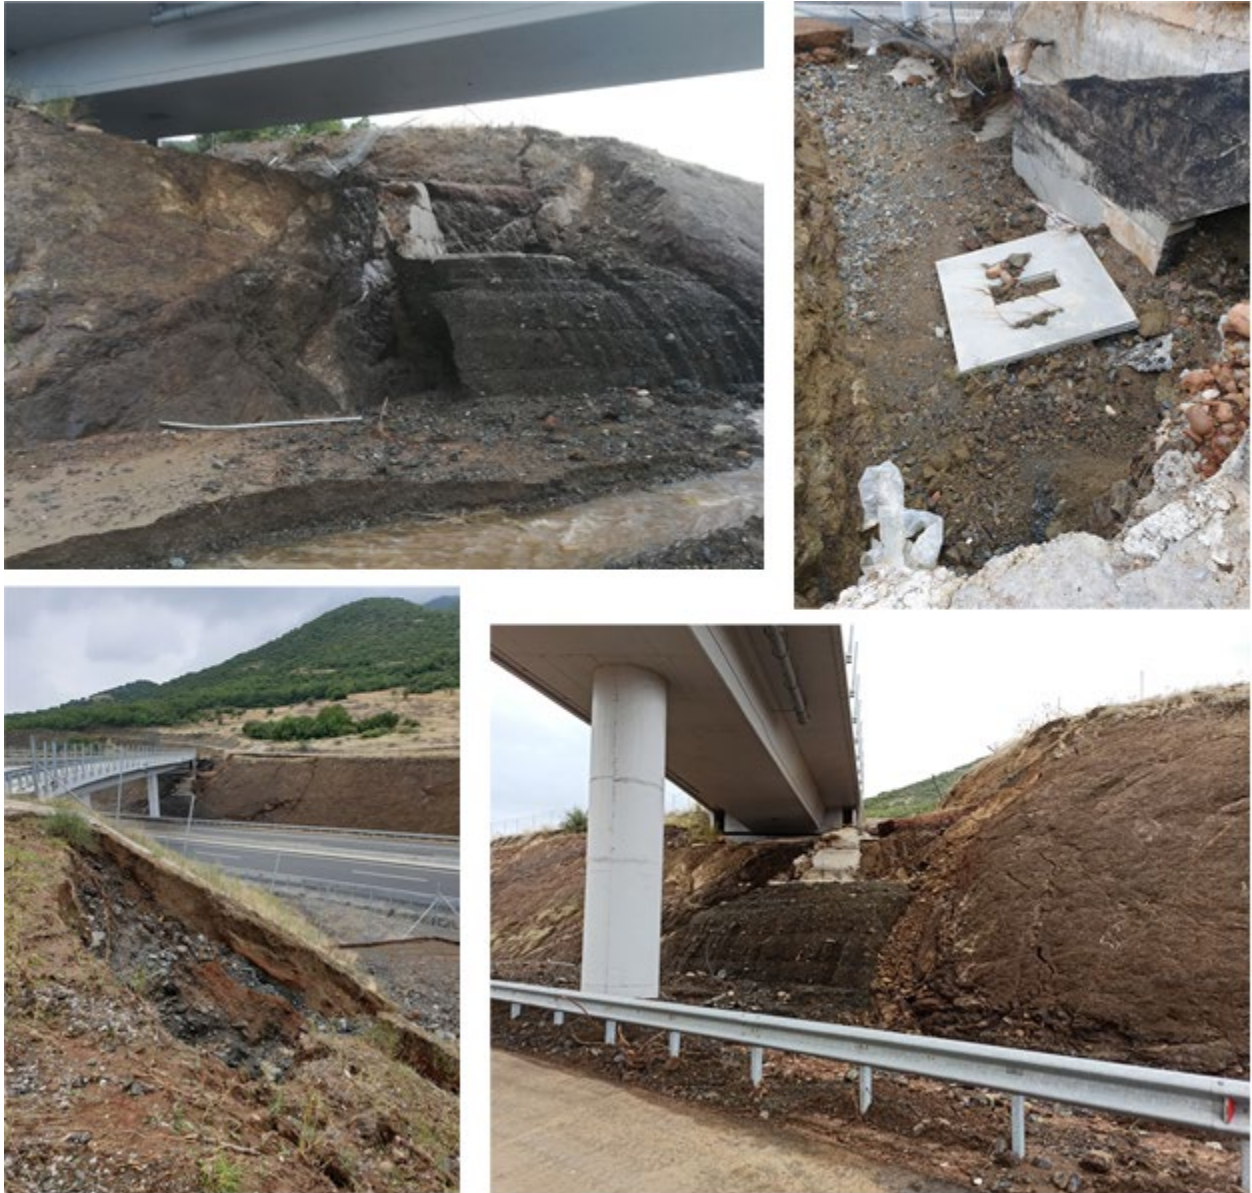
Figure 7.11. Bridge embankment erosion on Highway E65, km+56 outside the town of Anavra (39.172474°N, 22.091382°E) (view 3D model at: <https://skfb.ly/6W7AK>).

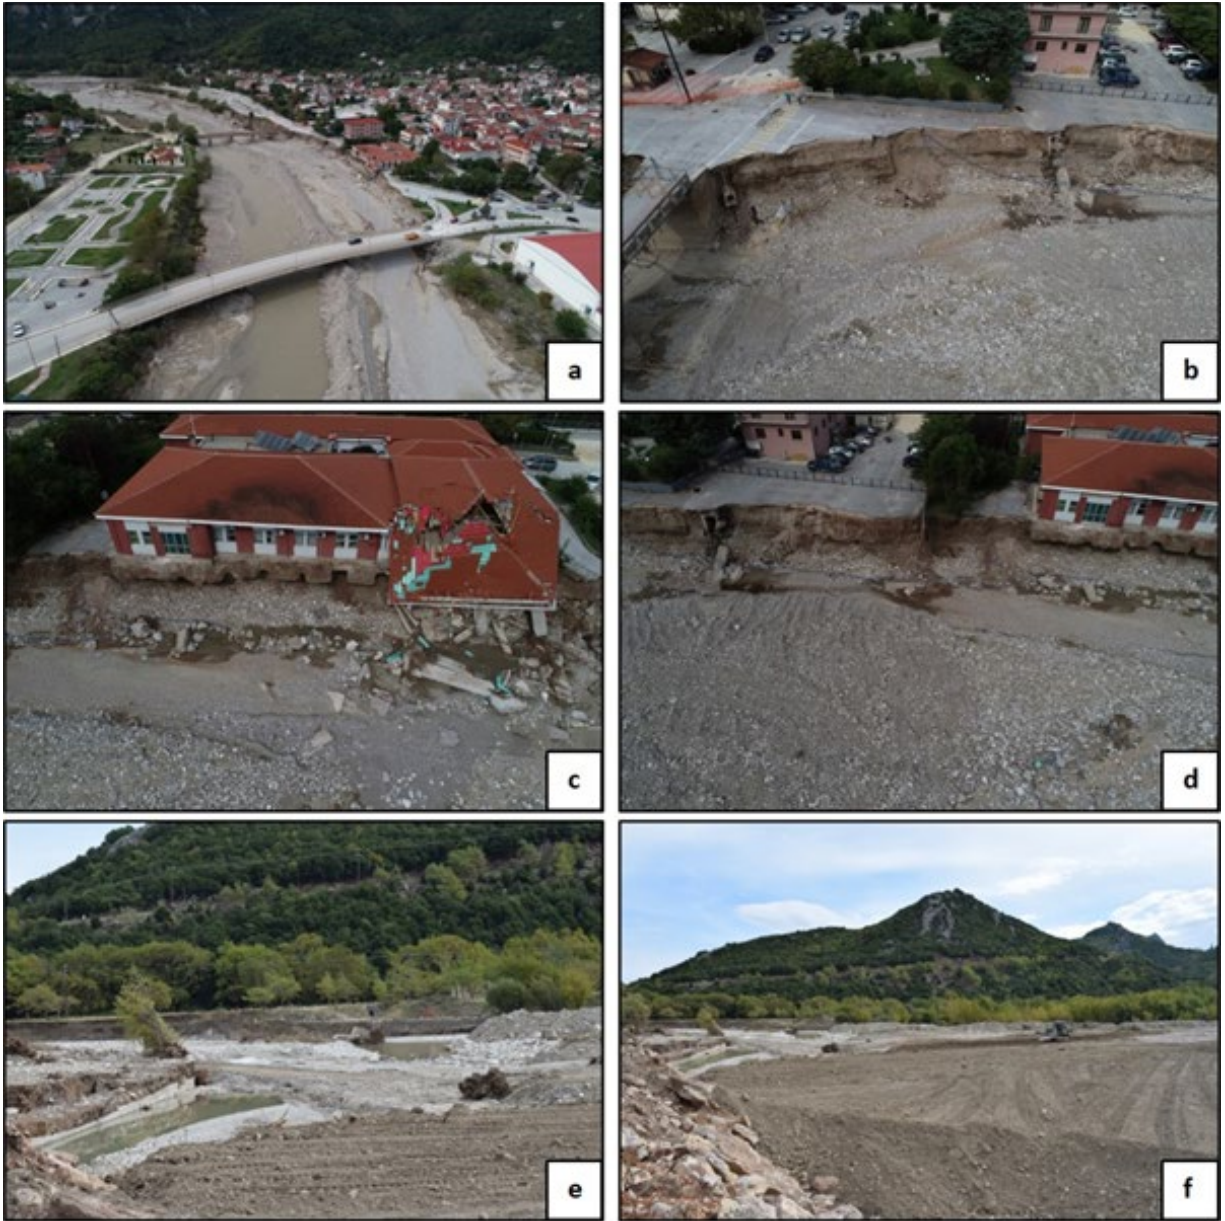
Figure 7.12. Mouzaki road failure (a-d) and remedial measures (e-f) on river embankments (39.427222°N, 21.666667°E).

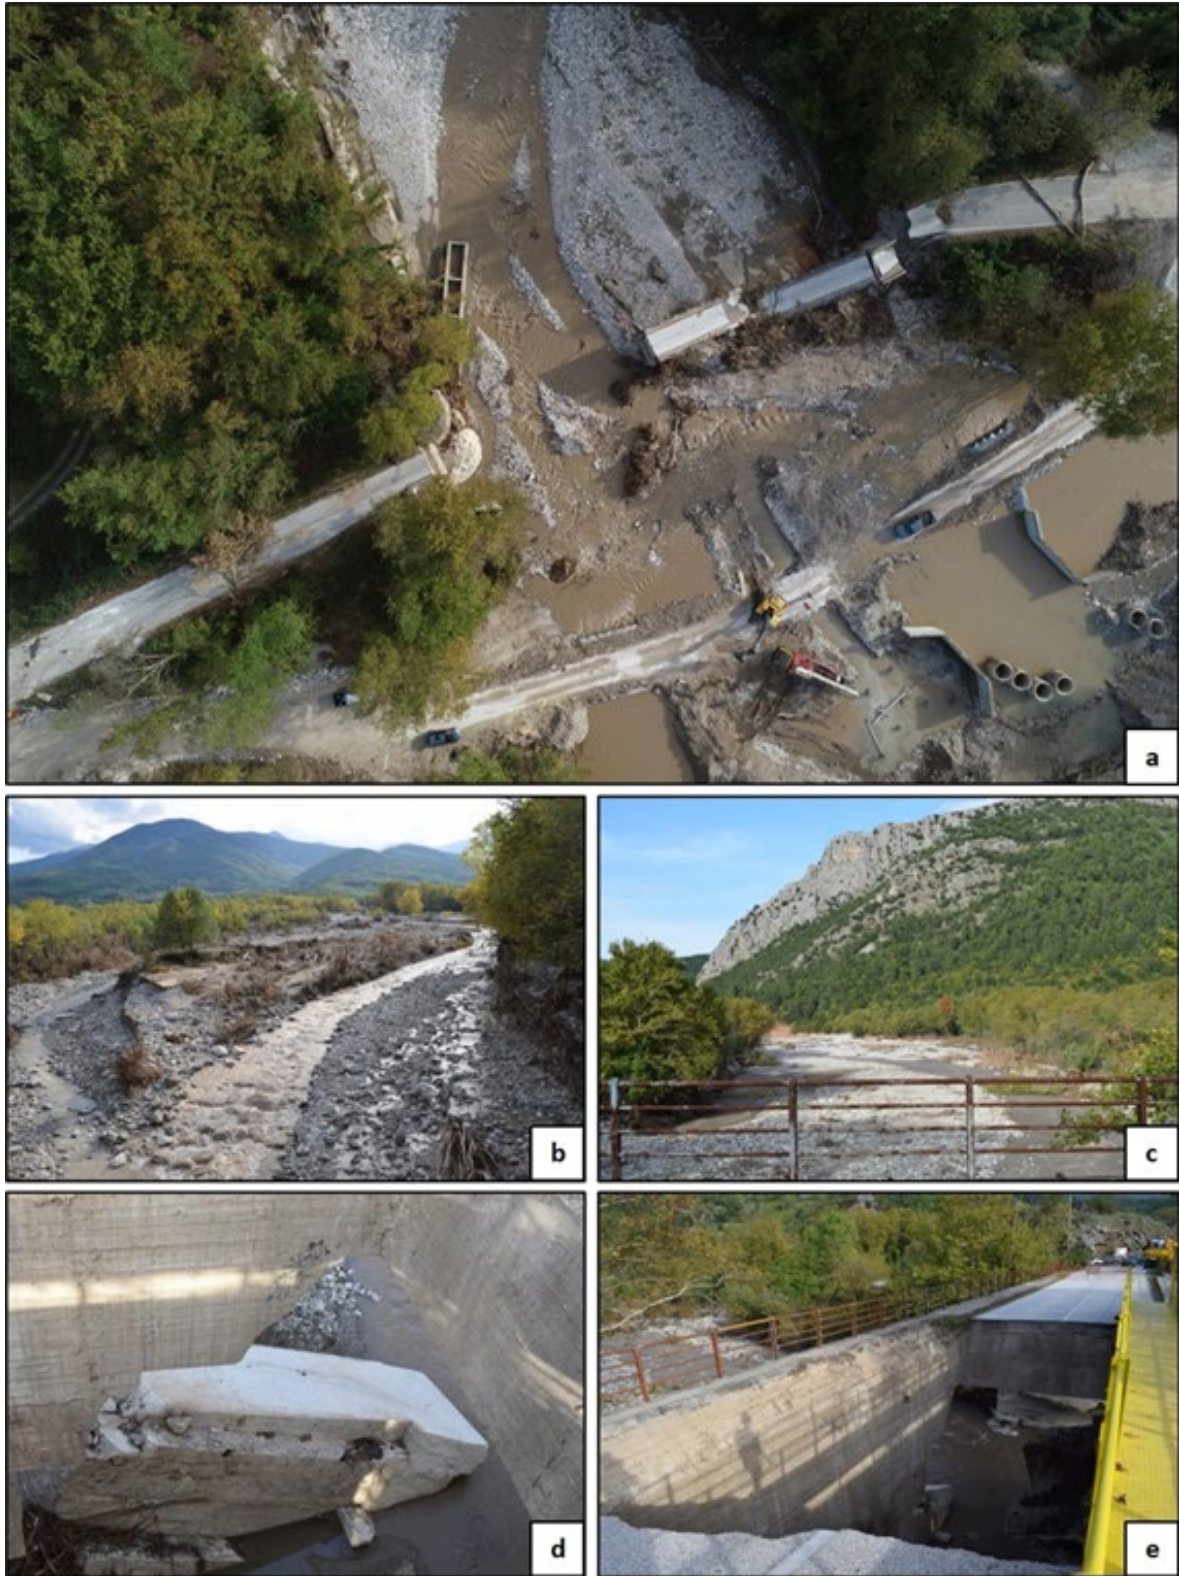
Figure 7.13. Debris flow caused damage to the bridges of a) Karaiskakis (39.401667 N, 21.653333 E), and b-e) Mpalanos (39.406111°N, 21.662778°E).

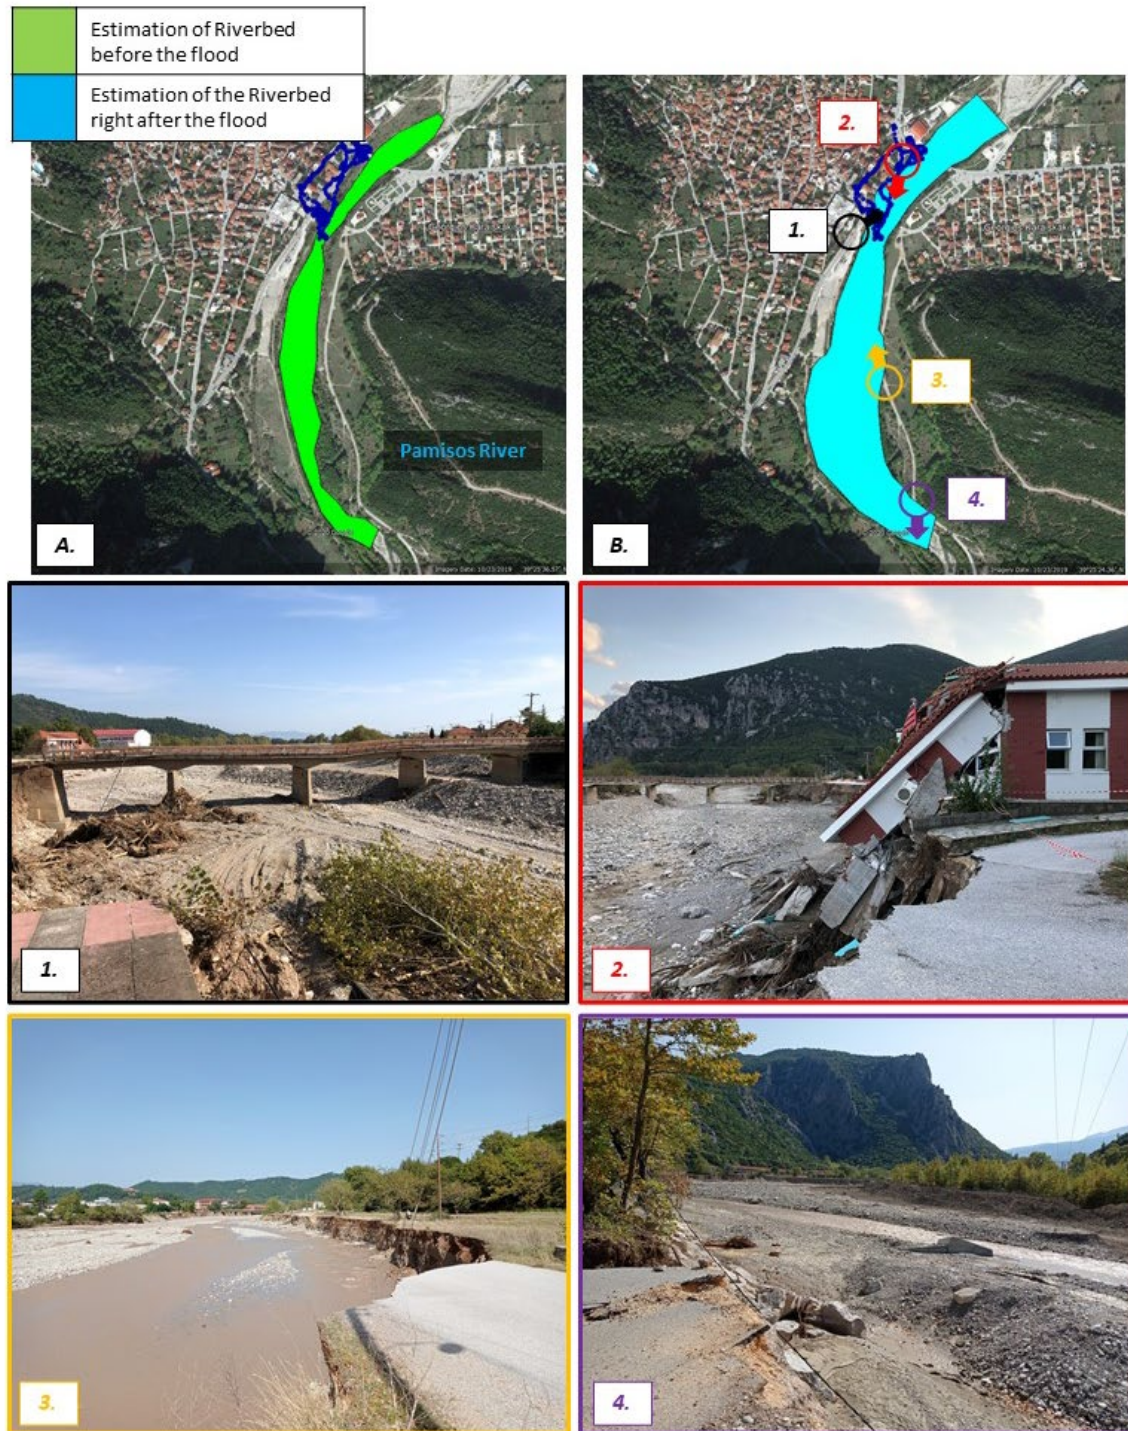
Figure 7.14. A) Pre-flood; and B) Post-flood riverbed area of the Pamisos river, estimated from the collapsed river embankments. The riverbed area increased by $\sim 120\%$. 1) embankment collapse – part of the riverside road collapsed in the river; 2) the spectacular collapse of the Mouzaki Health Center, due to the erosion and collapse of the founding embankment; 3,4) extensive embankment and road collapse upstream of Mouzaki.

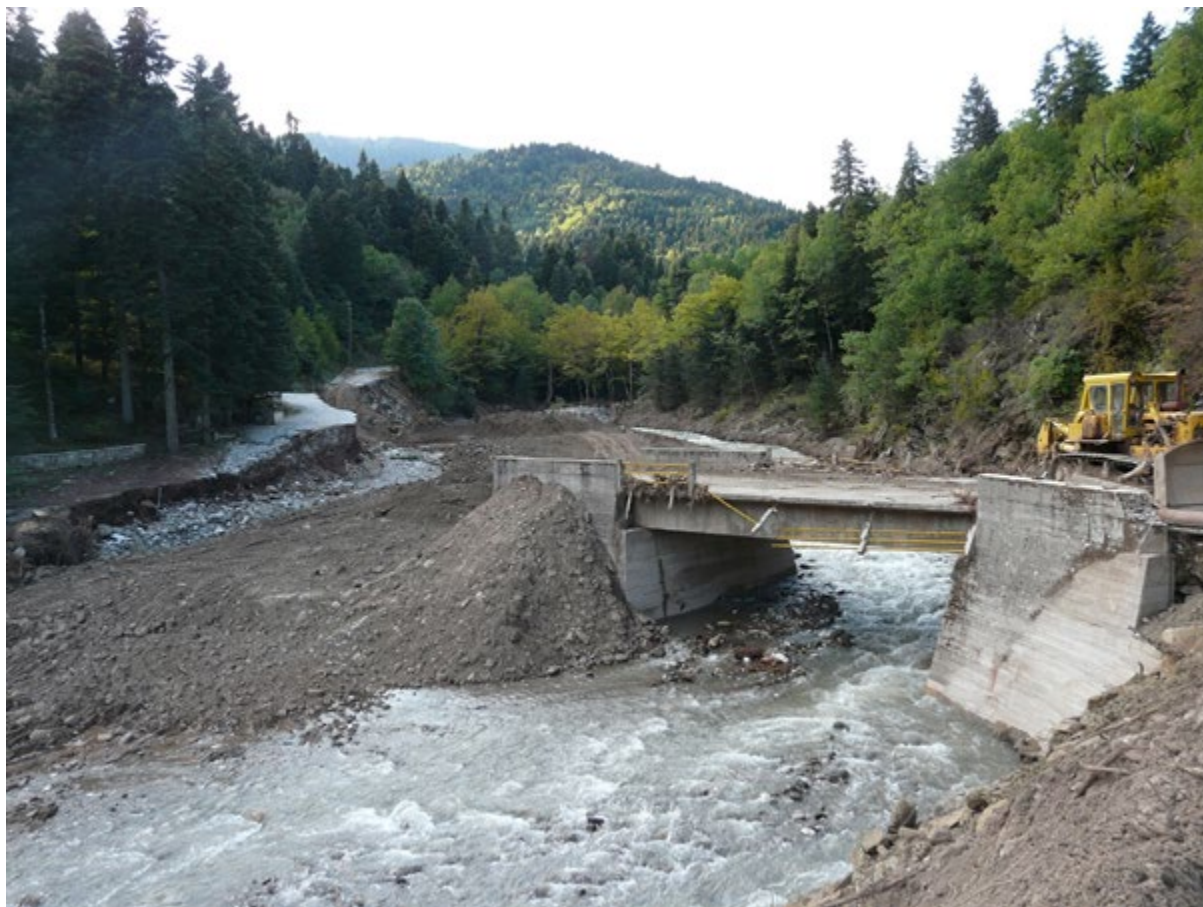
Figure 7.15. Riverbank erosion – slope failure that blocked the road. Karitsiotis river bridge, south of Belokomiti, Plastira Lake. (39.25381°N, 21.71591°E).

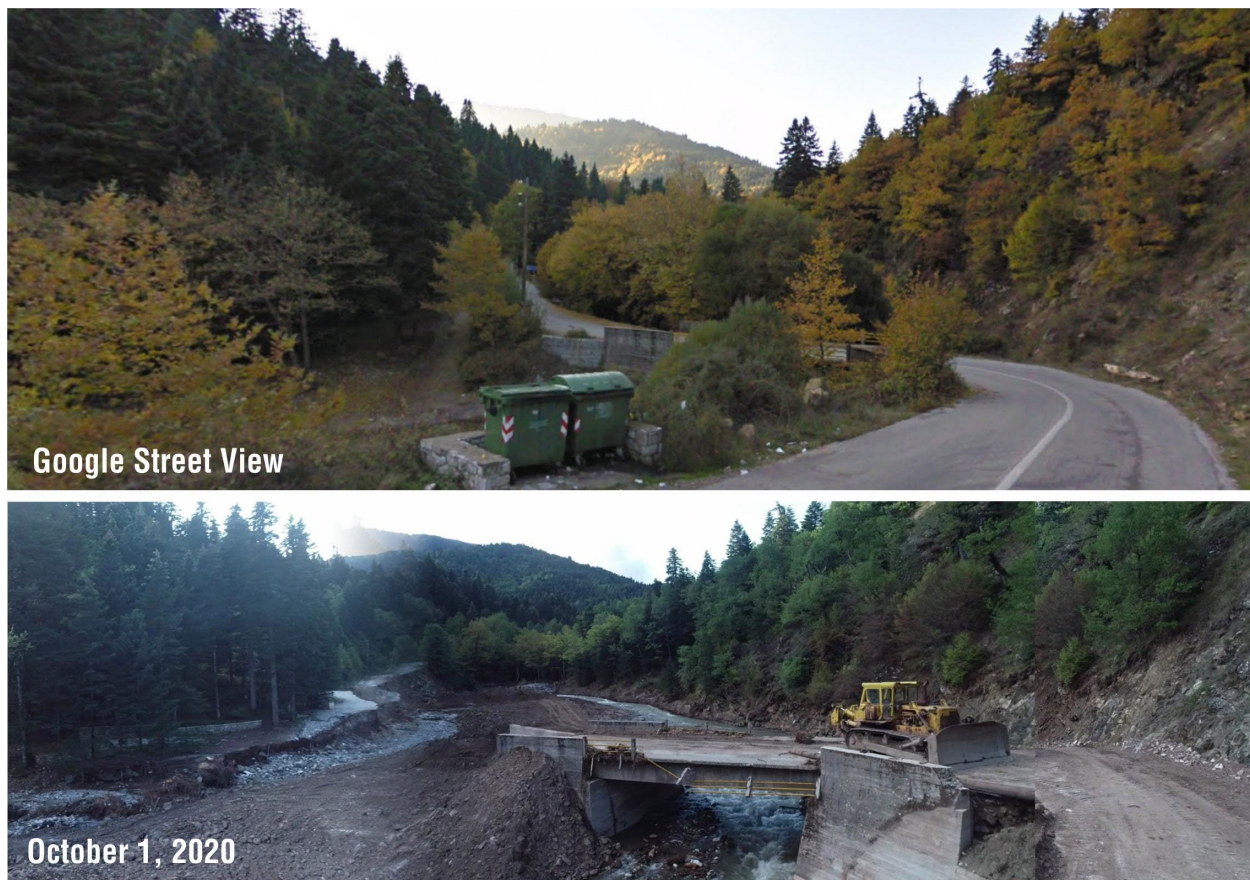
Figure 7.16. Comparison of previous state (Google Street View image) and post-Ianos damaged river pass at Karitsiotis river bridge, south of Belokomiti, Plastira Lake. (39.25381°N, 21.71591°E).

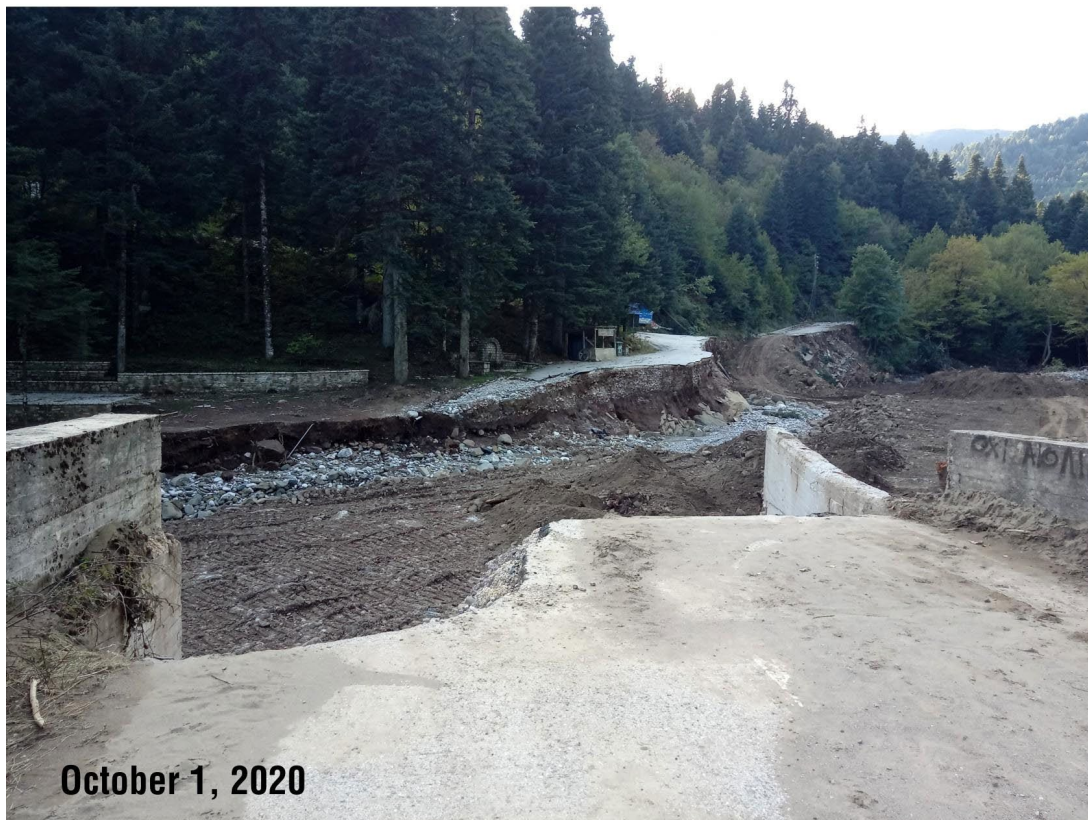
Figure 7.17. View towards south-west from the remaining Karitsiotis river bridge, south of Belokomiti, Plastira Lake. Comparison with Street View image. (39.2538°N, 21.7161°E).

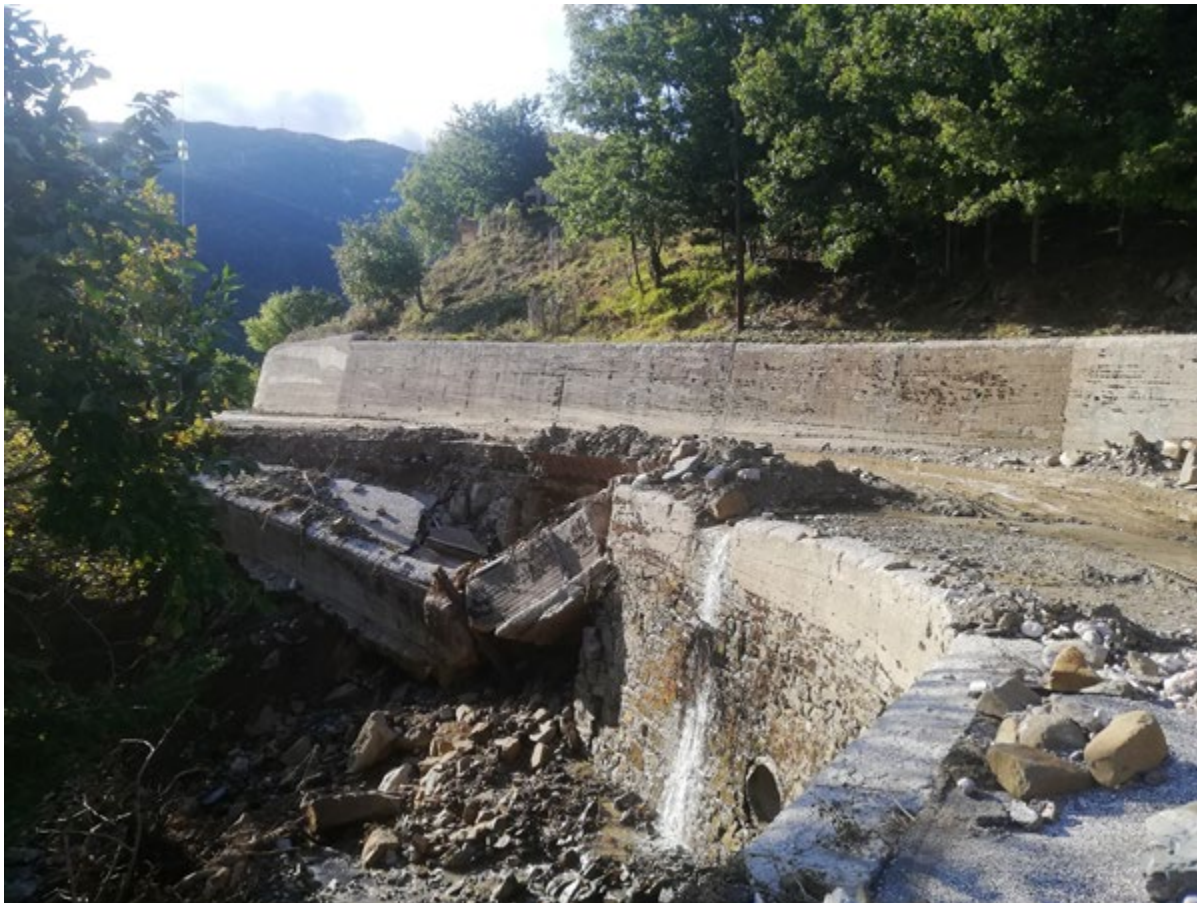
Figure 7.20. Riverbank erosion – slope failure that damaged partially the road. (39.26247°N, 21.71319°E)

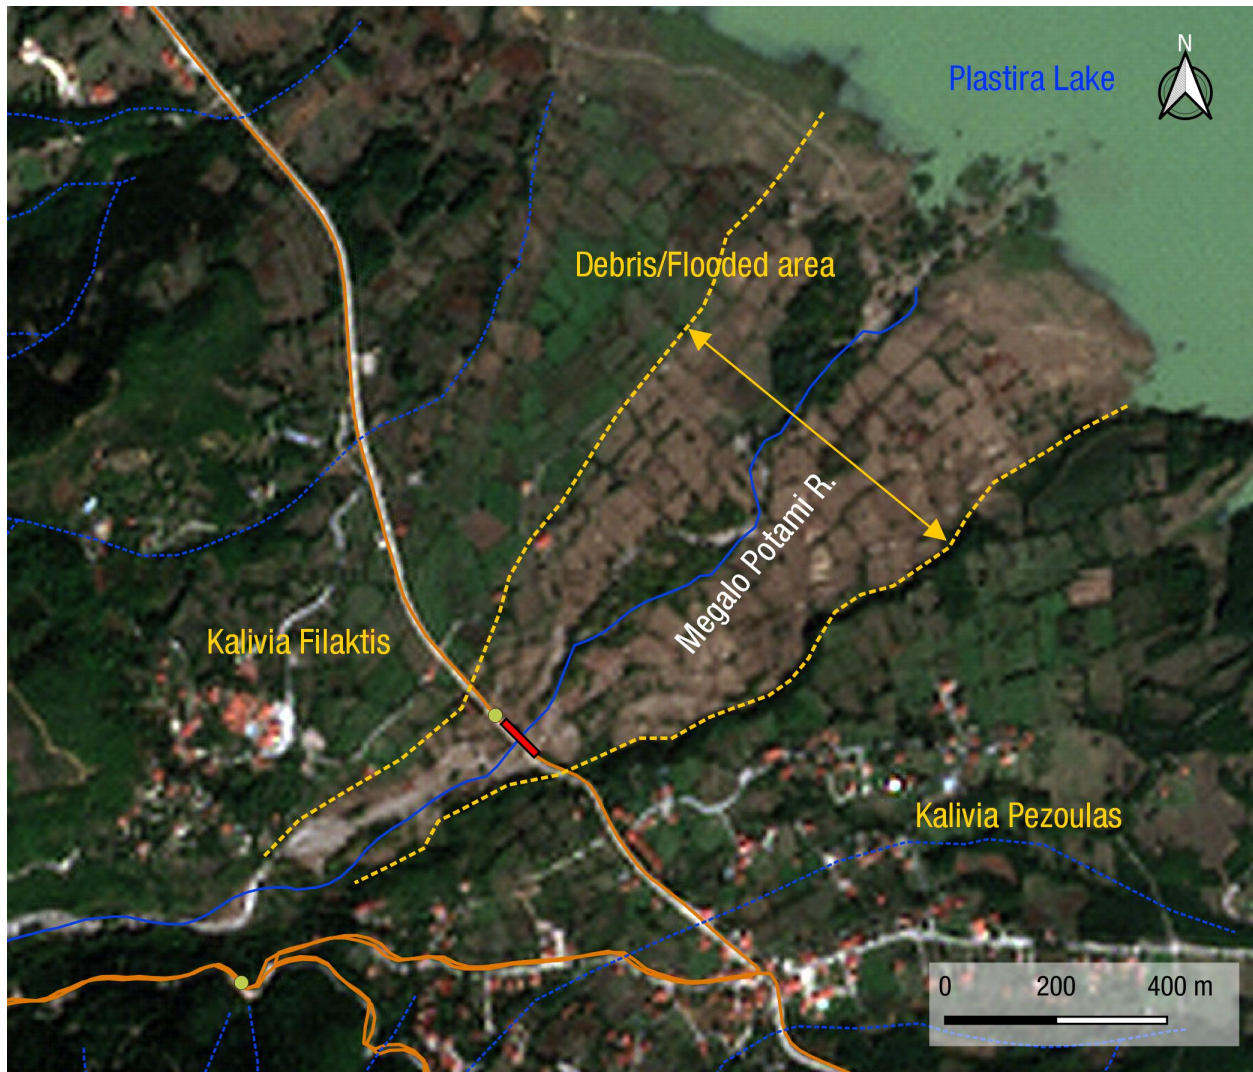
Figure 7.21. Riverbank erosion and debris flow near Pezoula and Filakti, Plastira Lake. Brown-discolored area in Megalo Potami river fan shows the extent of flooding and debris deposition. Red bar marks the location of the damaged road bridge (39.31226°N, 21.7109°E). Sentinel-2 (super-resolution) satellite imagery acquired on September 25.

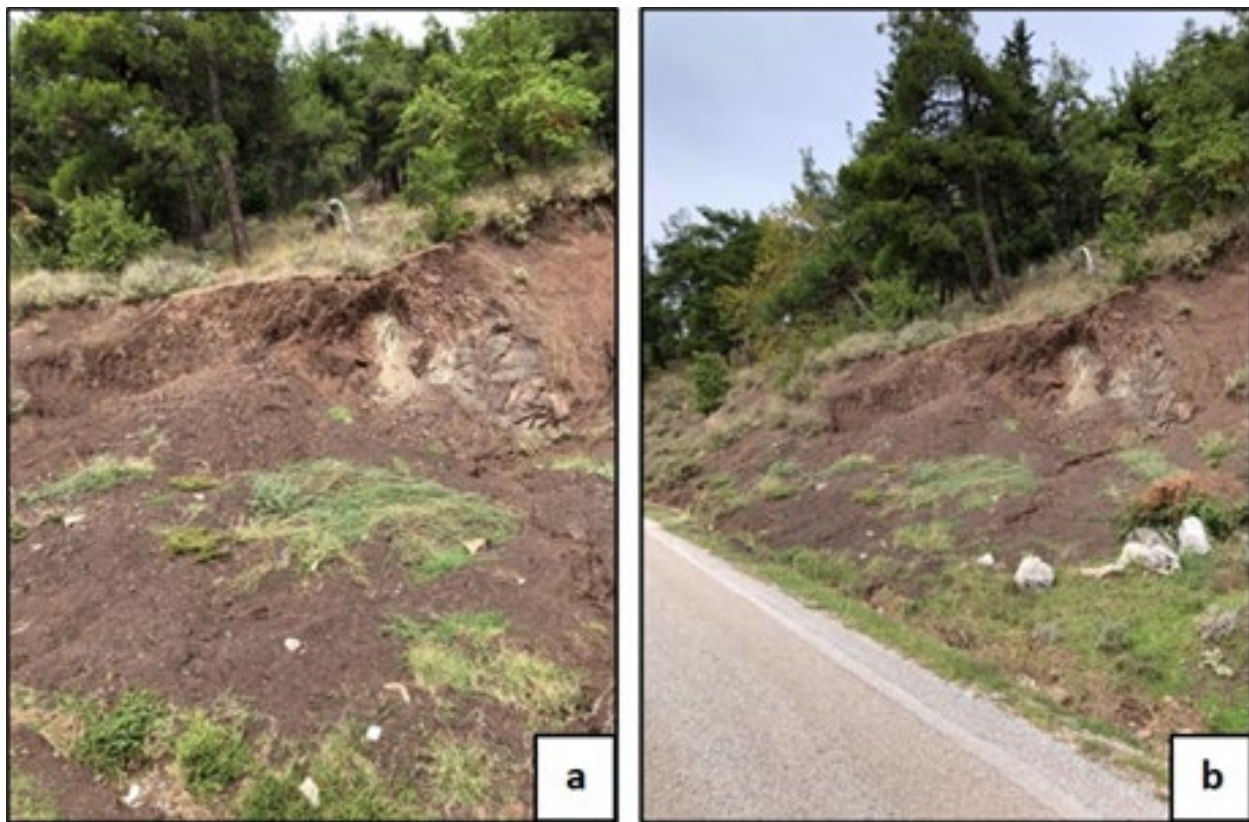
Figure 7.22. Surface erosion on Mouzaki to Porti road (39.410556°N, 21.658611°E).

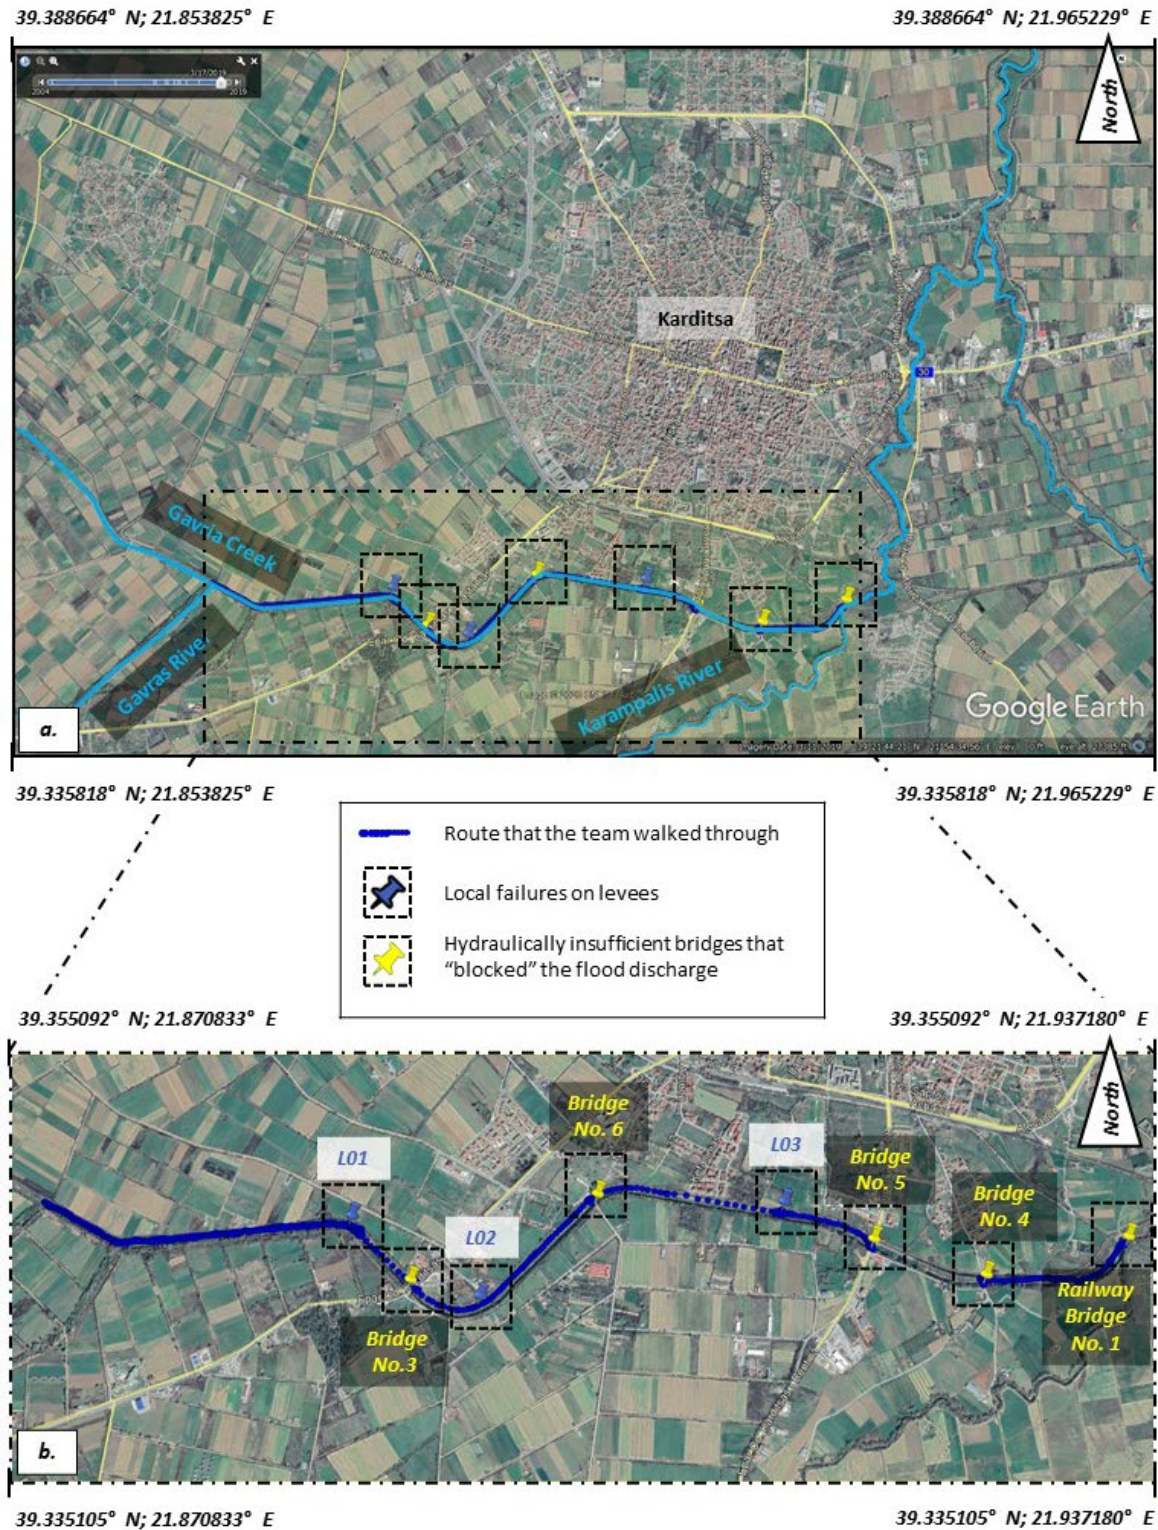
Figure 8.1. (a) Overview of the rivers and creeks that flooded the city of Karditsa; (b) Levees with local failures (*L##*) and hydraulically insufficient bridges (*Bridge No. #*) along the Flood Protection Levee of the Gavria Creek and the Karampalis River.

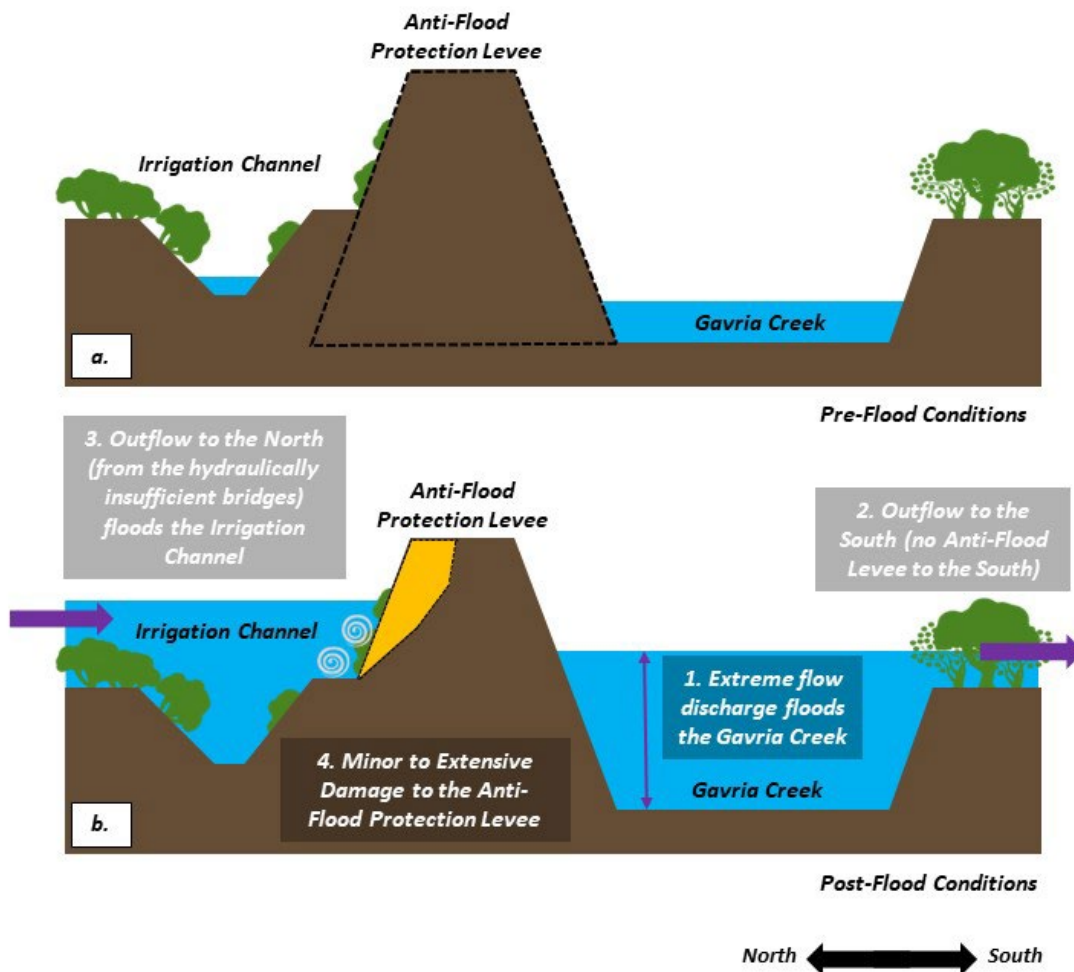
Figure 8.5. Conceptual sketches of the erosion damage on the Flood Protection Levee, on its northern side: (a) pre-flood conditions & (b) post-flood conditions and 4-step explanation of the erosion mechanism.
