# Impounded sediment and dam removal: Erosion rates and proximal downstream fate

## Abstract

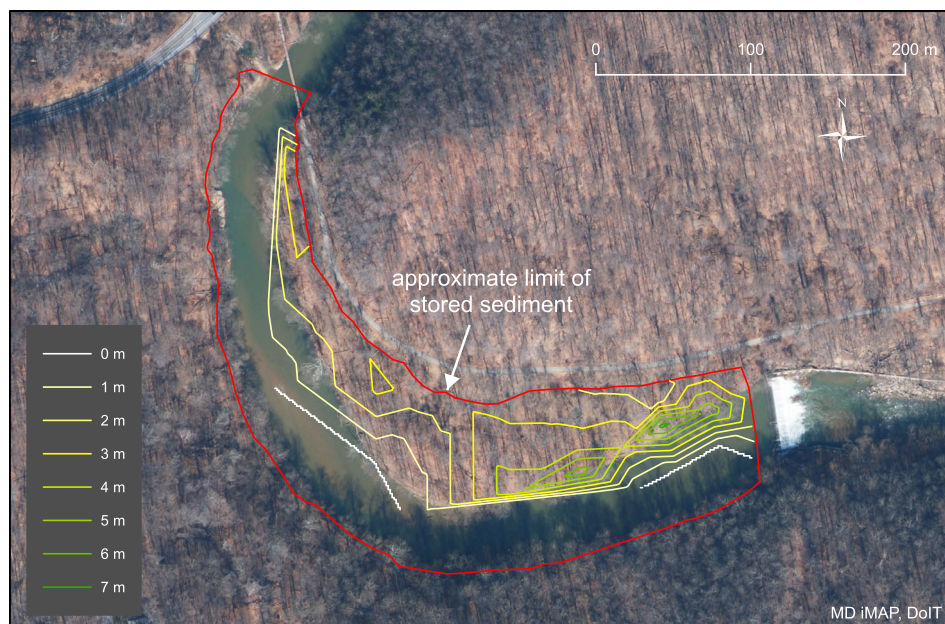
**FIGURE 4** Mud thickness contours showing the greatest accretions near the left bank and in the lower half of the former impoundment. The aerial image was taken in 2014 (MD iMAP, 2023c).

We estimated there was about 186 600 m<sup>3</sup> of stored sediment behind Bloede Dam just before removal that was composed of 70% sand and 30% mud. The sediment cores indicated that the mud facies occurred at the base of the stored sediment primarily along the left side of the impoundment and that the thickest accretions were in the

lower half near the dam (Figure 4). This matched the stratigraphy we observed soon after dam removal as the sediment deposit was rapidly incised and evacuated. We also observed some thin, discontinuous layers of decomposing organics in the deposit.
