Title of Thesis: A lidar-based approach to measure channel incision in headwater streams in an urbanizing landscape

A LIDAR-BASED APPROACH TO MEASURE CHANNEL INCISION IN
HEADWATER STREAMS IN AN URBANIZING LANDSCAPE

Thesis submitted to the Faculty of the Graduate School of the
University of Maryland, Baltimore County, in partial fulfillment
of the requirements for the degree of
Master of Science in
Geography and
Environmental Systems
2018

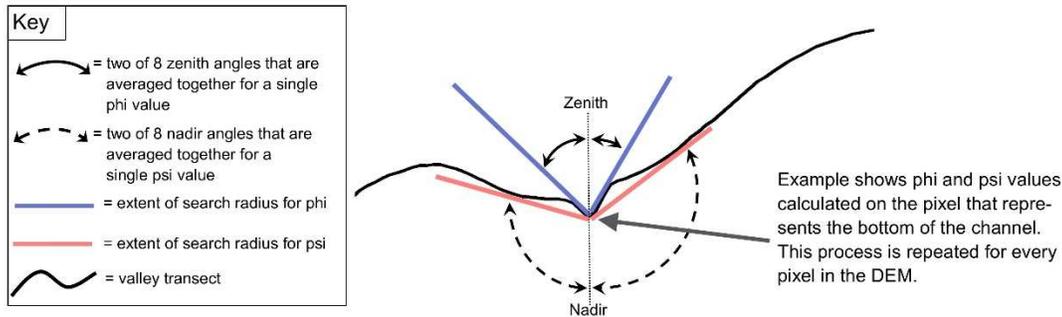
Figure 1.1: Example of positive (phi) and negative (psi) topographic openness calculation for a pixel within a stream channel. Angles are constrained by inflection points along the topography within the specified search distance. Positive openness is constrained by stream banks and is therefore potentially able to detect incised channels.

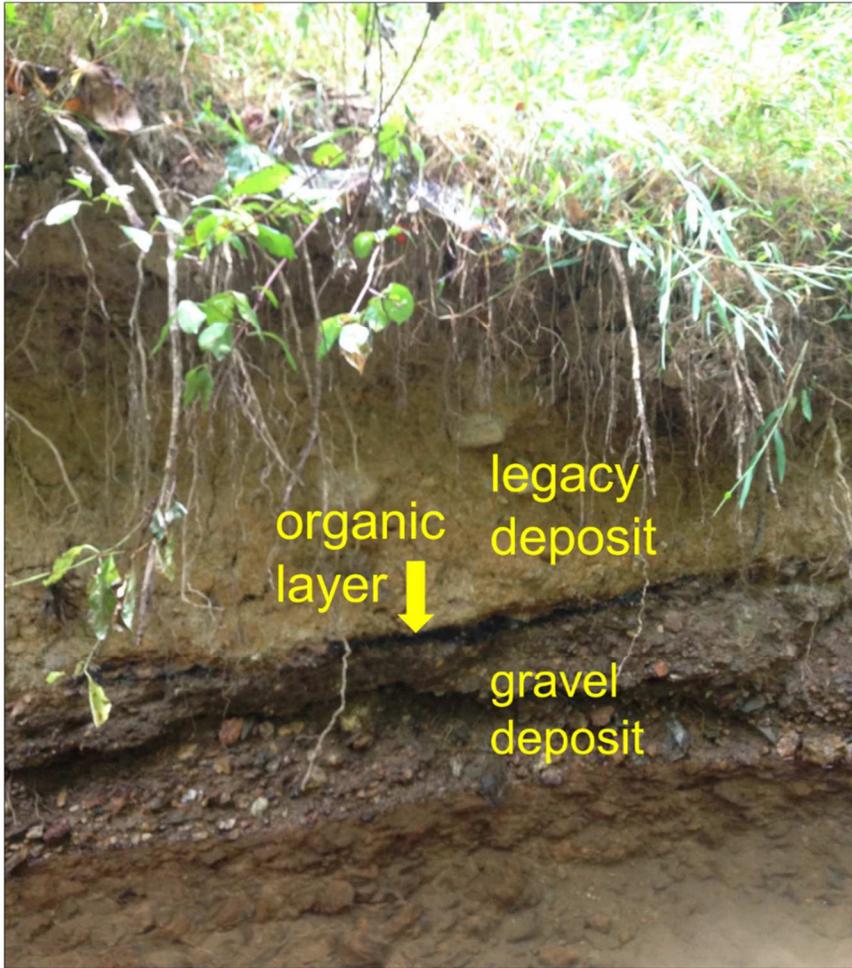
Figure 1.4: Exposed bank in TR104 shows a stratigraphic profile similar to other piedmont streams resulting from an agricultural land use history.

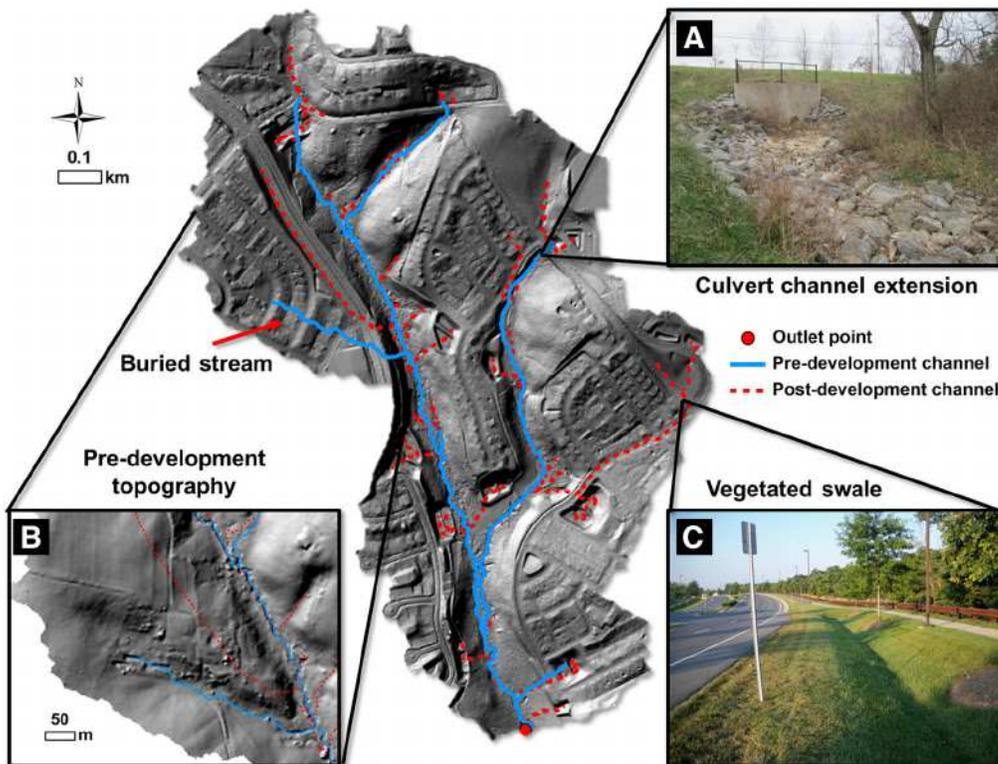
Figure 1.5: Pre- and Post-development stream network of TR104 showing where the development of artificial channels and loss of natural channels created an overall extension of the stream network. Adapted from Jones et al. (2014).

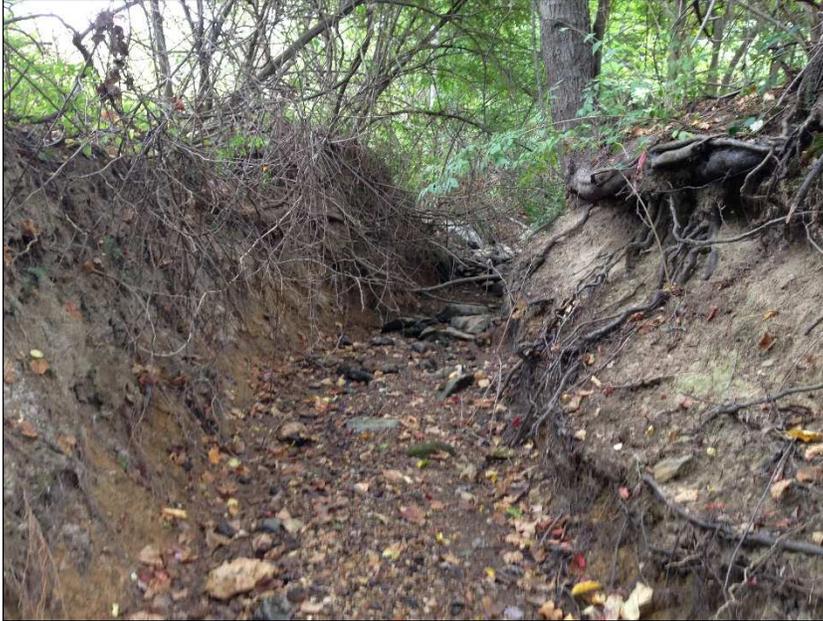
Figure 2.1: Severe channel incision in TR104. The depth and width of the channel have an approximate ratio of 1:1.

Stream incision, caused by disproportional erosion of the bed vs. banks, is one of the most obvious signs of an unstable channel and steep vertical banks that form are more susceptible to erosion (Figure 2.1). A variety of factors can contribute to channel incision but they are generally grouped into two categories based on the progression of incision over time: those that cause incision to progress either downstream or upstream (Galay 1983) (Table 1). The primary driver of incision in urbanized watersheds is land use change, which alters sediment supply and the flow regime. Urban channels typically incise by rapid downcutting after the implementation of impervious surfaces and efficient storm drain networks rapidly deliver runoff from streets into adjacent streams (Hammer 1972, Booth 1990, Cole et al. 2016). Incised channels may perpetuate a positive feedback loop of erosion by confining higher magnitude flows within the steep banks that would have otherwise been able to overtop the banks and disperse energy by spilling onto the floodplain. Eventually, oversteepened banks may collapse and through subsequent removal, return the channel to a more stable form (Schumm et al. 1984). If impervious surfaces and/or stormwater outlets direct runoff to steep hillslopes, channels can also incise directly into upland surfaces where floodplains do not exist.

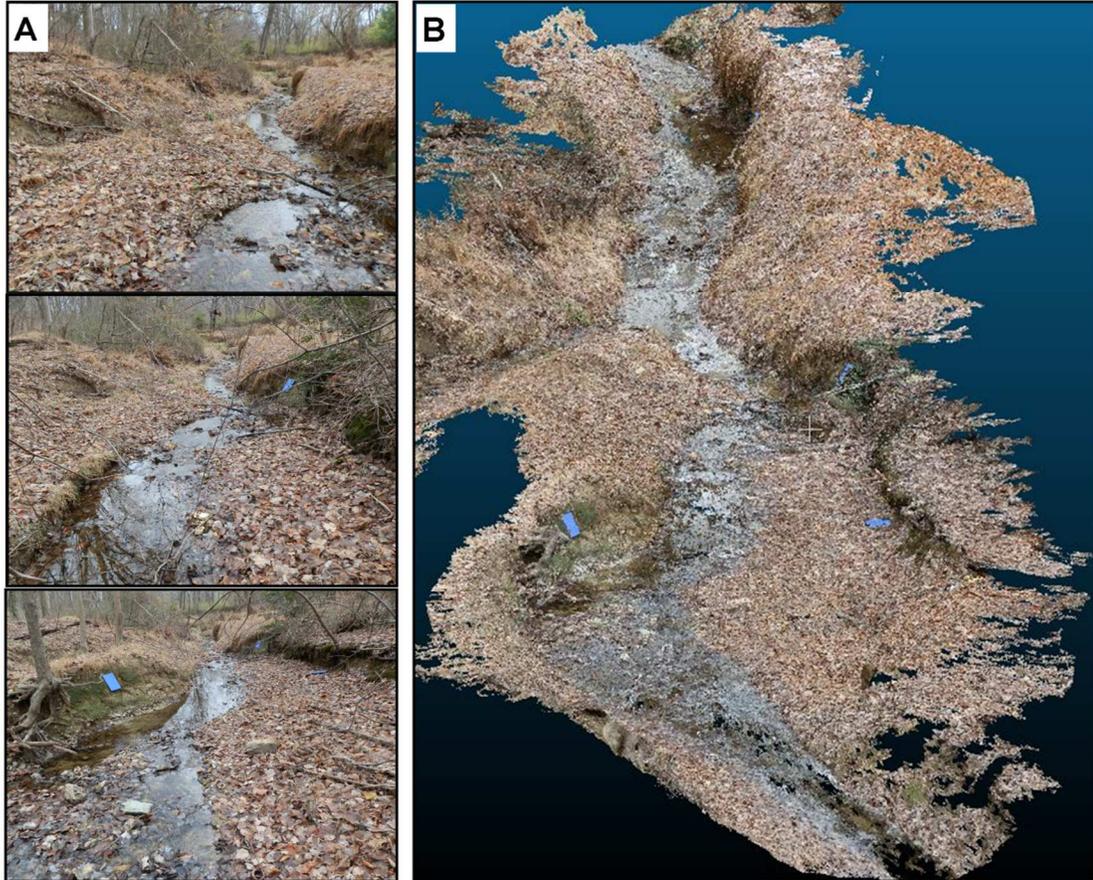
Figure 2.3: Examples of photos collected in the field (A) that were used to derive a 3-dimensional point cloud of a stream reach (B). The blue squares are scale markers used to correctly scale the point cloud.

Compare® to filter out large sections of vegetation and other non-ground points (Figure 2.3).

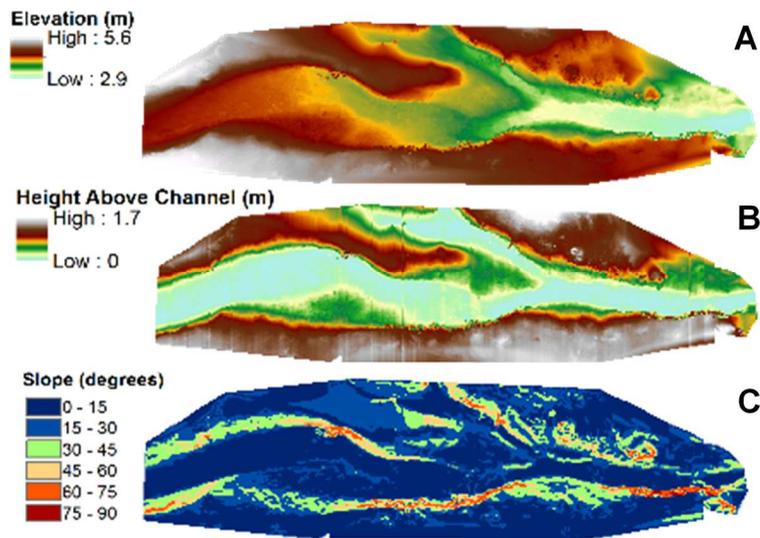
Figure 2.4: Original 0.1 m DEM generated from the scaled, filtered point cloud (A). The overall elevation was adjusted to represent elevation above the local channel minimum (B). The degree slope was then calculated from the original DEM (C).

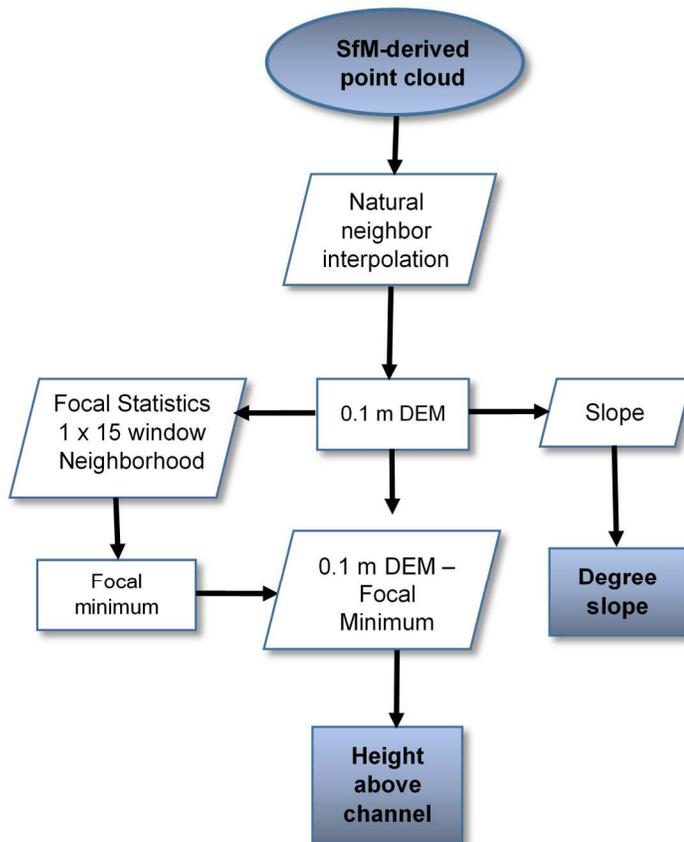
Figure 2.5: Workflow for processing SfM-derived DEMs of stream reaches to determine bank height and bank angle.

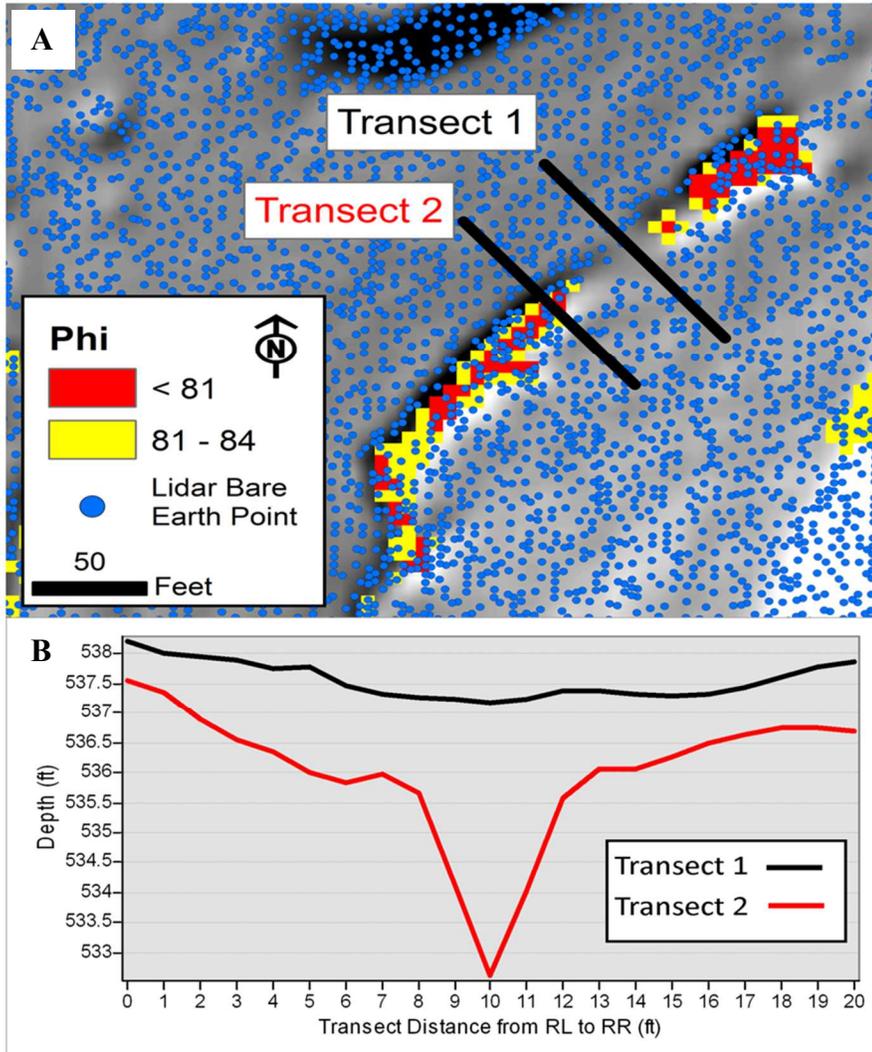
Figure 2.6: Example of areas along the channel where there are low point counts, and phi values are > 84 (indicating a non-incised reach) even though this is an area with known severe incision (A). Two cross sections were extracted from the DEM. The channel is not detected along transect 1 but is detected in transect 2. (B). Additionally, the v-shape of Transect 2 isn't showing true channel form but is a result of using a coarser 1.8 m DEM, which is approximately the width of the channel.

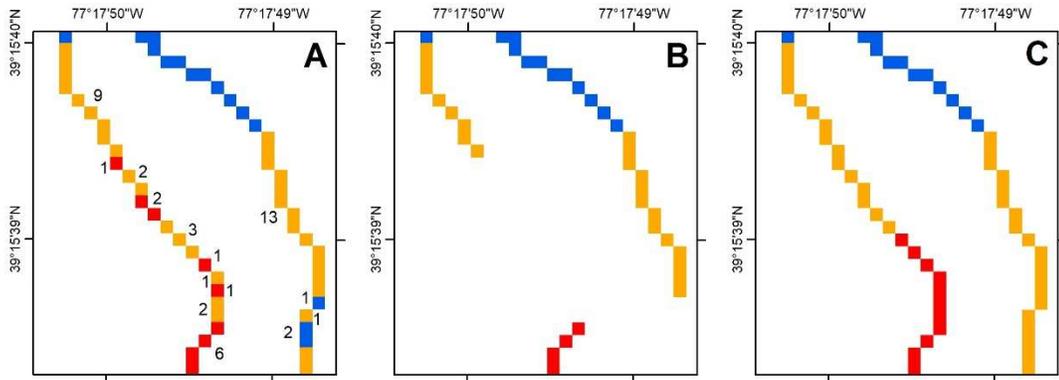
Figure 2.7: Result of original phi values reclassified into three different levels of incision, represented by red (level 2), orange (level 1), or blue (level 0) pixels. The region group tool counts the number of contiguous pixels of the same value (A). The set null tool was set to remove groups under a value set by the user (B). The nibble tool was then used to fill in the gaps removed from set null with surrounding pixel values (C).

classifications and represent incision at a scale closer to what was typically detected in the field (Figure 2.7). All three watersheds had an improved accuracy and kappa statistic when single pixels different than the adjacent pixels were smoother over. The most improvement in TR109 and Soper Branch was observed using a threshold of smoothing areas with less than 4 (7 m) contiguous pixels of the same value (Table 2.2), with TR104 resulting in a slightly higher improvement with a threshold of 5 pixels (9 m). Since the incision method introduced here was also applied to lidar collected prior to 2013 to understand incision changes through time, the optimal threshold of 5 pixels was selected for all analyses in TR104, rather than the threshold of 4 pixels selected for all analyses in SB and TR109. This 7 – 9 m threshold is closer to the scale at which transitions in incision were observed in the field. In the absence of field data to support a more objective smoothing threshold, a threshold of 4 pixels, which improved the accuracy in all three watersheds tested here, would likely result in improved accuracy in similar settings.

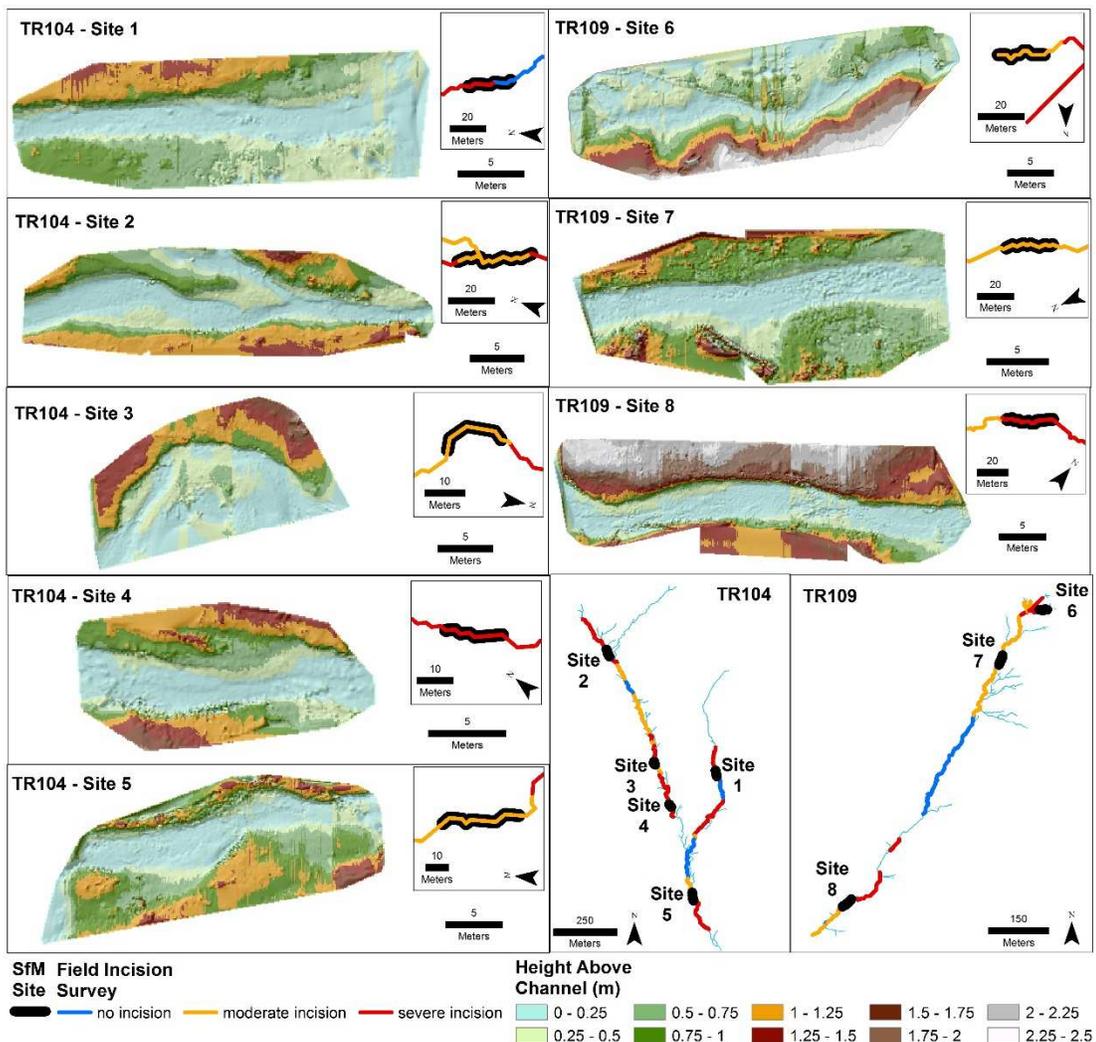
Figure 2.9: Results of SfM survey of bank height after elevation was adjusted to reflect height above the channel rather than relative elevation.

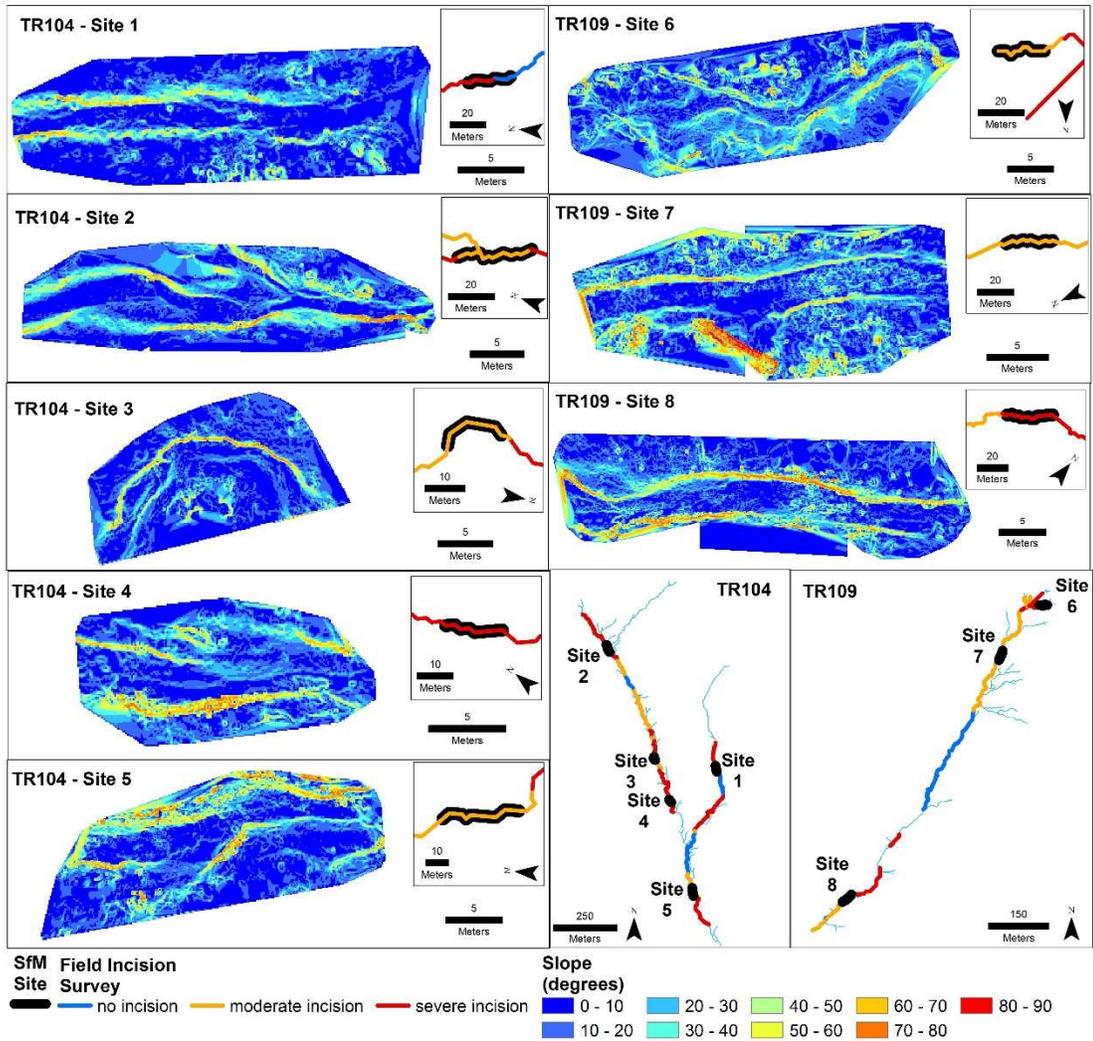
Figure 2.10: Results of SfM survey of bank angle in degrees per pixel, to obtain bank slope information on each reach.

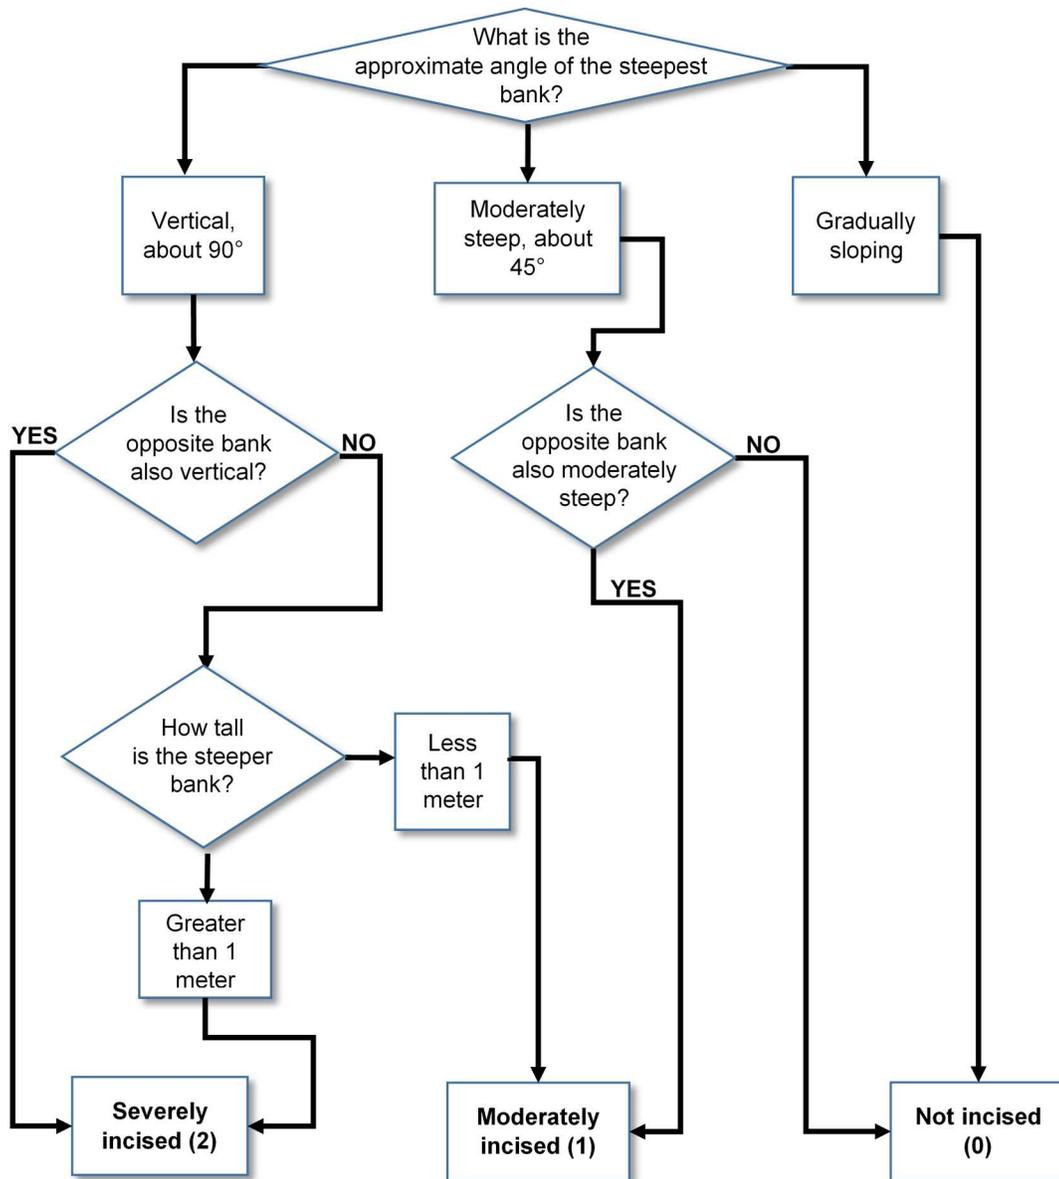
Figure 2.11: Decision tree for classifying reaches into incision classifications of severe, moderate, and none, based on channel observations and data extracted from the SfM-derived DEMs.

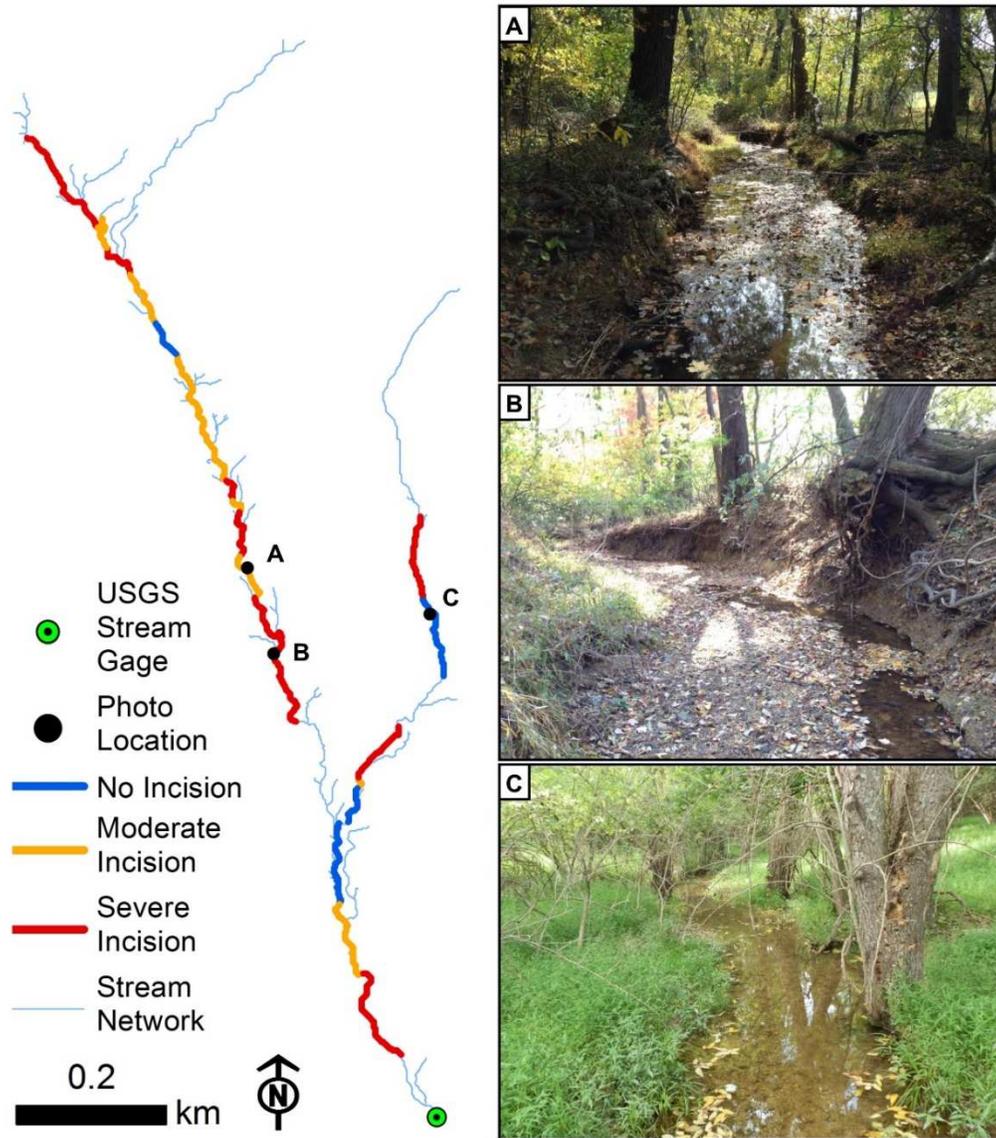
Figure 2.12: Results of incision field survey for TR104. Examples of reaches with moderate incision (A), severe incision (B), and no incision (C).

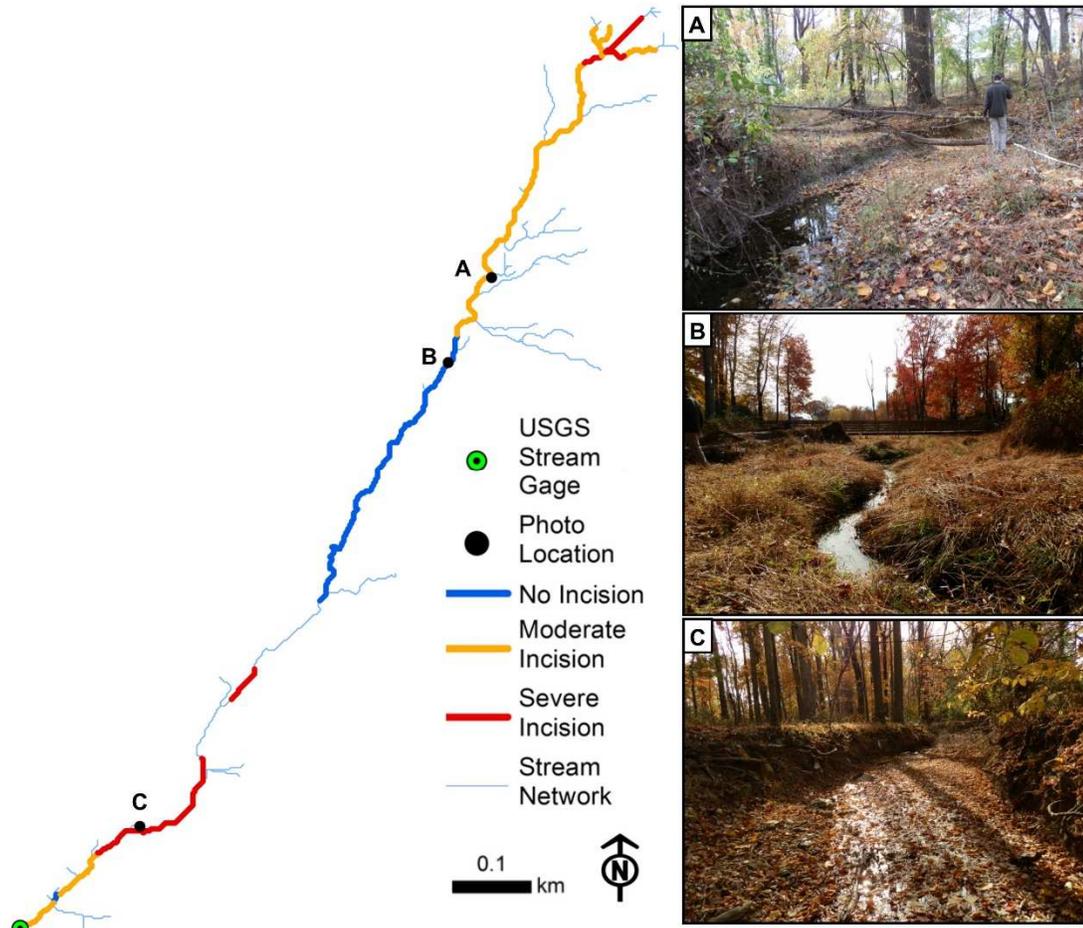
Figure 2.13: Results of incision field survey for TR109. Examples of reaches with moderate incision (A), no incision (B), and severe incision (C).

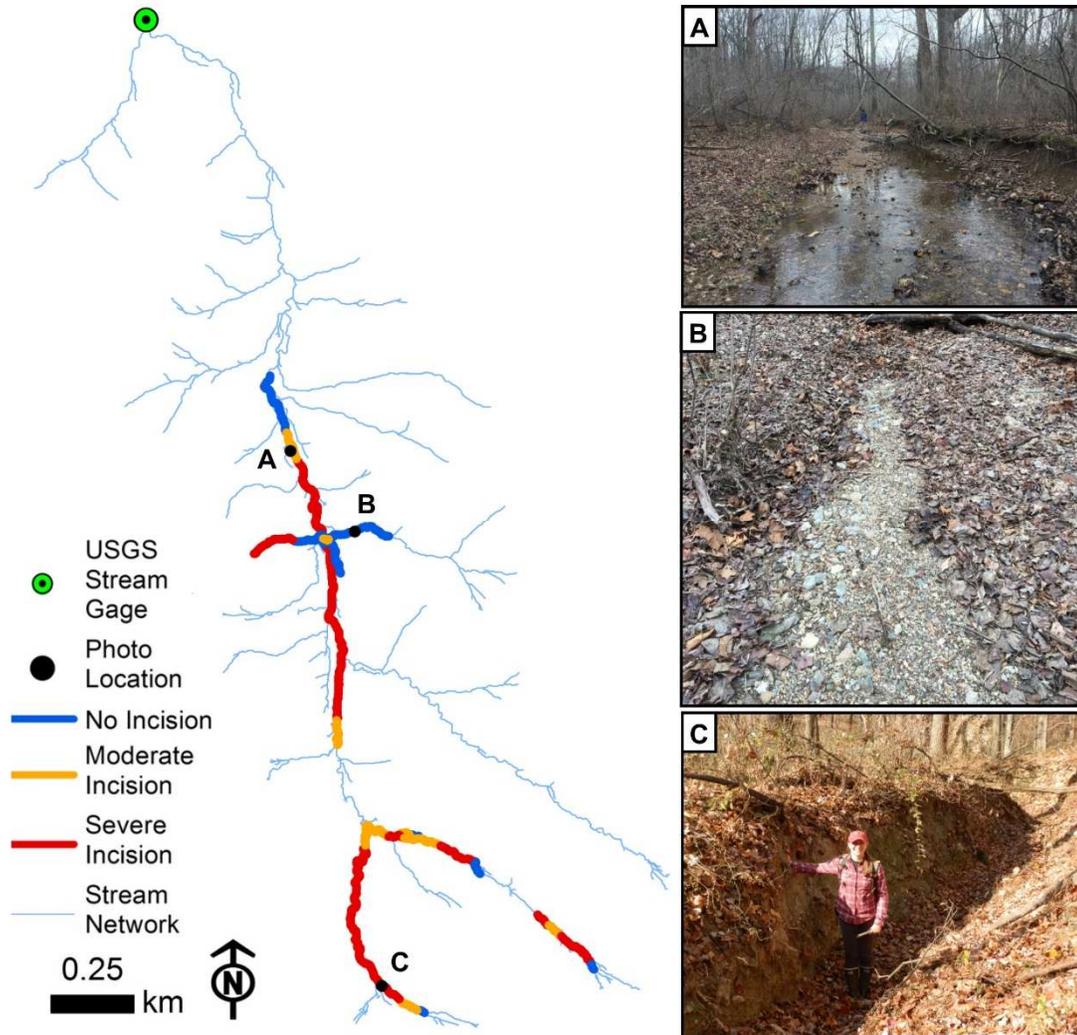
Figure 2.14: Results of incision field survey for SB. Examples of reaches with moderate incision (A), no incision (B), and severe incision (C).

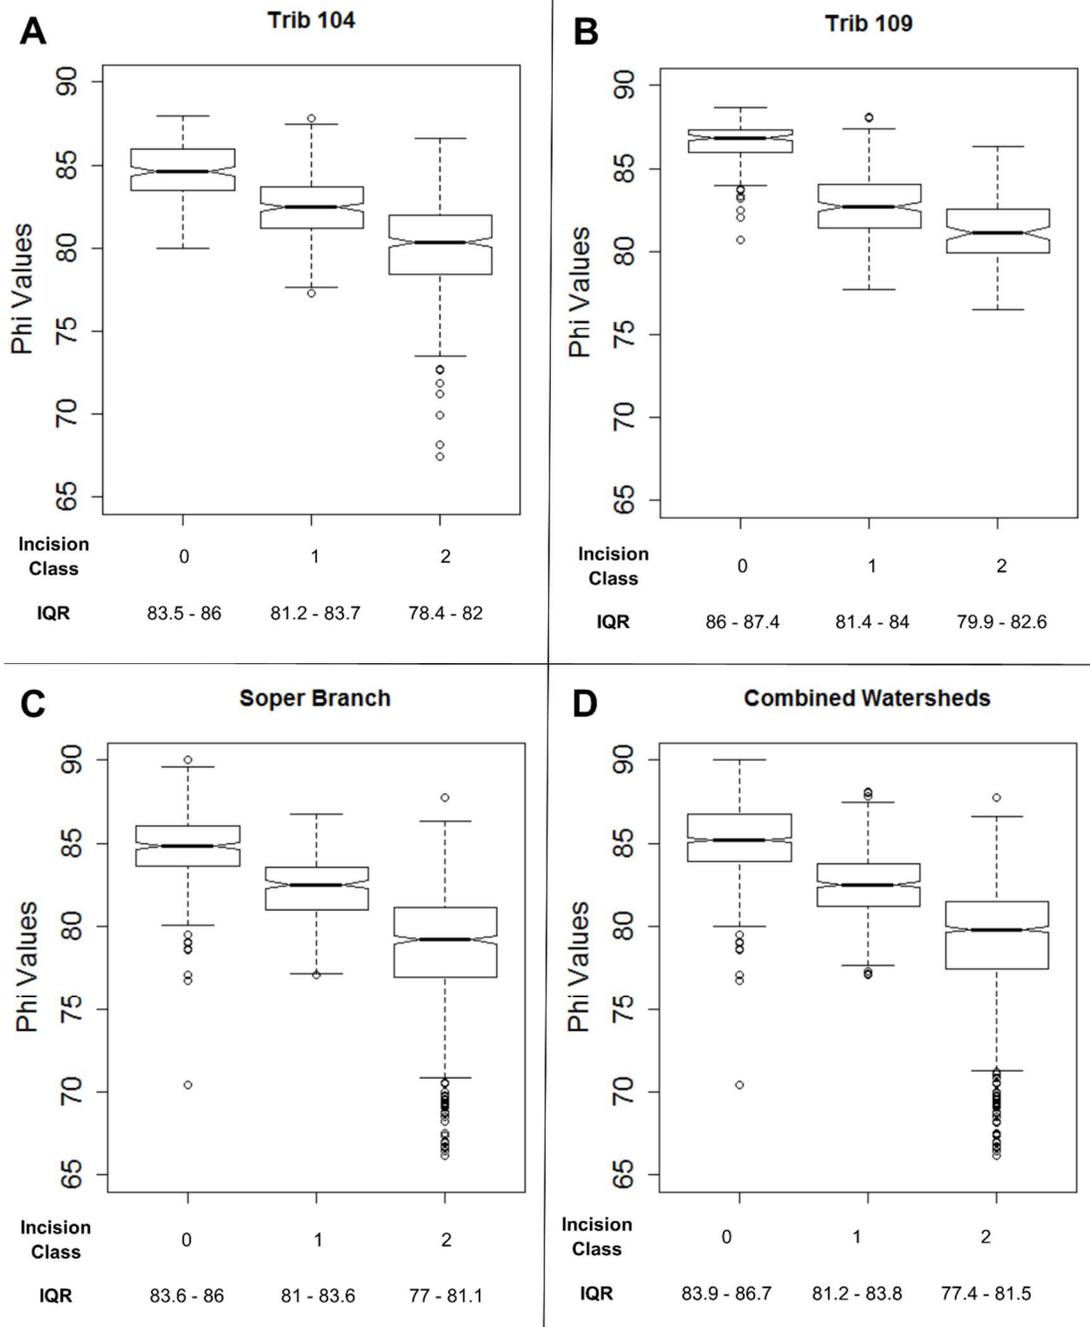
Figure 2.15: Boxplots displaying the distribution of positive openness values overlapping with each level of incision surveyed in the field. Notches show 95% confidence intervals of the median and suggest the median between groups differ when not overlapping.

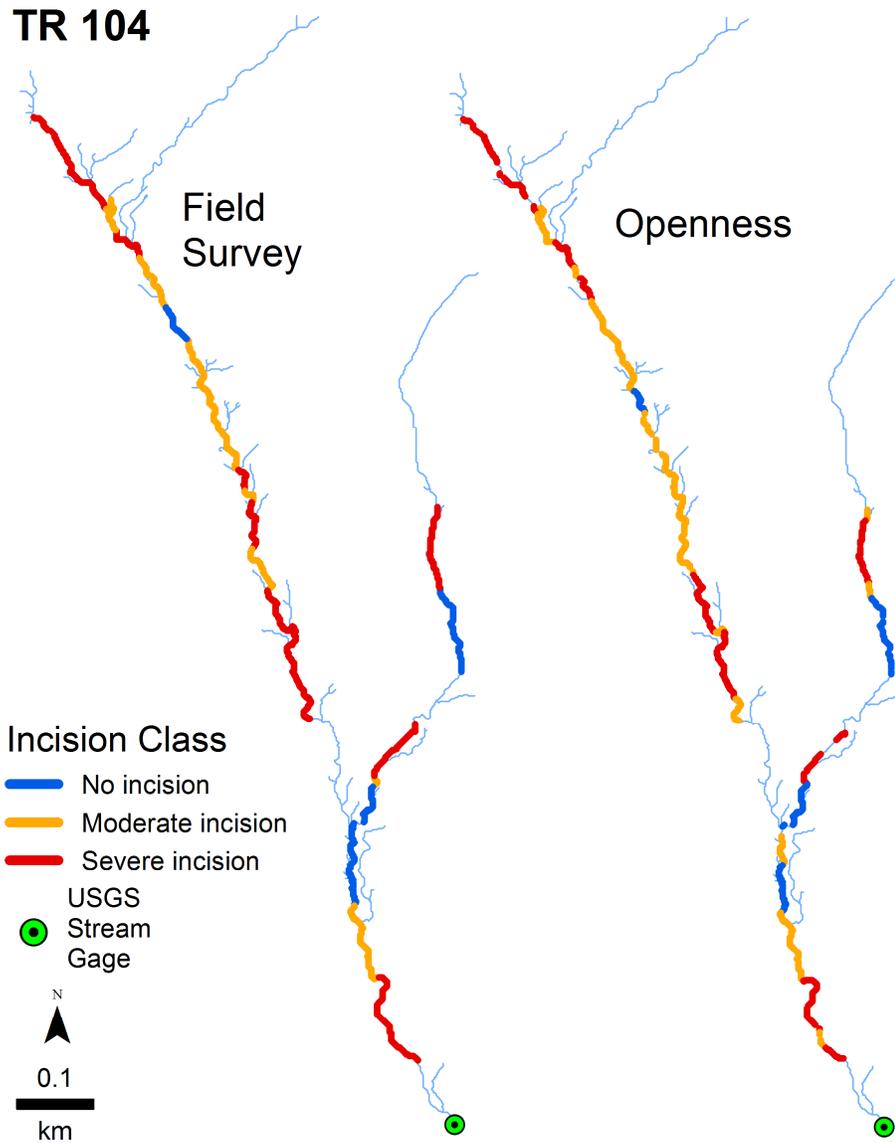
Figure 2.16: Results of the openness model, after smoothing, compared with the field survey for TR104.

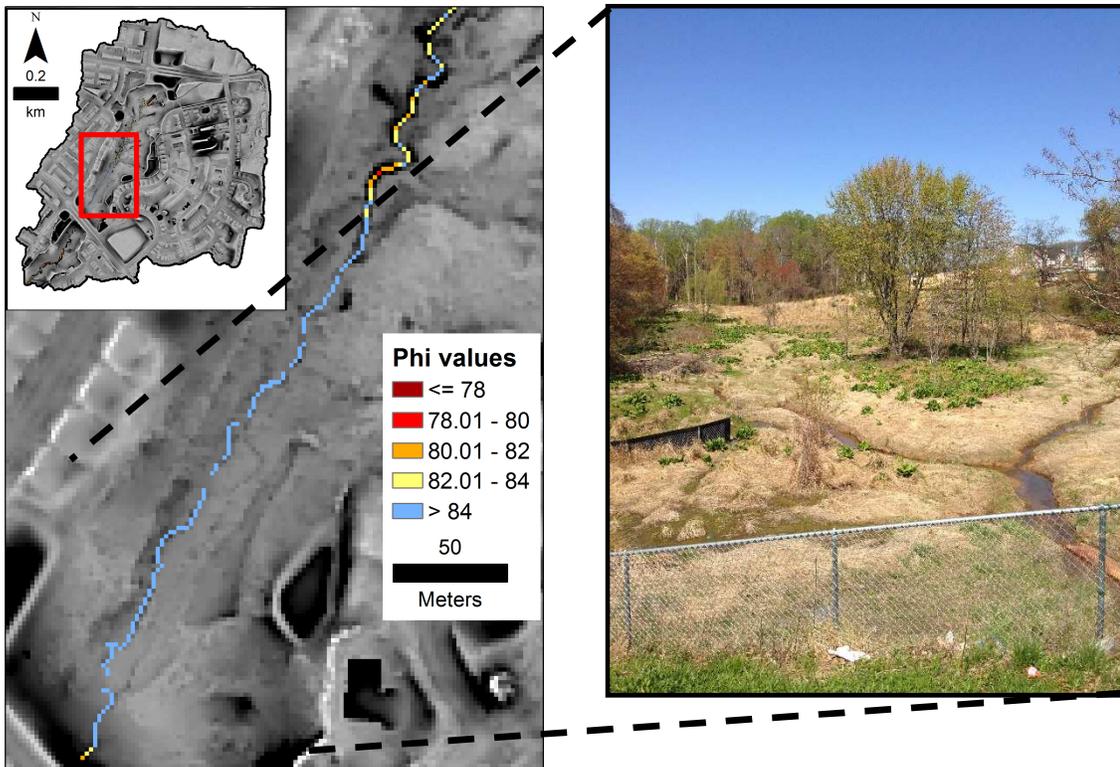
Figure 2.17: Example of long continuous reach with no incision in TR109, likely driving the success of the overall model. The openness pixels within the stream are reclassified to the scale shown in the legend. The long stretch of blue pixels represent a section of the stream flowing through a wetland so the area is relatively flat and easy to identify as not being incised in the openness model.

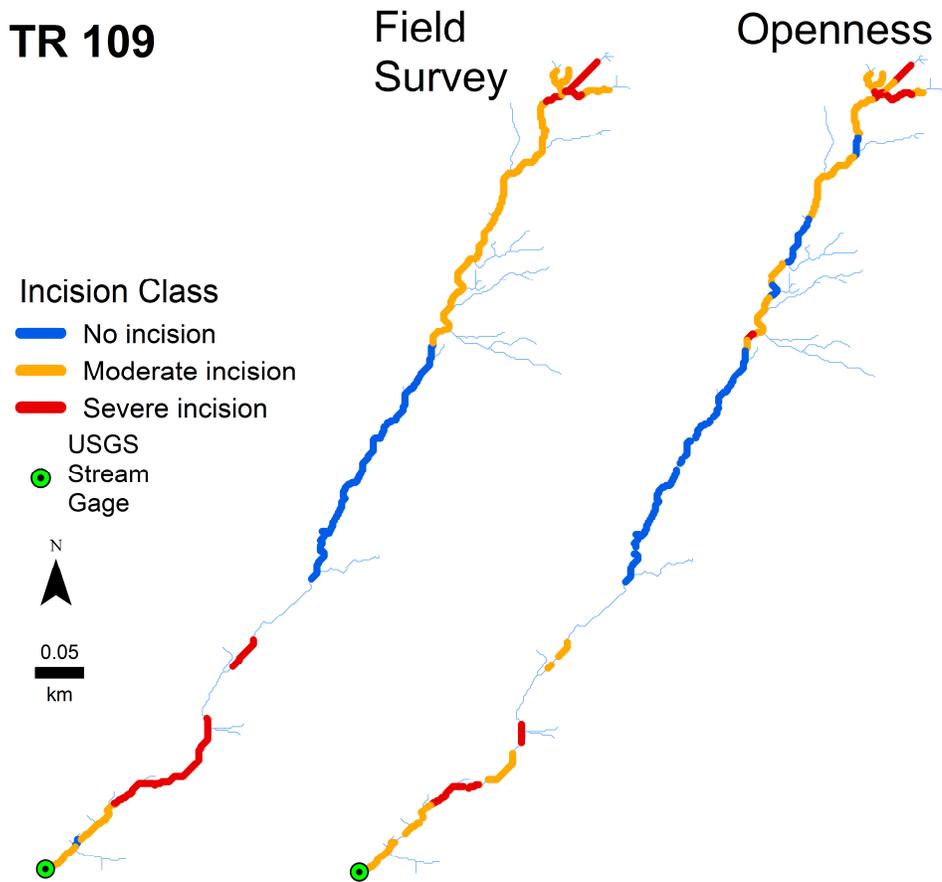
Figure 2.18: Results of the openness model, after smoothing, compared with the field survey for TR109.

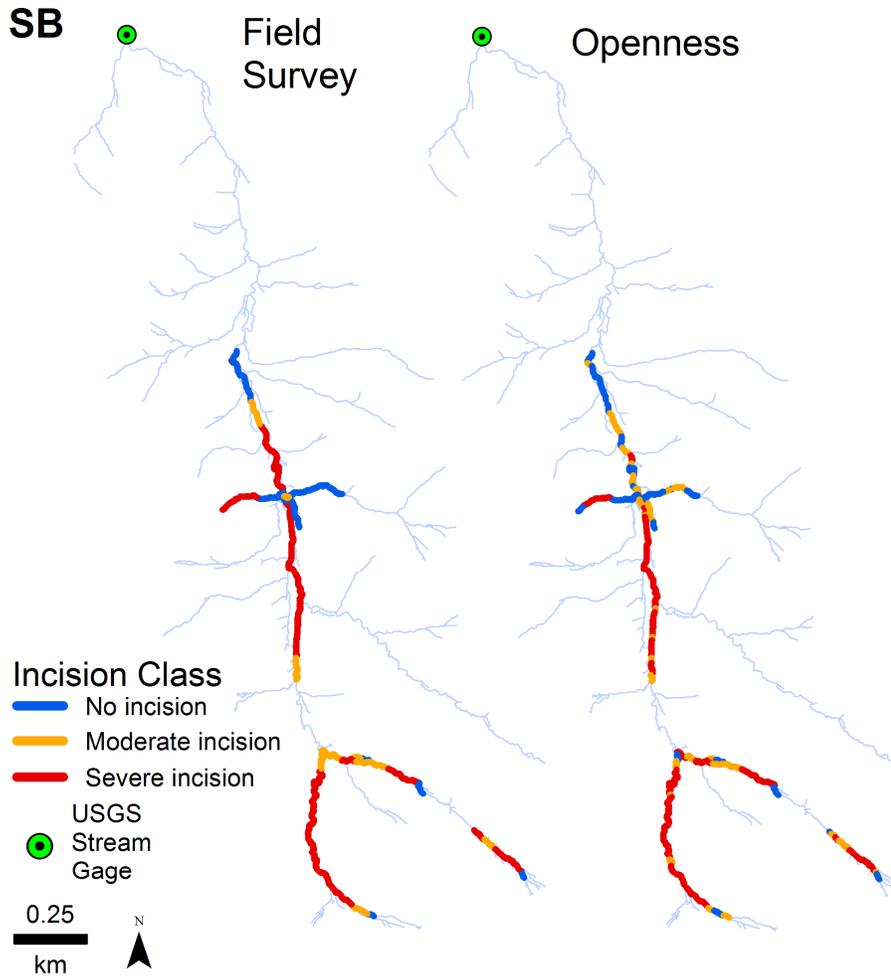
Figure 2.19: Results of the openness model, after smoothing, compared with the field survey for SB.

contained a significant portion that was surveyed 2 but classified as a mix between 0 and 1 (Figure 2.19). The cause of this is further explored in the discussion section.

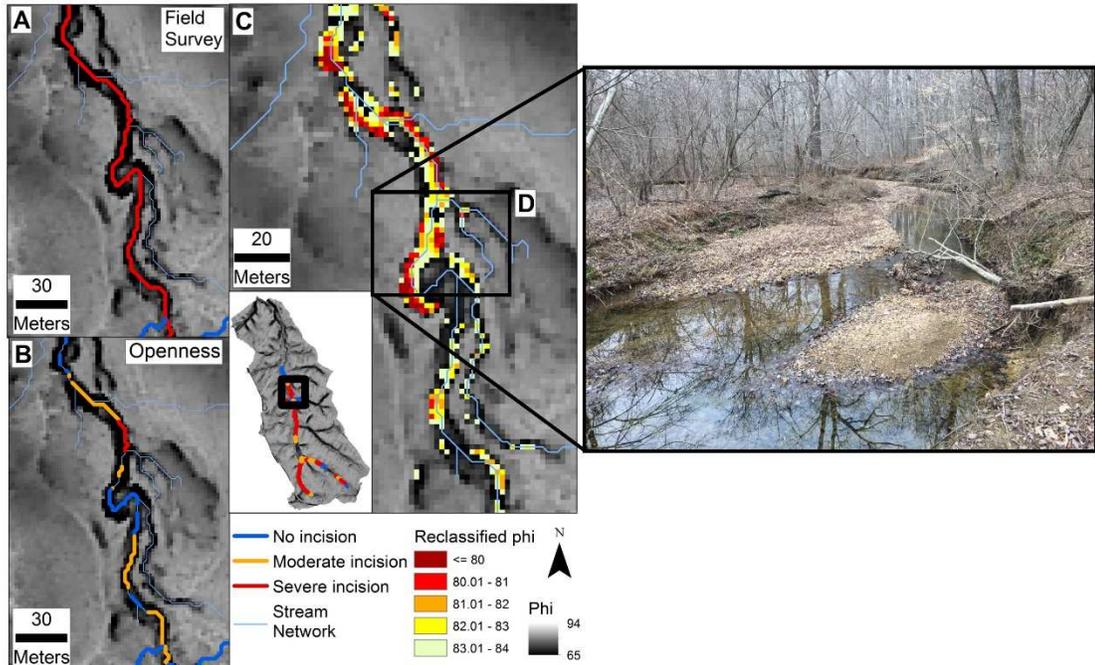
Figure 2.20: Large discrepancies between the field survey (A) and openness model (B) in main channel of SB. Reclassified openness pixels show some areas of the channel with a range of incision but the result of the openness model is based on where within the channel the network is delineated (C). High openness values within the incised channel are likely picking up bars within the channel (D). Here the channel is wider than much of the other survey locations, indicating adjustments may need to be made for higher order channels.

vertical to lateral erosion based on both stream power and longitudinal profile form (Jain et al. 2008). Below this transition, depositional sand and gravel bars were observed in the field (Figure 2.20). The growth of these bars can divert the channel to disproportionately erode one side of the bank, leading to bank failure and channel widening. This process begins at the boundary between a confined valley upstream and a partially confined valley downstream where the confined bank erodes and discontinuous floodplains begin to form on the depositional side (Jain et al. 2008). Moving downstream, erosion and deposition alternate from one side of the channel to the other as the channel meanders. There may also be a bedrock control preventing the channel from downcutting further, as observed in other Piedmont streams (Colosimo & Wilcock 2007, Lyons et al. 2015). Just downstream from transect A are two tributaries entering the main channel and the contribution of sediment from these tributaries may also lead to additional aggradation from the increased sediment supply. The transition between a partially confined and laterally unconfined valley was less distinct, but evidence of an unconfined valley was also observed near the confluence with a larger river. Figure 2.25 shows how topographic openness and Geomorphon can be used to identify all three valley settings described by Jain et al. (2008) within SB.

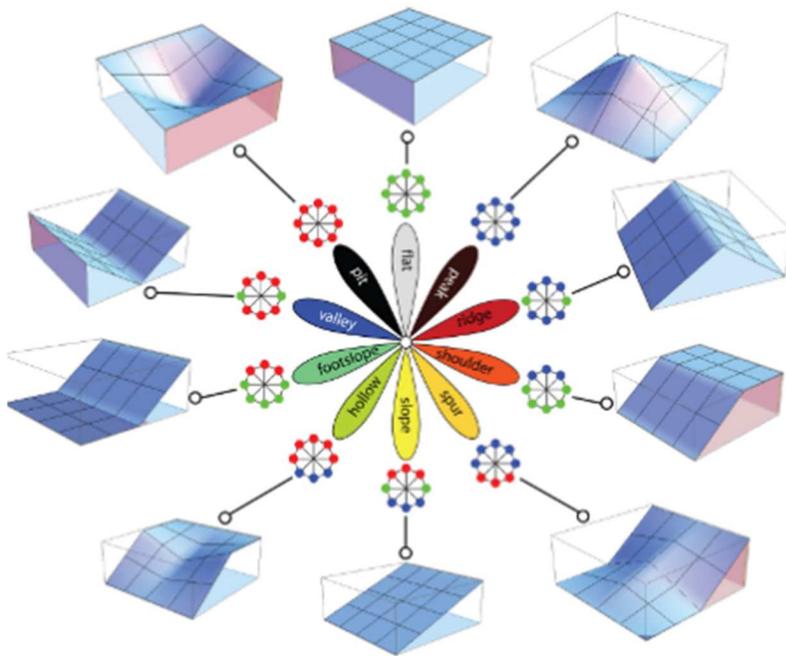
Figure 2.21: The 10 most common landforms classified with Geomorphon and an example of the typical form for each classification. Each of the 8 points surrounding the focal pixel in each form indicate if the point is above (red), below (blue), or equal (green). Adapted from Jasiewicz & Stepinski (2013).

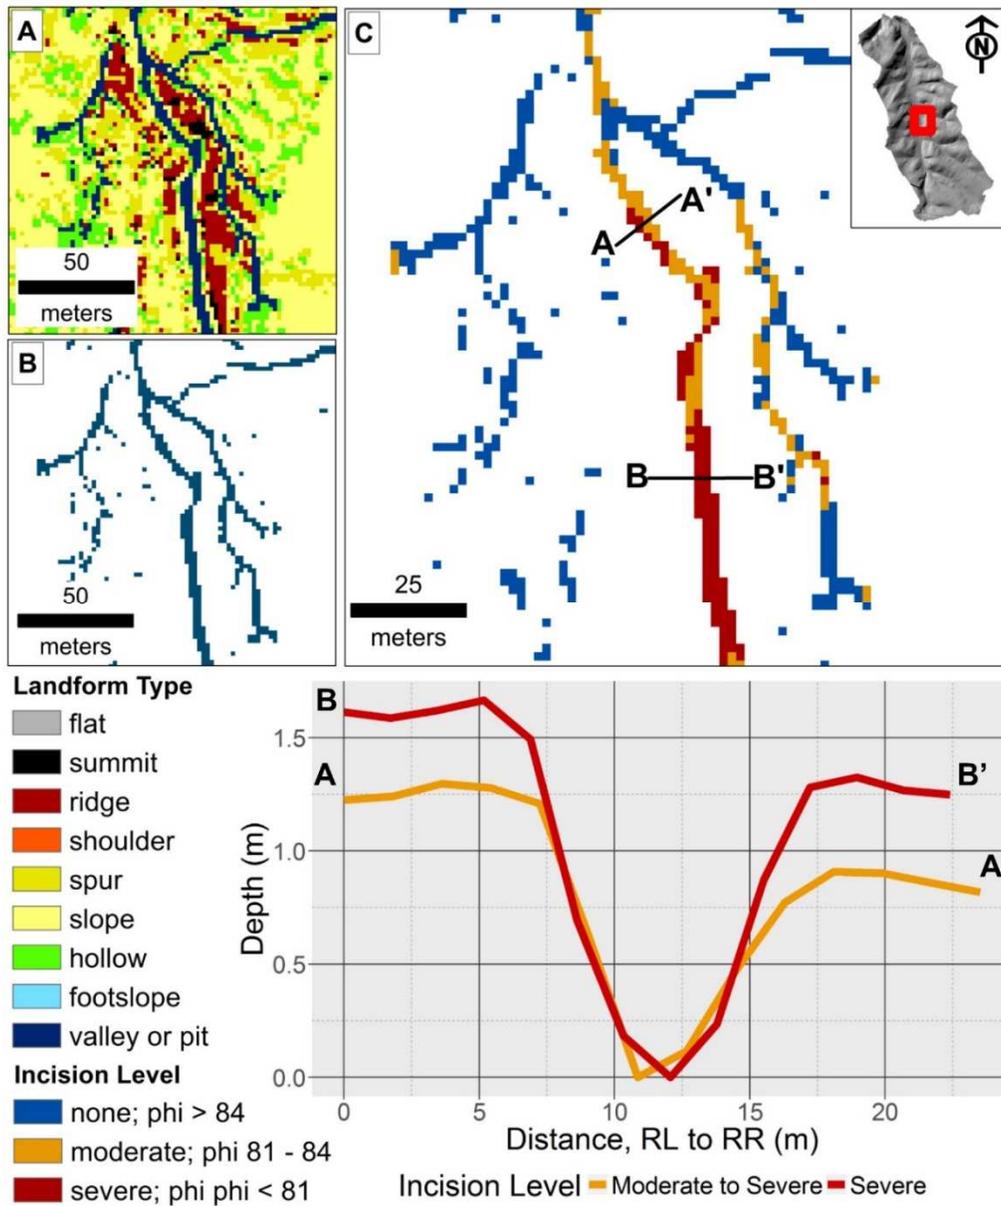
Figure 2.22: Geomorphon is a landform classification tool (A) and was used to isolate pixels classified as valley or pits, indicative of stream channels (B). The valley and pits were used as a mask to isolate and then reclassify openness into incision levels. This method better displays channel complexity in wider channels (C). Cross section A shows how the side of the channel with severe incision corresponds to a steeper bank than the other side showing only moderate incision. Cross section B shows a severely incised channel, which corresponds to the incision classification.

A change in the slope of the bed along the shift in incision shown in Figure 2.22 was not detectable from the lidar. Although this type of reach was not as well characterized, the context of surrounding channel conditions can be used to infer channel characteristics in these types of reaches. The incorporation of Geomorphon to classify all pixels within the channel illustrates how the channel is deeply incised near transect B before the channel widens and aggradation occurs, represented by a wider channel width a lower bank height at transect A. Sinuosity also increases downstream from this transition point (Figure 2.20). This point indicates a transition in the dominant geomorphic processes occurring in the channel that causes a shift from
