Title of Thesis: A lidar-based approach to measure channel incision in headwater streams in an urbanizing landscape

A LIDAR-BASED APPROACH TO MEASURE CHANNEL INCISION IN
HEADWATER STREAMS IN AN URBANIZING LANDSCAPE

Thesis submitted to the Faculty of the Graduate School of the
University of Maryland, Baltimore County, in partial fulfillment
of the requirements for the degree of
Master of Science in
Geography and
Environmental Systems
2018

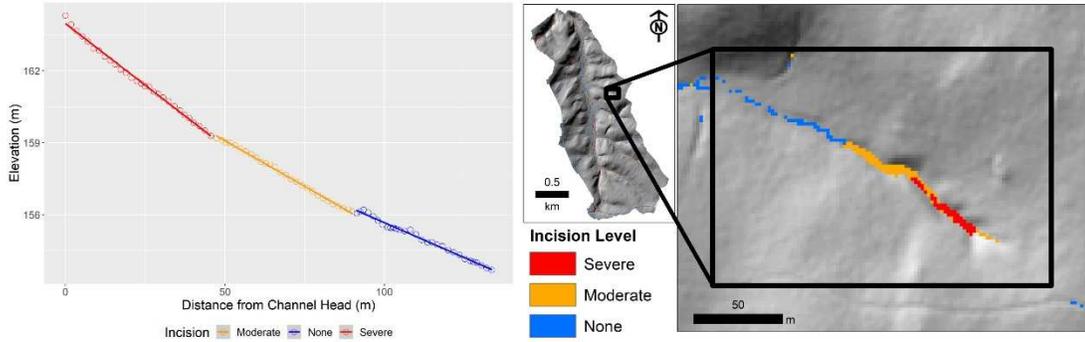
Figure 2.24: Longitudinal profile of a reach within Soper Branch that begins as an incised channel near the head, where the slope is steeper, and gradually transitions to moderately incised, and finally not incised, with slope of the bed becoming more gradual as incision severity declines. Sediment eroded in the steeper reach could also be deposited in the shallower slopes and further contribute to the development of the longitudinal profile and shifts in slope corresponding to shifts in incision level.

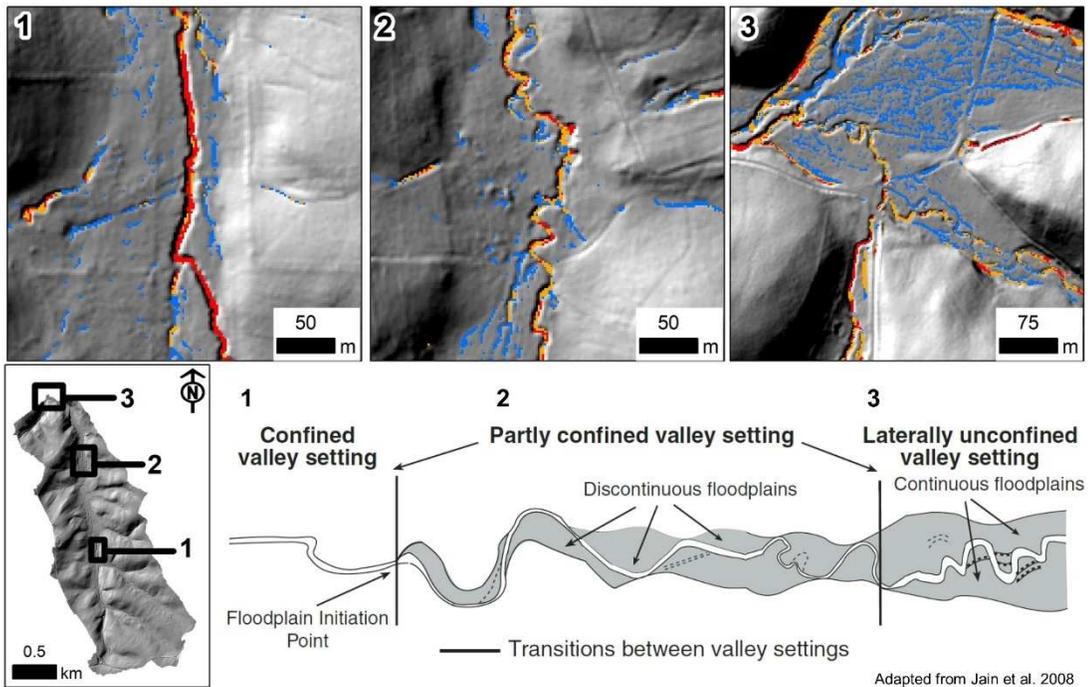
Figure 2.25: Examples of various channel forms in SB extracted from Geomorphon and topographic openness, with the corresponding channel form described by Jain et al. (2008). Example 1 shows the channel in a confined valley setting, characterized by a relatively straight channel with steep banks. Example 2 shows a partially confined valley with evidence of meandering. The red pixels indicate some severe incision or steep slopes along cut banks but the orange pixels indicate more gradual banks throughout most of the channel as a result of channel widening and point bar development that creates discontinuous floodplains. Example 3 shows the lower portion of SB near the confluence with a larger channel within an unconfined valley. The blue pixels indicate small side channels suggesting there is a broad, continuous floodplain.

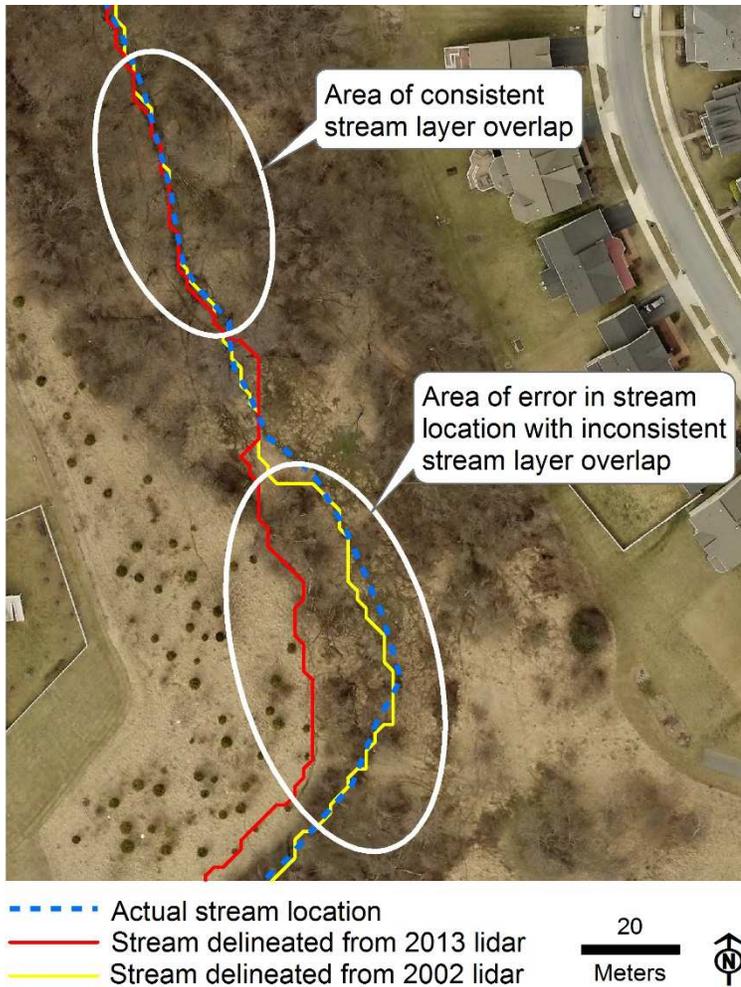
Figure 3.1: Example of the stream network deviating from the dominant channel location in 2013. (Aerial imagery is from 2012.) This was in a non-incised wetland section that quickly transitions to severe incision. Although the 2013 stream network appears to follow a less dominant channel in the wetland, the network does not overlap with the severely incised section until about 100 m downstream. The 2013 stream layer deviates outside the main channel and was removed from the analysis. Further upstream, the 2002 and 2013 stream layers accurately match the actual stream location.

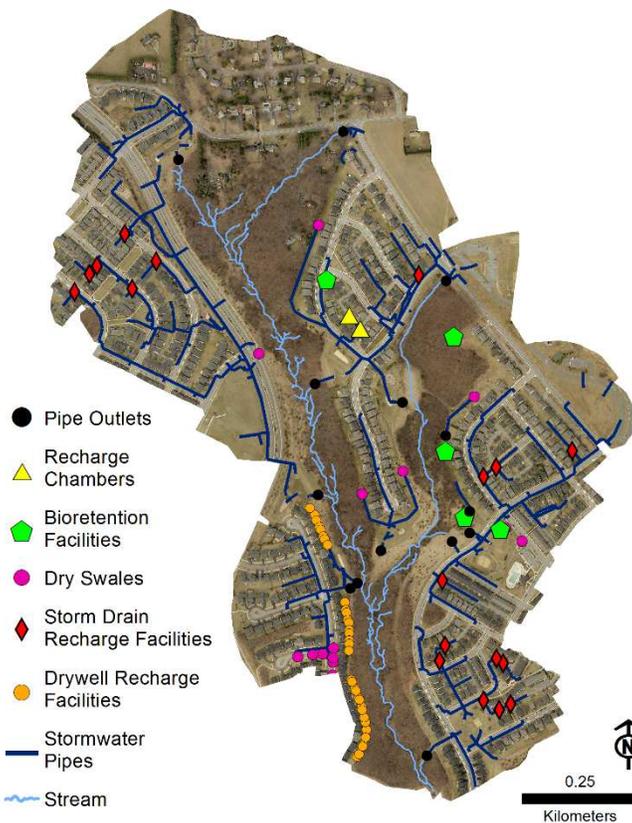
Figure 3.2: Locations of IF-SWM facilities in TR104. The drywell recharge facilities on the lower west side of the watershed show an area where seeps would be expected to occur more frequently on the west side of the stream bank if these facilities are enhancing groundwater discharge.

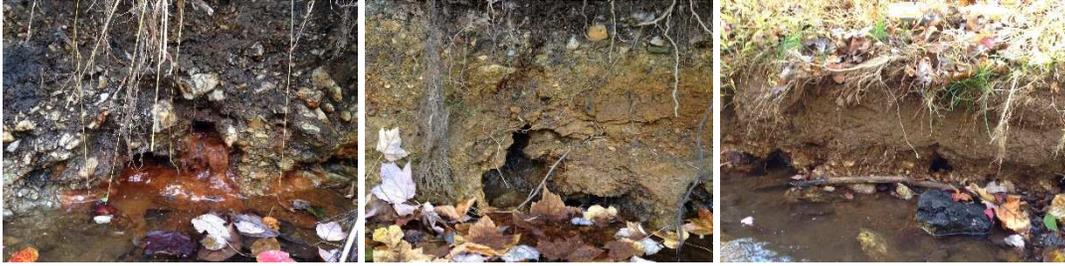
Figure 3.3. Indications of groundwater seeps in stream banks. The picture on the left shows iron in groundwater reacting with oxygen to form the rust color when seeping out. The picture in the middle shows water actively seeping from the bank. The picture on right does not have any indication of groundwater seepage other than the features formed in the bank.

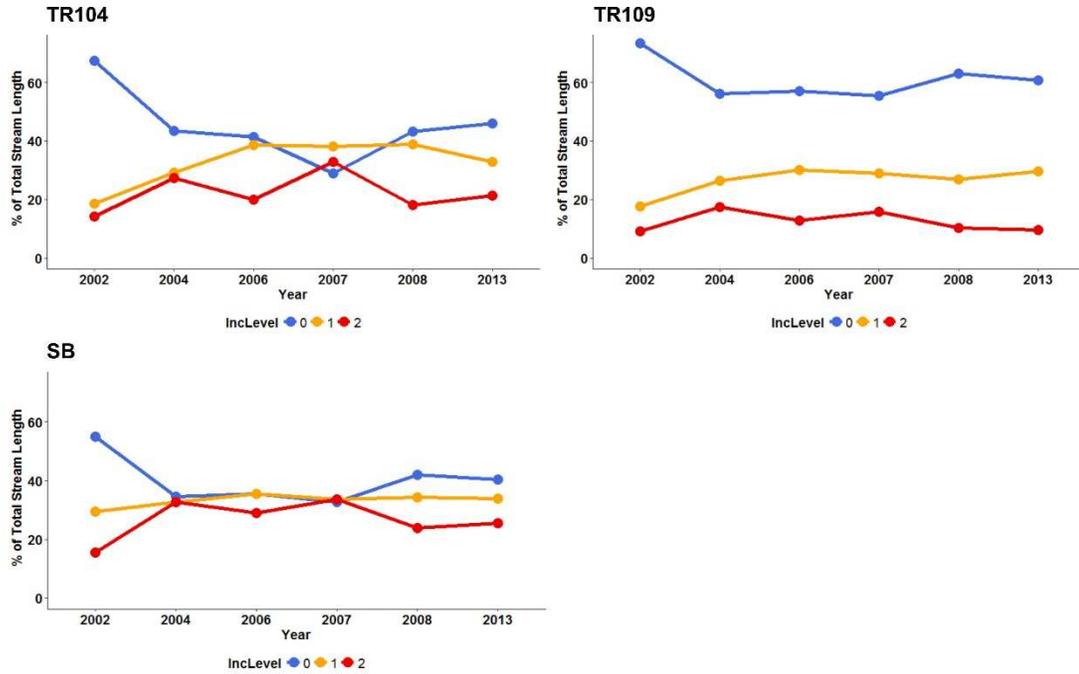
Figure 3.4.: The percent of the stream network classified as not incised (0), moderately incised (1), and severely incised (2). Only areas of the stream network that overlap within a 2.7 m (9 ft) buffer in every year are considered.

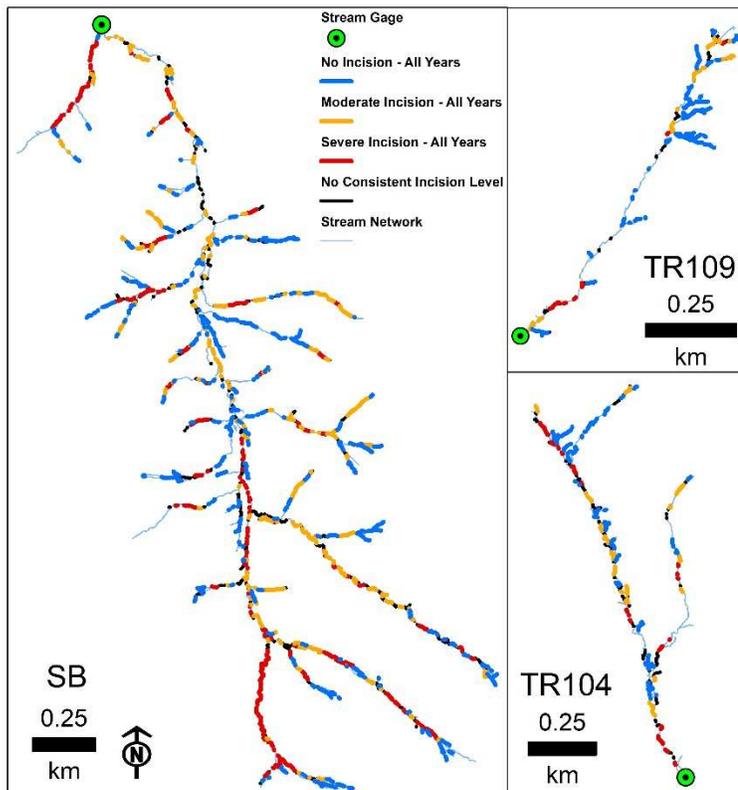
Figure 3.5.: Areas of each network where the incision level has remained consistent in at least five of the six years. Gaps are areas where the stream network did not overlap within a 2.7 m buffer in every year.

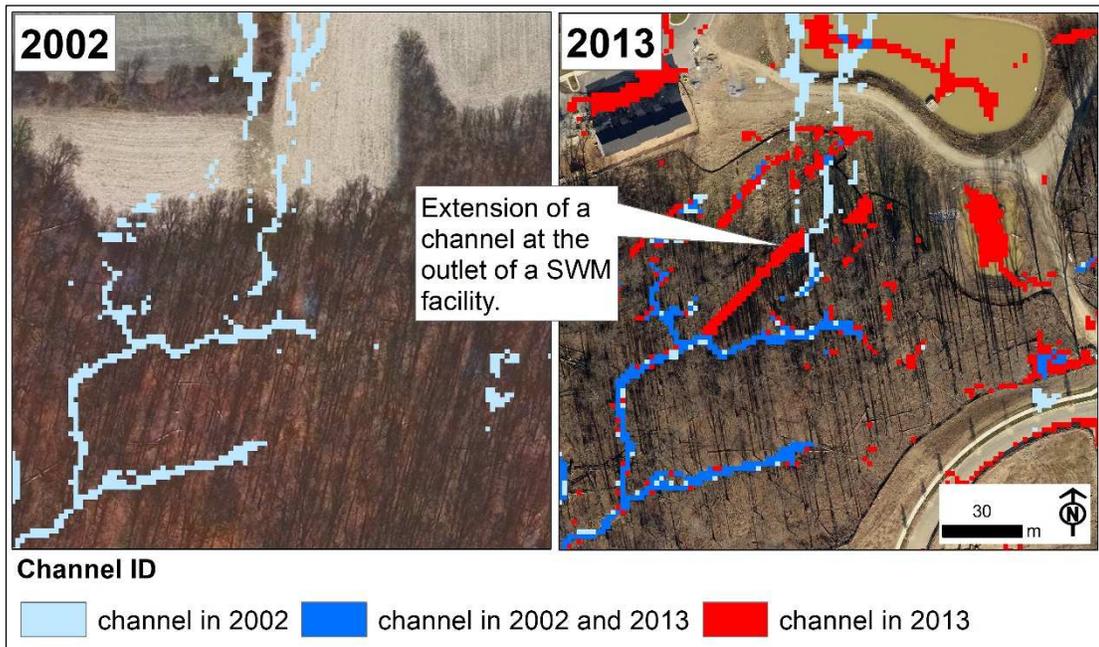
Figure 3.6: Example of channels in TR109, represented by valleys and pits extracted from Geomorphon. The darker blue shows areas that were mapped as channels in both 2002 and 2013. The red shows areas mapped as channels in 2013 but not in 2002, and a prominent feature is the artificial channel at the outlet of a SWM pond that was added to the stream network as a direct result of urban development. The light blue pixels in the panel on the right show channels that were filled in as a result of urban development. These types of areas were excluded from the portion of the analysis assessing overlapping stream networks but were included when incorporating Geomorphon to delineate the channel extent.

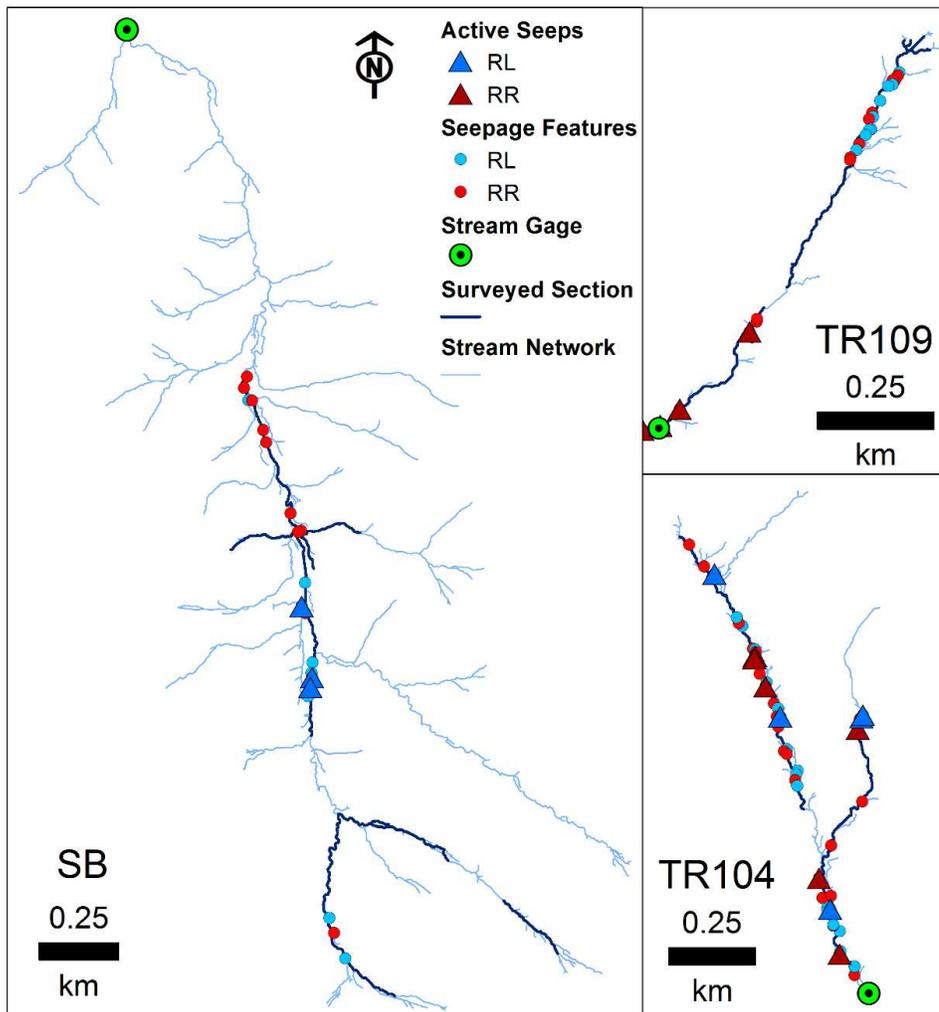
Figure 3.7: Results of the groundwater seep survey. Triangles indicate seeps were active. Circles indicate seeps were inactive but resembled characteristics of known groundwater seeps. Blue indicates the feature was on the left bank and red indicates the feature was on the right bank.

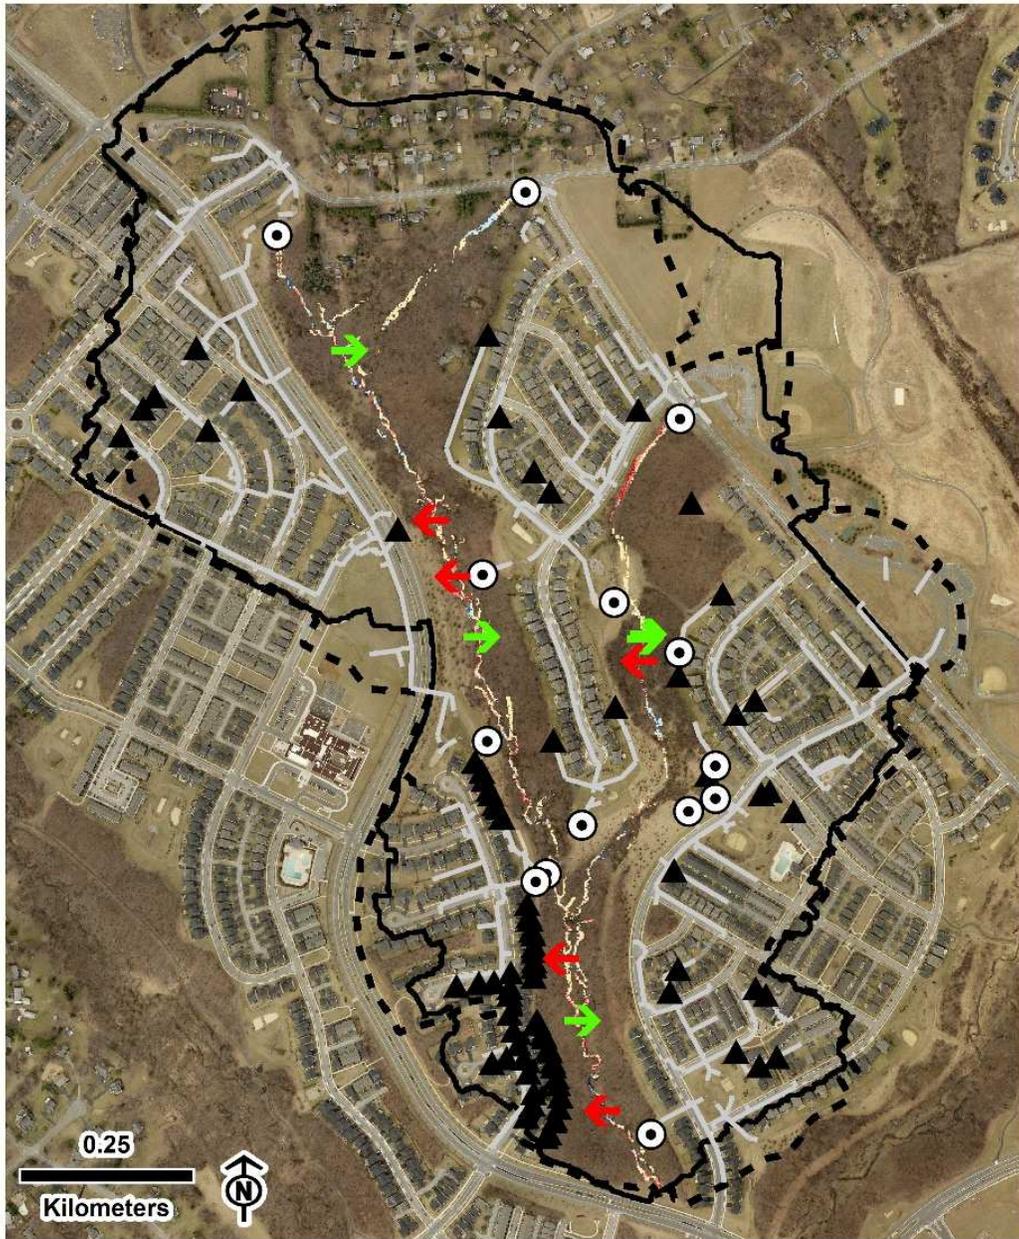
Figure 3.8: The location of active seeps in TR104 in relation to IF-SWM facilities.

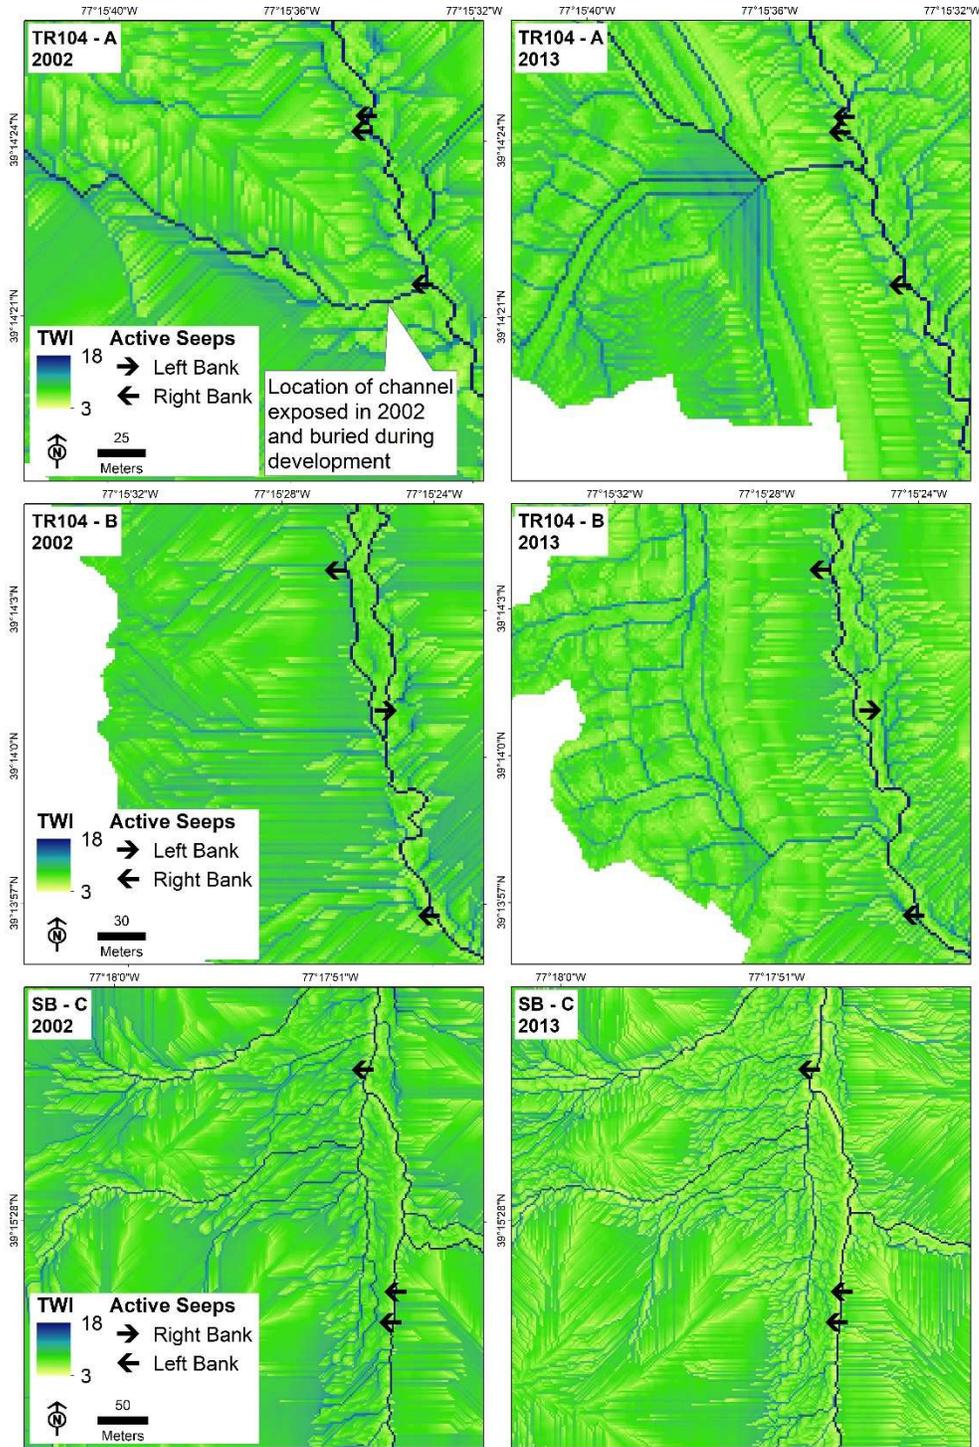
Figure 3.9: TWI for two different locations in TR104 and one location in SB. Higher values of TWI, represented as linear features in dark blue, indicate likely sites of groundwater discharge. The left panels show each location derived from 2002 lidar and the right panels show the same location derived from 2013 lidar. Changes in both drainage network and watershed boundaries for TR104 and TR109 are a direct result of the development process.

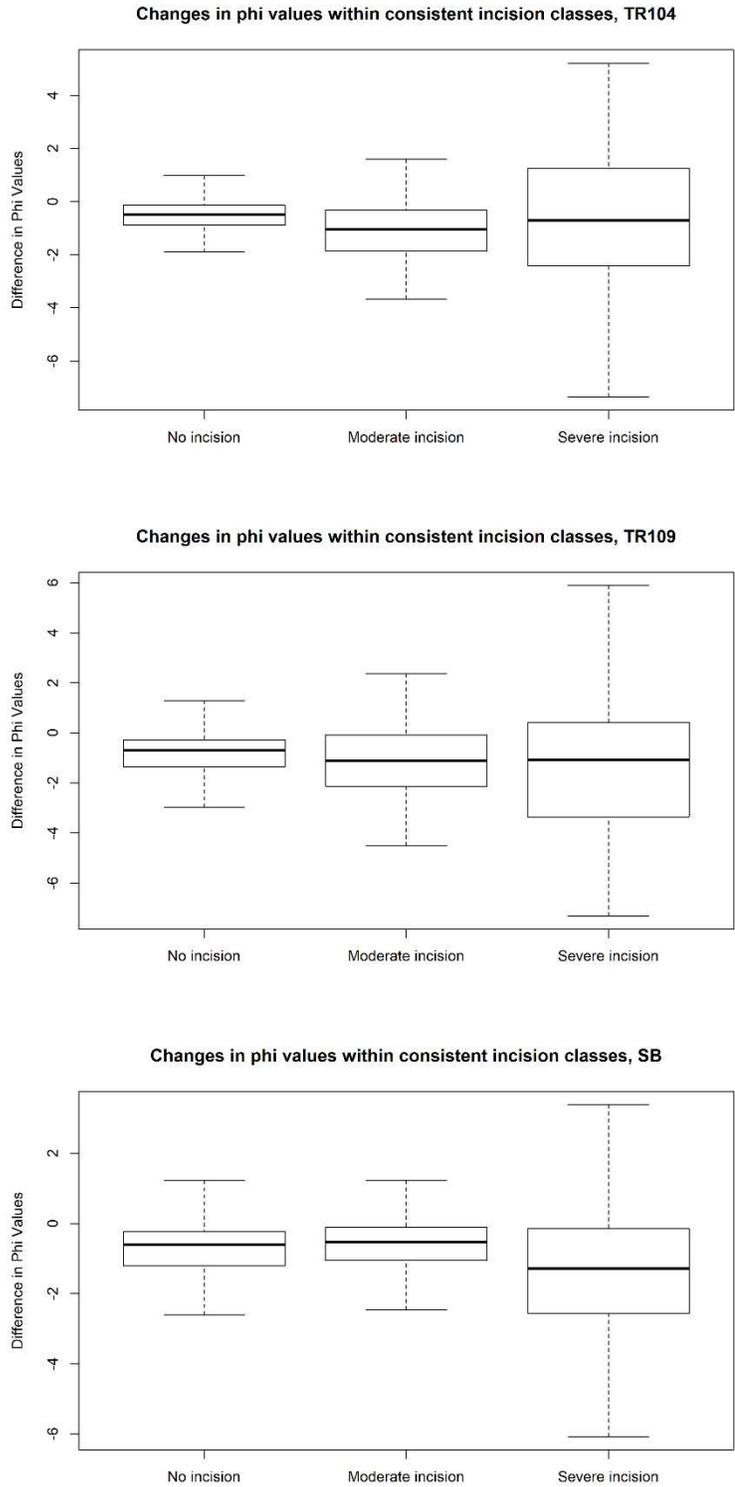
Figure 3.10: The range of phi value differences between 2002 and 2013 only within areas of consistent incision classes.

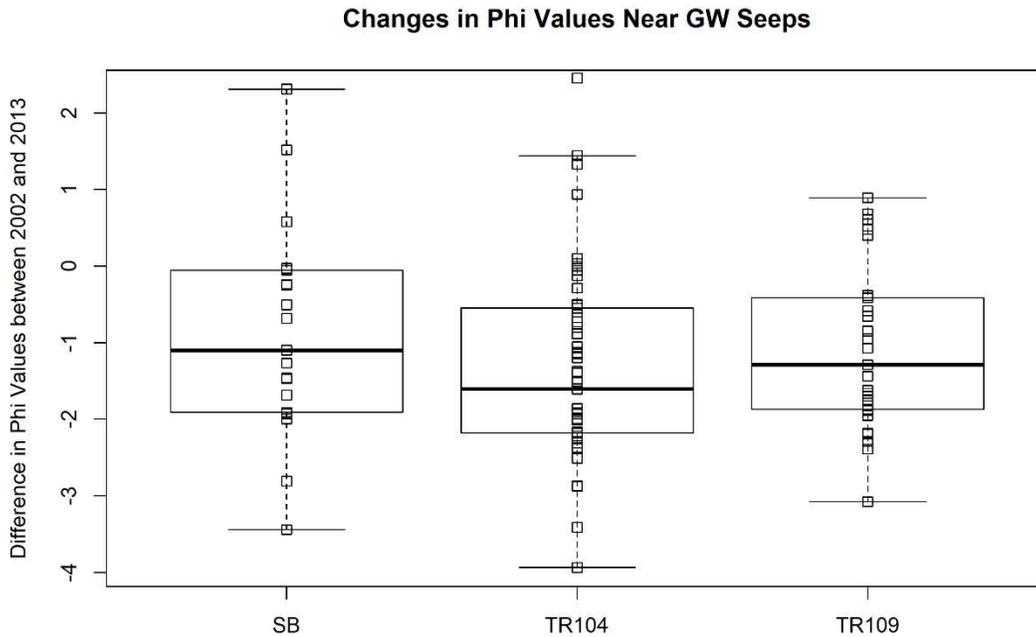
Figure 3.11: The range of changes in phi between 2002 and 2013 near sites of active and potentially inactive groundwater seep locations. Similarities across all three watersheds indicate similar erosion patterns in the forested and urban watersheds with respect to groundwater seepage.

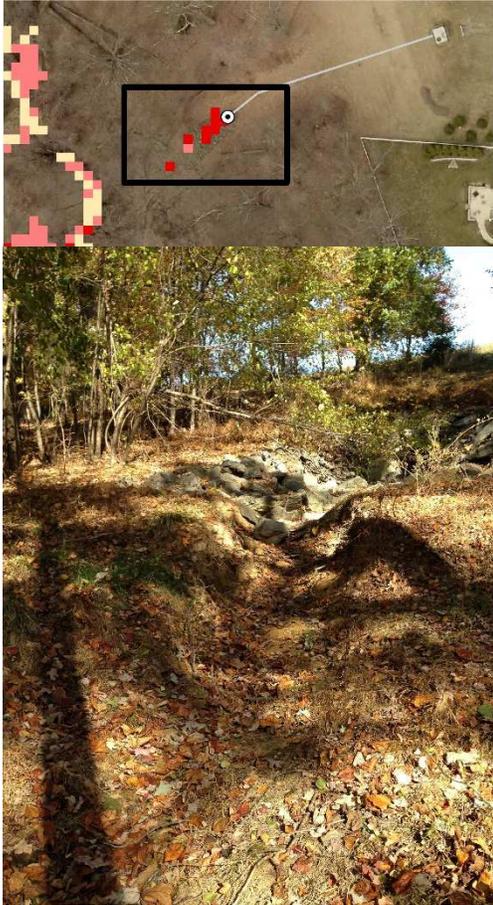
Figure 3.12: The outlet of a SWM facility in TR104 where the phi difference is showing incision directly downstream from the outlet (top) and evidence of erosion observed in the field (bottom). Incision tapers to a small, non-incised channel in the floodplain.

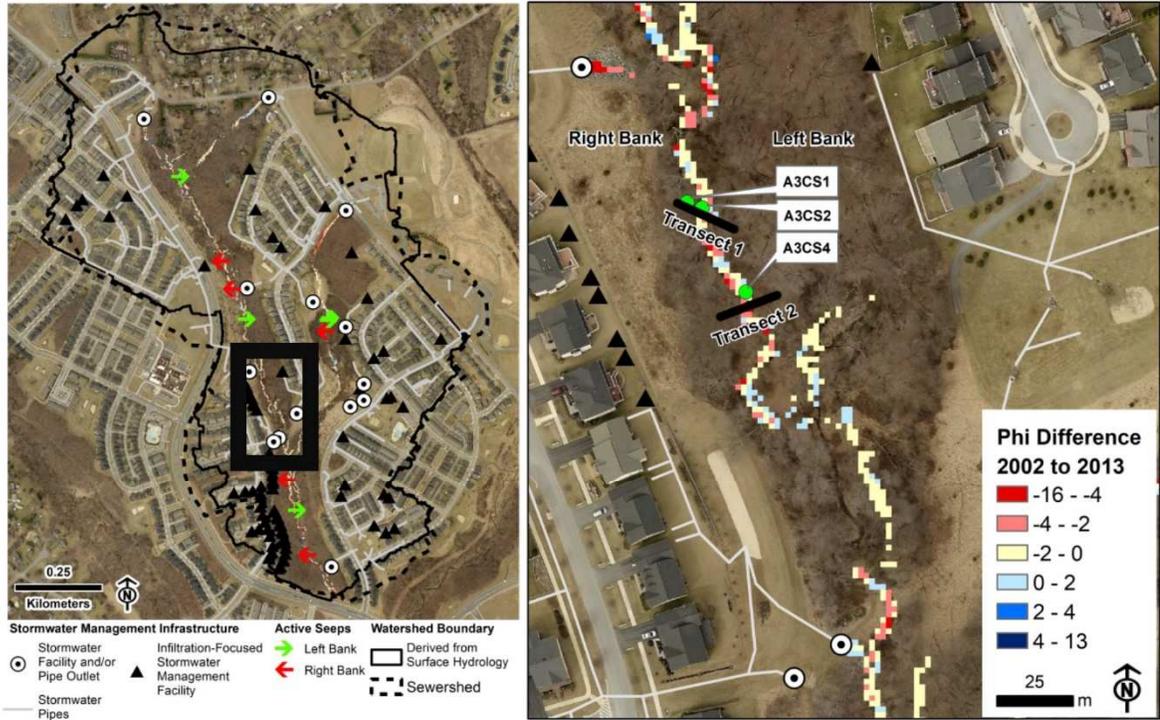
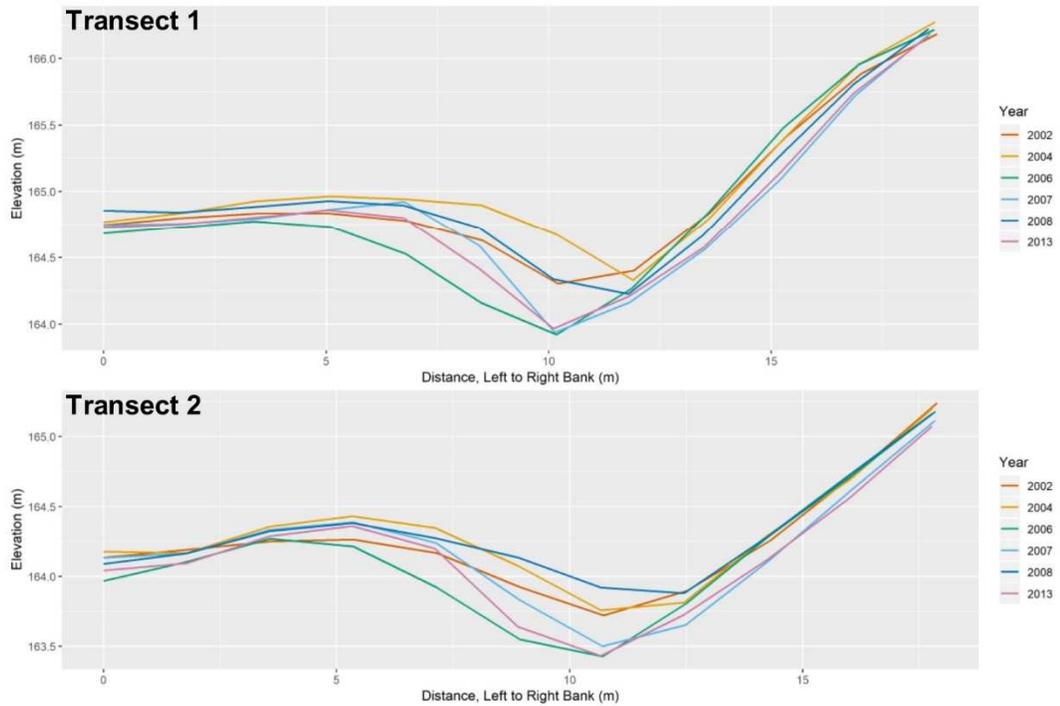
Figure 3.13: Transects 1 and 2 show channel instability and the pattern of bank retreat and downcutting resemble the patterns of change from the field surveyed cross sections in this area of TR104.

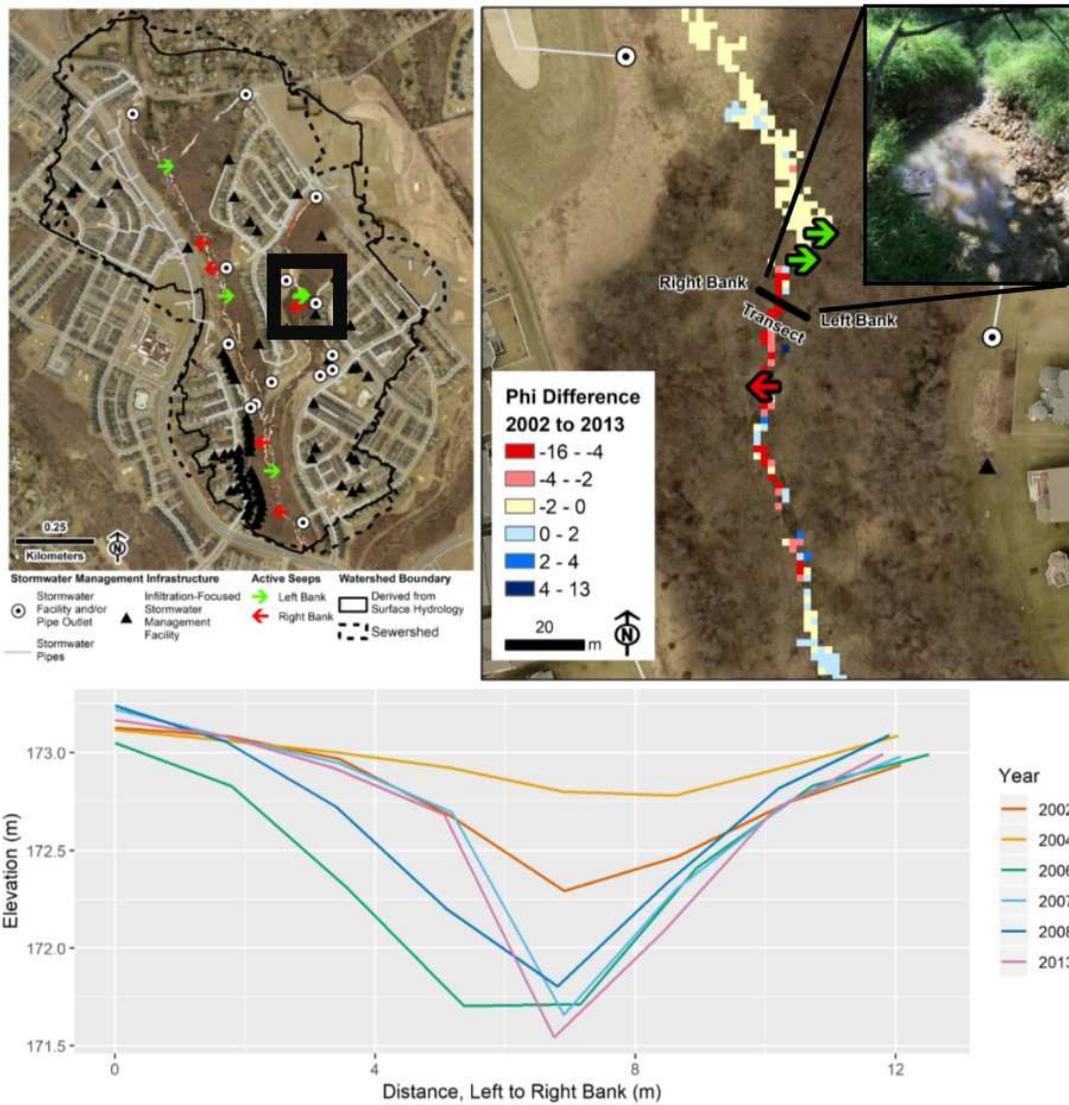
Figure 3.14: This transect shows an area of headcut erosion at the beginning of a severely incised reach in TR104. There is also groundwater actively seeping from the banks just upstream from the headcut. The image in the upper right corner shows the area near the headcut.

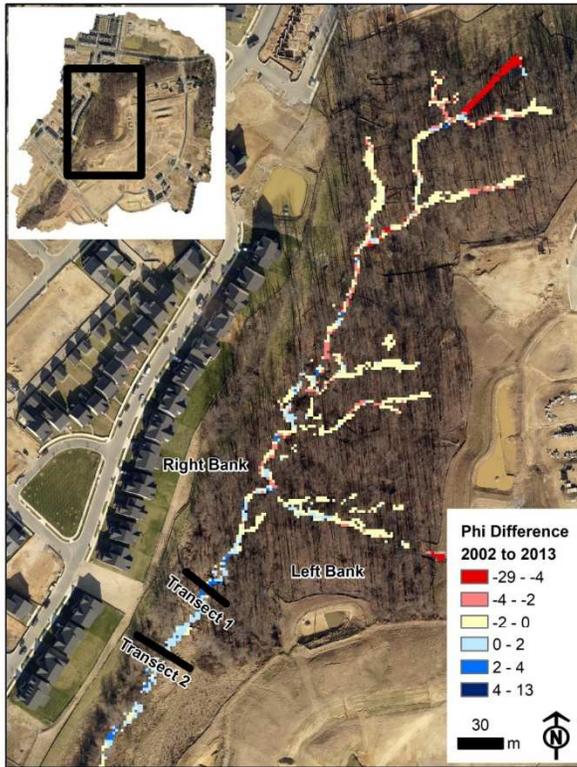
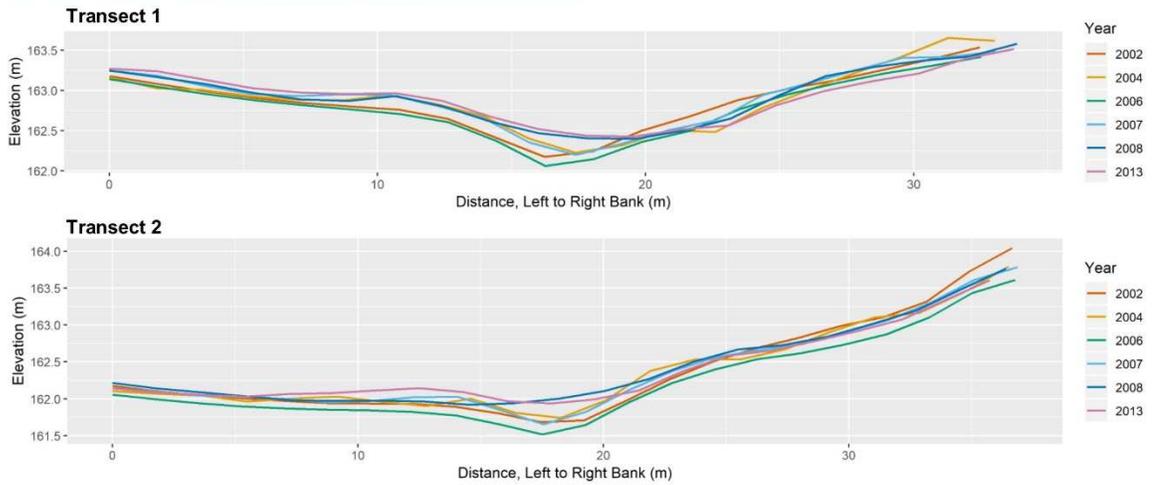
Figure 3.15: Transect 1 and 2 both show areas that have never been moderately or severely incised during the study period, but appear to be flattening in TR109. This could potentially be a hot spot for sediment deposition.

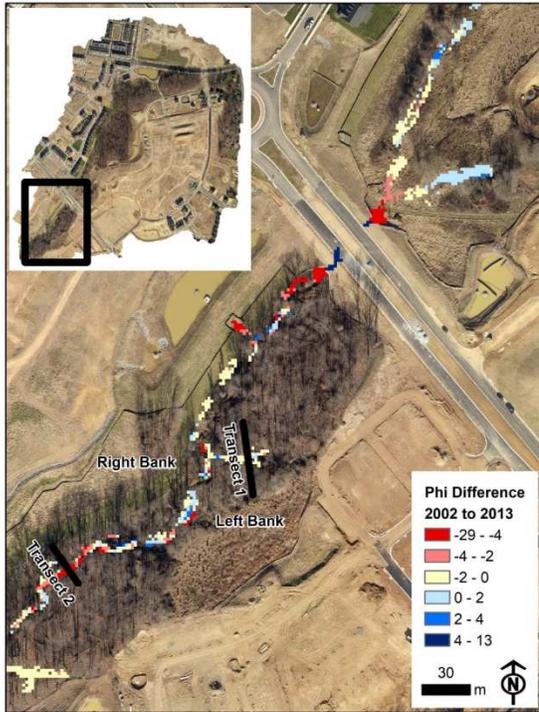
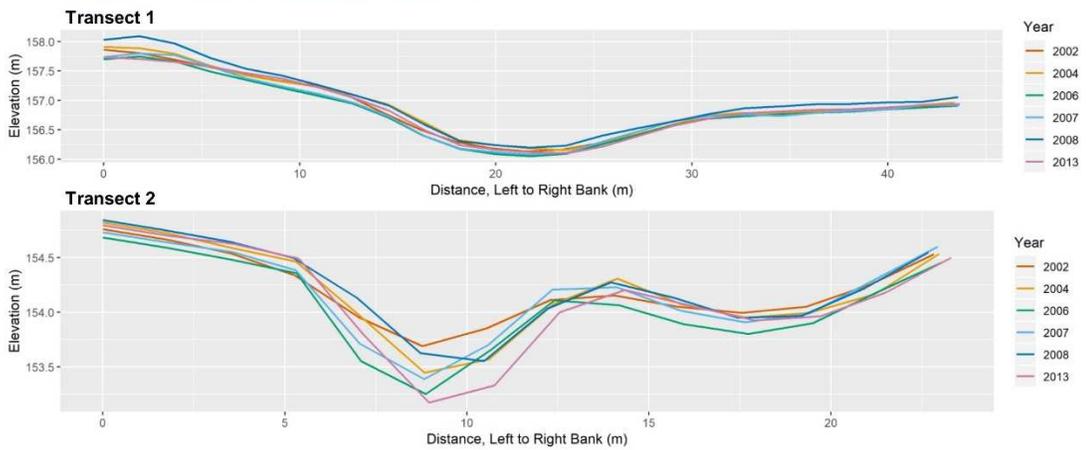
Figure 3.16: Transect 1 shows an area of stability in TR109 which is also reflected in the phi difference. Transect 2 is an area in TR109 that was already severely incised and continued to incise through 2013.

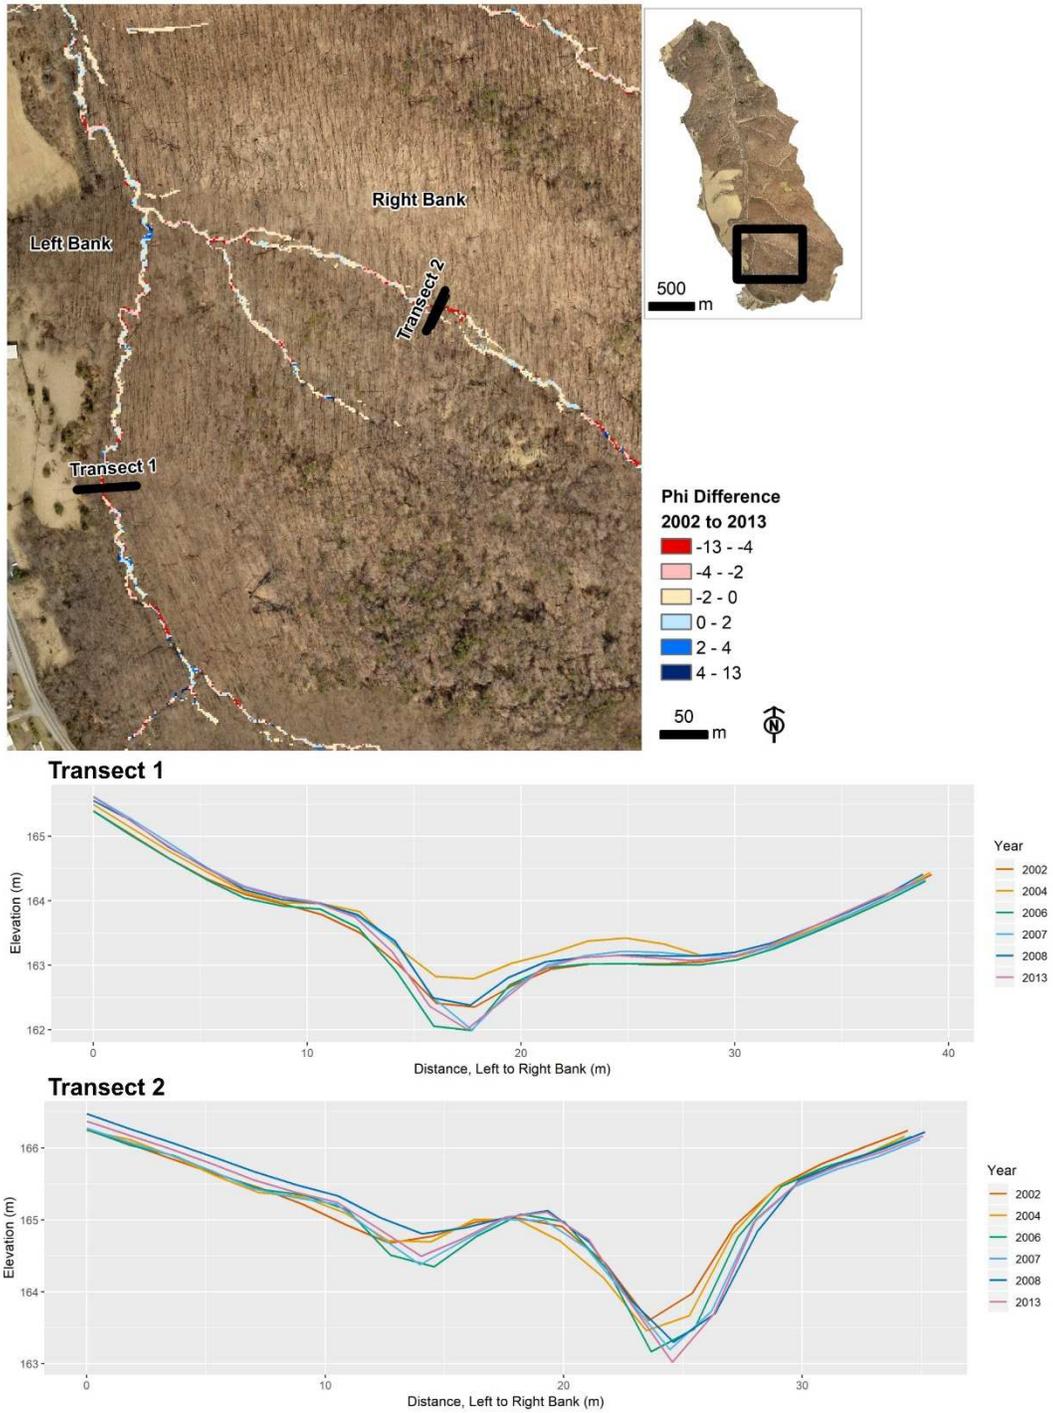
Figure 3.17: Transects 1 shows an area that transitioned from moderately to severely incised in SB. Transect 2 is an area that was already incised in 2002 and continued to incise through 2013.

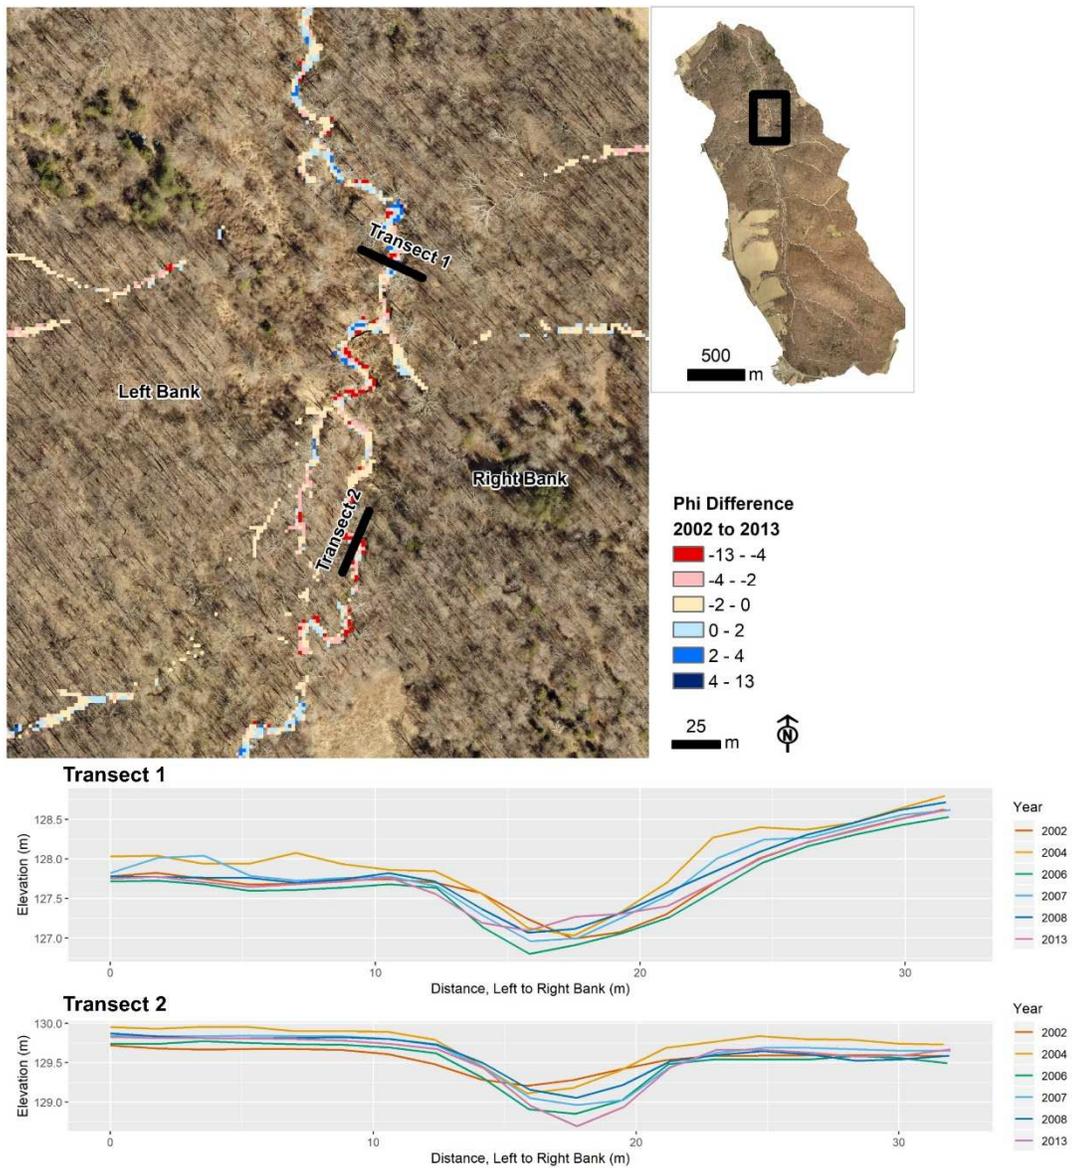
Figure 3.18: Two transects showing change over time in SB. Transect 1 shows an area where the channel has widened and has positive values of phi differences because the channel became more open. Transect 2 shows an area that has been eroding and becoming more enclosed.

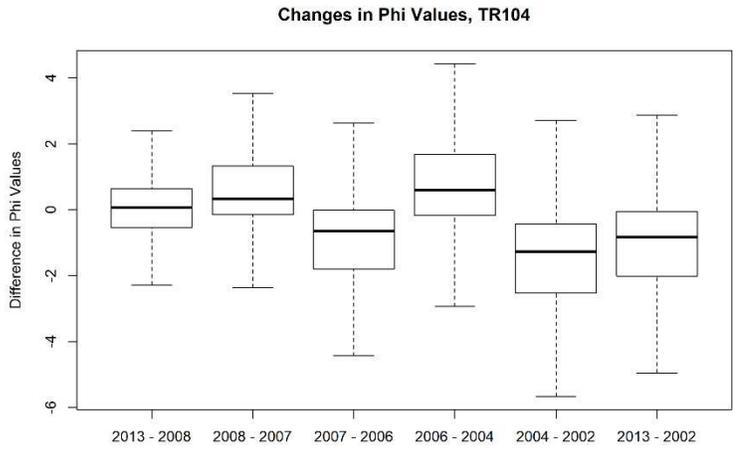
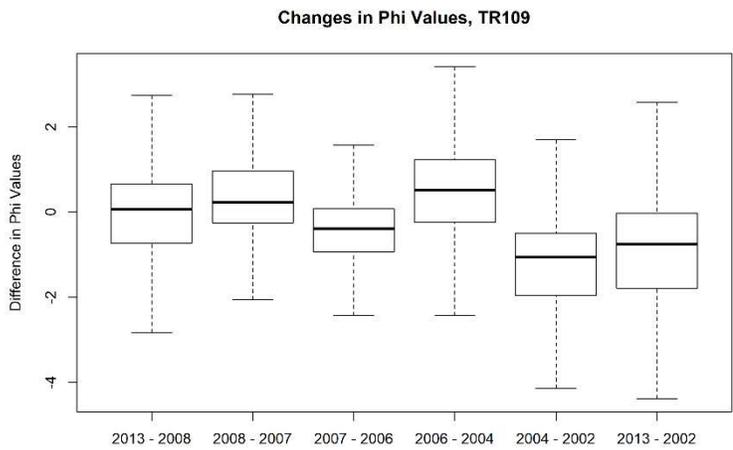
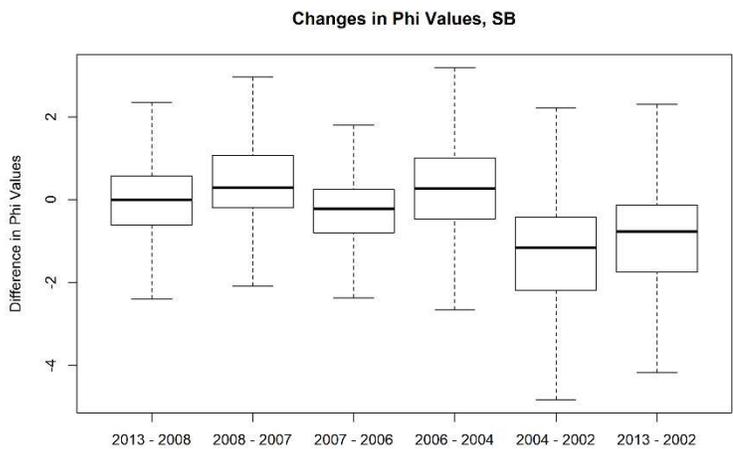
Figure 3.19. Boxplots showing the difference in raw phi values for incremental time steps in each watershed. Negative values indicate areas becoming more enclosed, indicative of incision, and positive values indicate areas becoming more open, either through deposition or channel widening. Outliers have been removed from the plots.

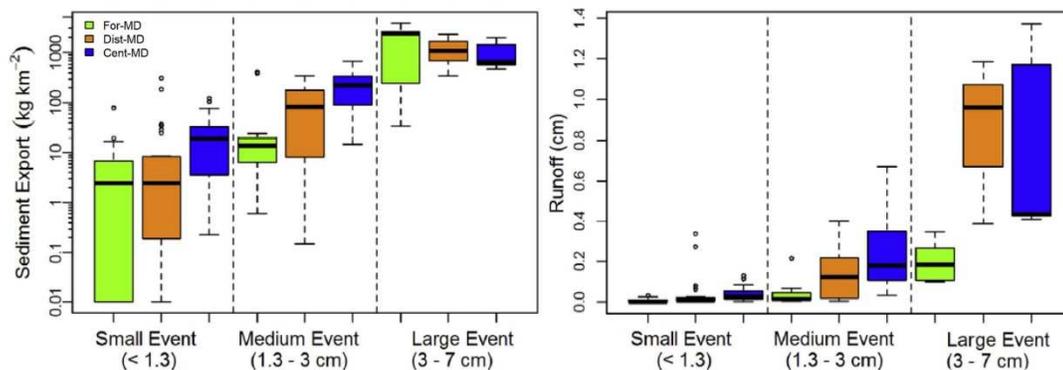
Figure 3.20: Boxplots showing sediment export and runoff for SB (green plots) and TR104 (orange plots), along with a nearby watershed developed using older, centralized SWM (blue plots). Adapted from Hopkins et al. (2017).

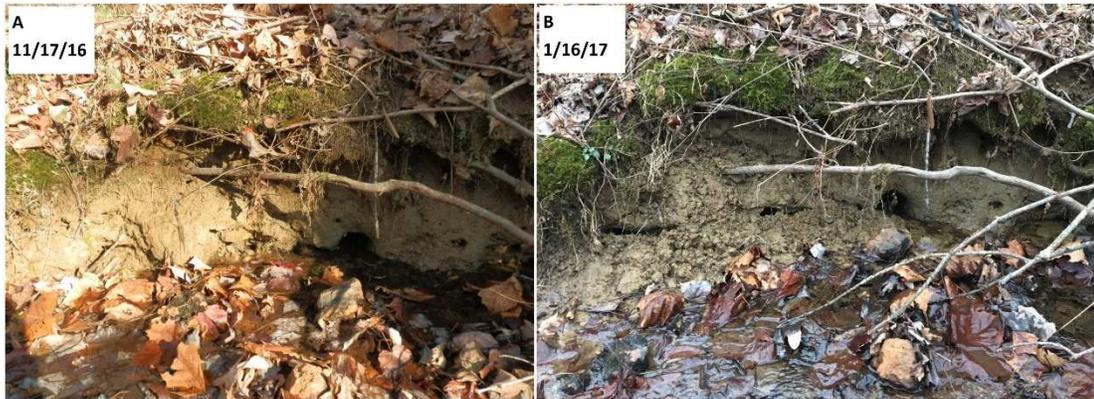
Figure 3.21: An area with features formed from groundwater seeps and/or animal burrowing in November 2016 was observed with recent bank erosion two months later. These features create unstable banks that eventually leads to bank failure.
