Title of Thesis:       **THIS DEBRIS MATTERS: PRESERVING FIRE-DAMAGED HISTORIC BUILDINGS**

THIS DEBRIS MATTERS:  
PRESERVING FIRE-DAMAGED HISTORIC BUILDINGS

Thesis submitted to the Faculty of Goucher College in partial  
fulfillment of the requirements for the degree of  
Master of Arts in Historic Preservation  
2013

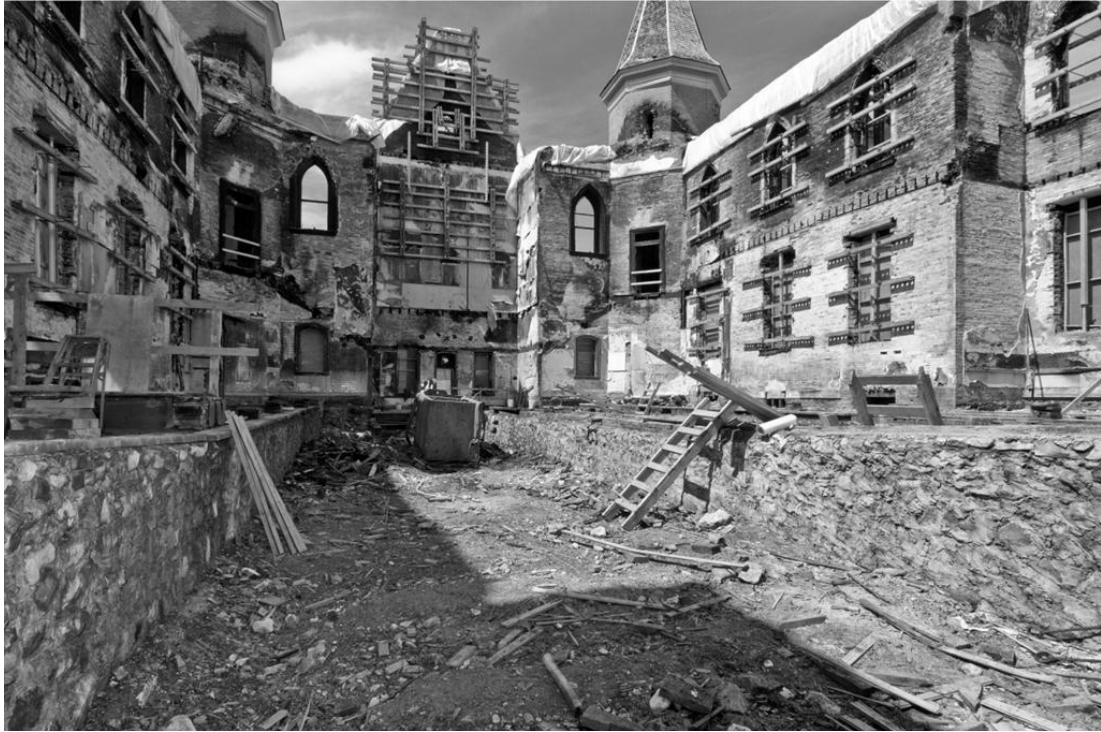
Figure 4: Provo Tabernacle Interior, March 2011. Note the steel bracing at almost all of the window openings. Most of the plaster was destroyed in the fire and most headers were also destroyed. The floor was partially removed in anticipation of construction of a new full height basement instead of the pre-fire crawlspace. Plastic sheeting was placed over the tops of masonry walls to protect them from further deterioration after the roof collapse. [Image courtesy LDS Church History Department.]

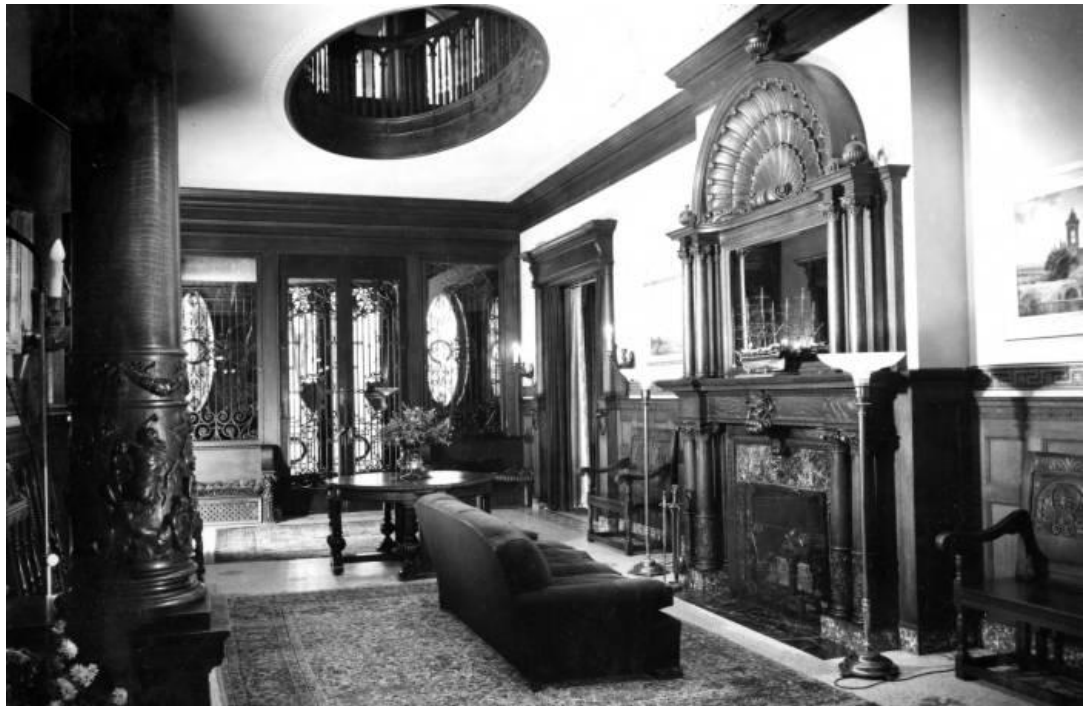
Figure 7: Kearns Mansion Interior, 1954. Note the opening in the ceiling that extended up two stories. This opening became a major path for the fire. [Image courtesy Utah State Historical Society.]

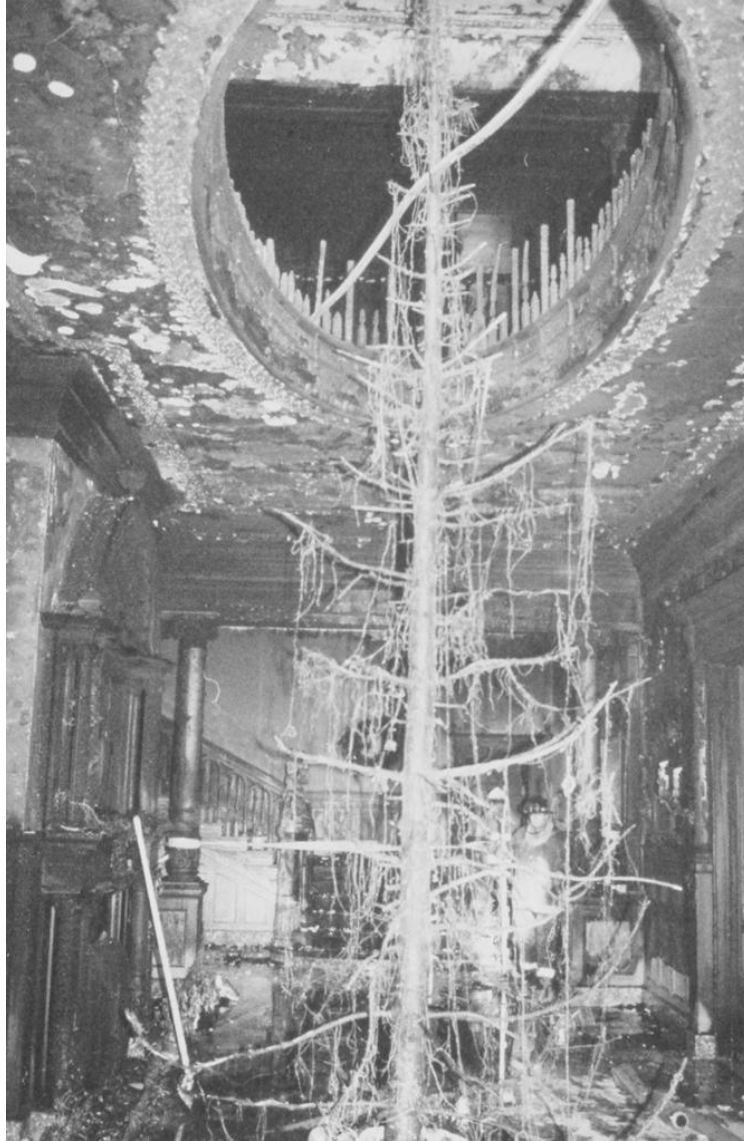
Figure 8: Kearns Mansion Grand Hall showing fire damage, December 1993. The Christmas tree that started the fire can clearly be seen in the center of the photo. Note partial combustion of materials immediately around the tree with less significant damage of finishes at the rear of the hall. [Image courtesy Utah State Fire Marshal.]

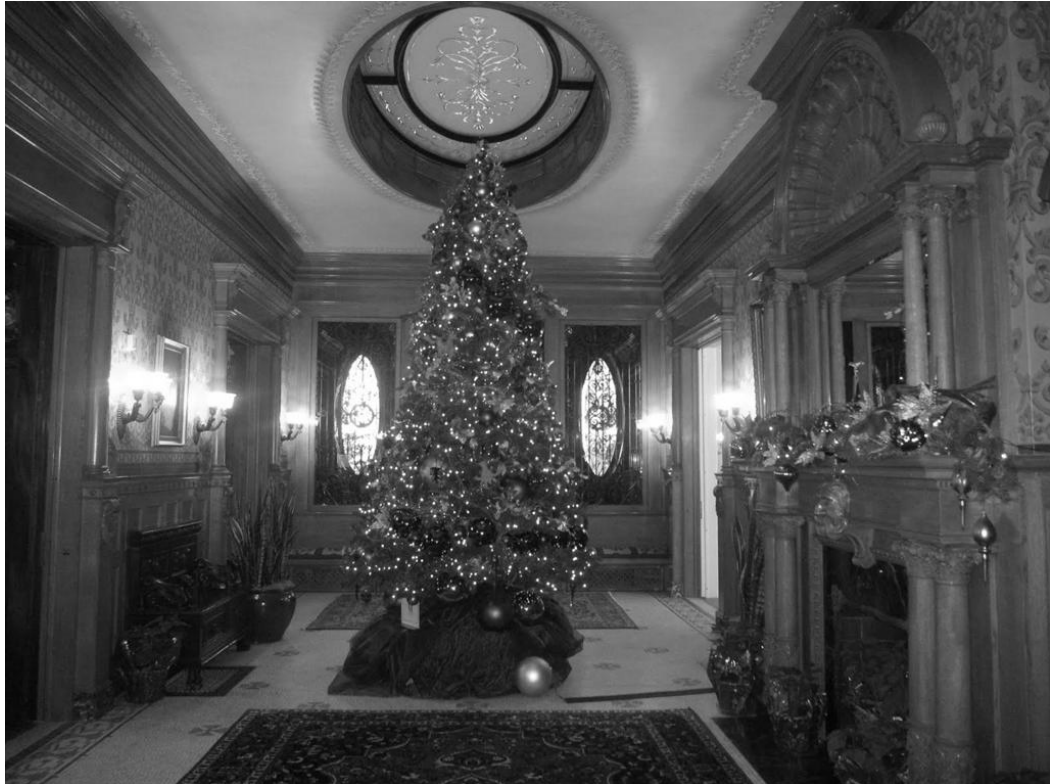
Figure 9: Kearns Mansion Grand Hall in 2010. All interior architectural and decorative were restored or reconstructed. A removable art glass skylight was placed in the center of the atrium to act as a fire break for upper floors and to improve building security. [Image from Google Images, accessed February 2012.]

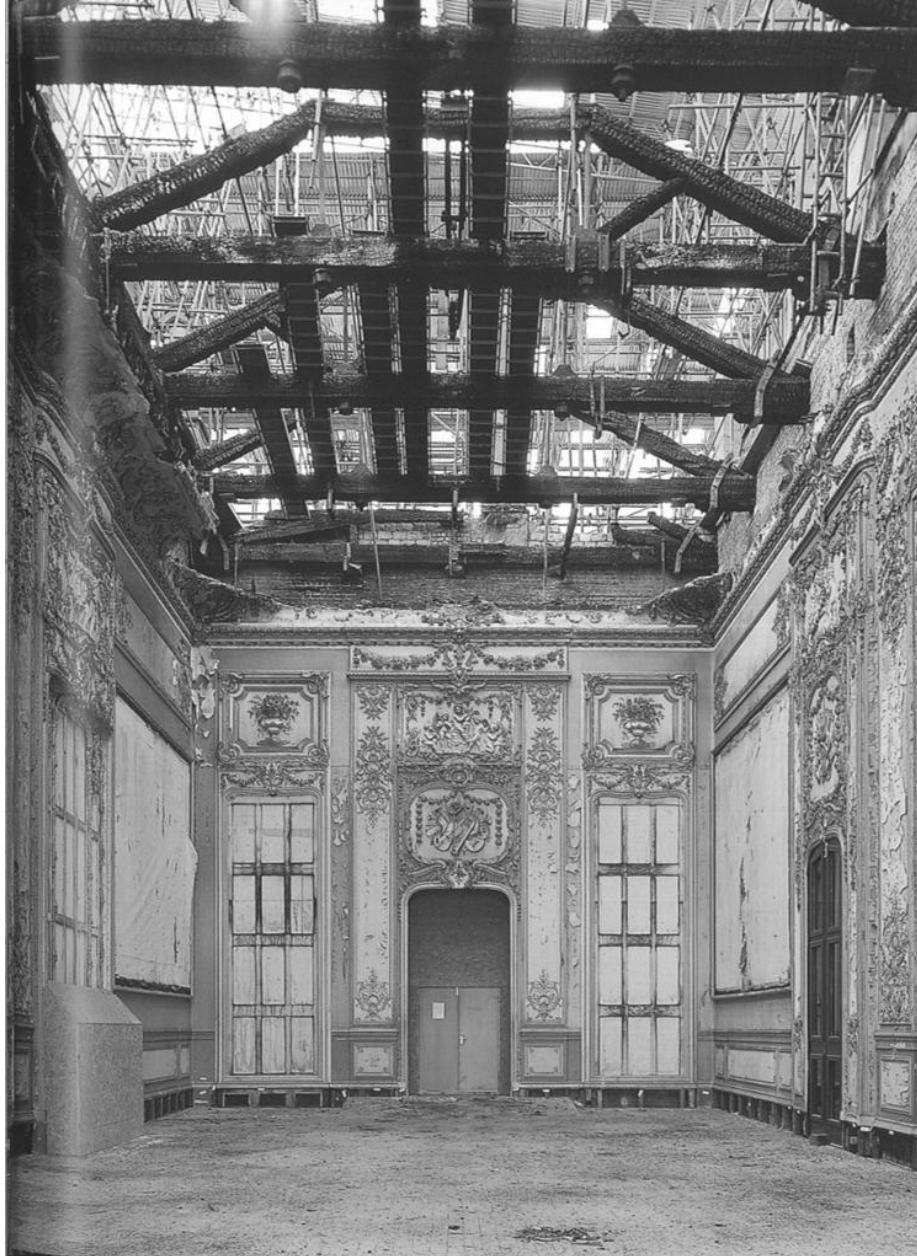
Figure 13: Grand Reception Room after the Fire. Note that the ceiling was completely destroyed while wall finishes were left almost completely intact. A temporary roof and scaffolding has also been erected above the Grand Reception Room. This room was restored to its original condition because wall finishes retained their integrity after the fire. [Image from *Restoration: the Rebuilding of Windsor Castle*.]

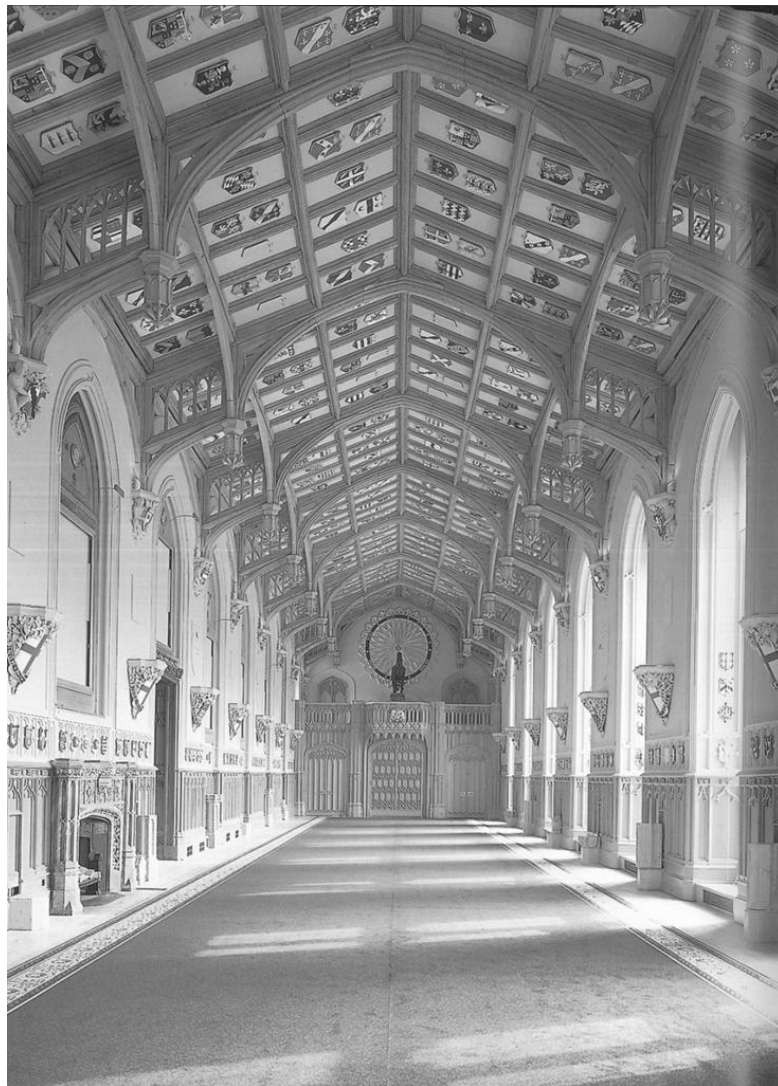
Figure 14: New Roof Design for St. George's Hall. This design, while new, retained integrity of feeling because of its consistency with historic precedent. [Image from *Restoration: the Rebuilding of Windsor Castle*.]

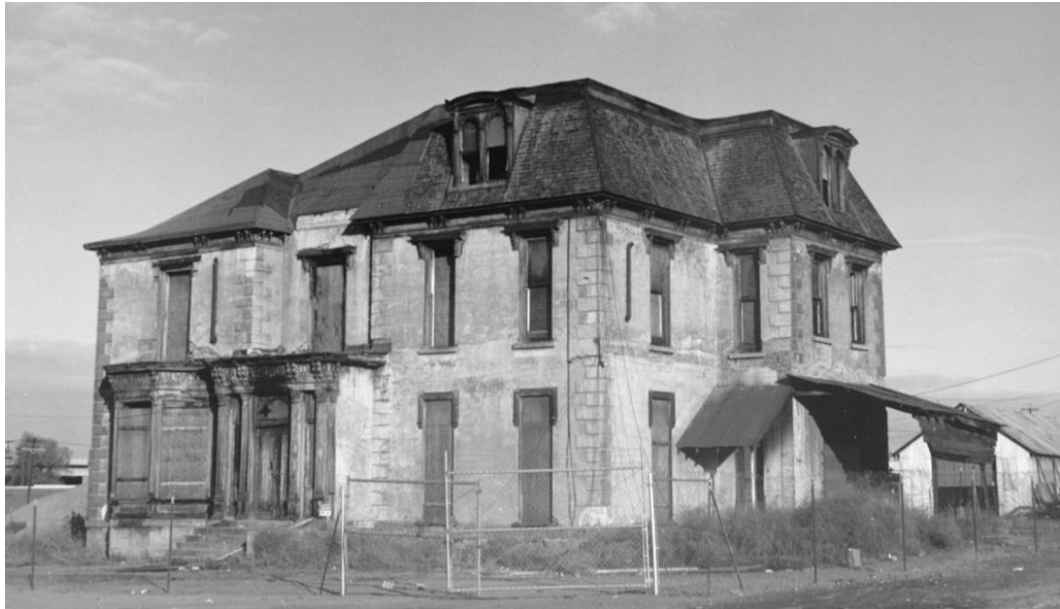
Figure 16: Devereaux Mansion before Restoration, about 1980. The fire caused a partial roof collapse and damaged exterior woodwork around the front door. Other exterior problems were caused by neglect and poor management of the building. [Image courtesy LDS Church History Department.]

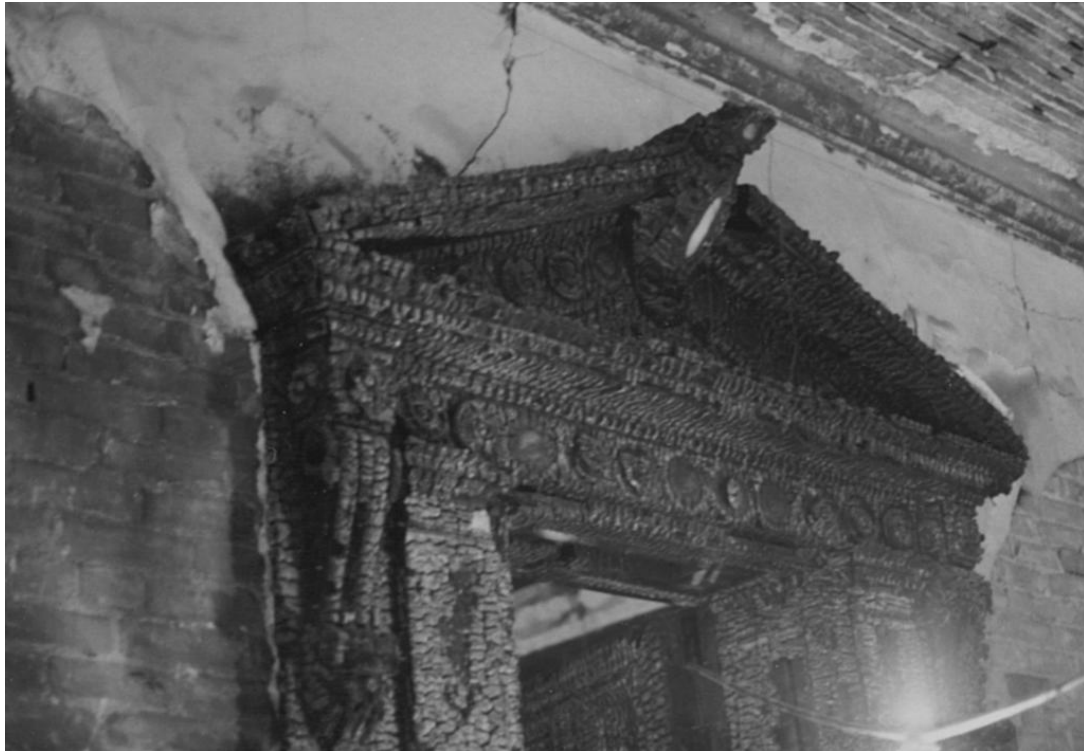
Figure 17: Damaged Finishes in the Devereaux Mansion Grand Hall, 1979. The woodwork around the door was partially destroyed by the fire but profiles remained intact for reconstruction. Wall plaster was likely damaged by the fire. It is unknown if the damaged ceiling plaster was caused by the fire or by the general building neglect. [Image courtesy LDS Church History Department.]
