The September 18-20 2020 Medicane Ianos Impact on Greece

Phase I Reconnaissance Report

Geotechnical Extreme Events Reconnaissance Association

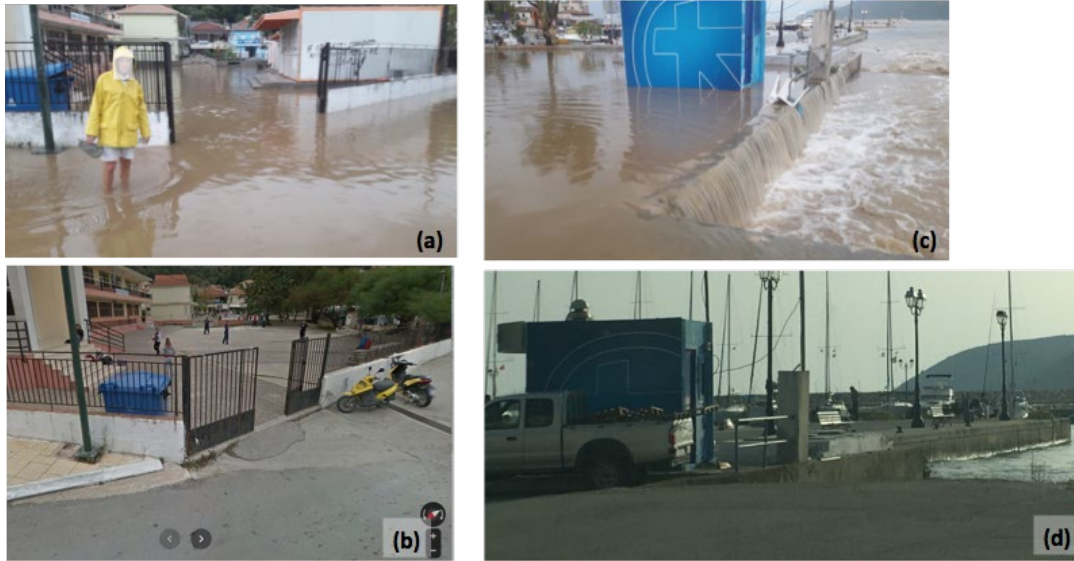
flooding occurred (Figure 4.7), while minor erosional features and road embankment failures were observed along the river bank of the Vasiliki valley (Figure 4.8). Sediment movement and landslide activity was also observed along the western coastline of Lefkada where significant landsliding occurred during the 2015 Lefkada earthquake.

Figure 4.7. a) Flooding along the seaside at Vasiliki village, Lefkada, as photographed by an eye witness on the day vs. b) reference photo from GoogleMaps (38.627504°N, 20.607268°E). c) flooding at the same spot on the day vs. d) reference photo (38.627504°N, 20.607268°E).

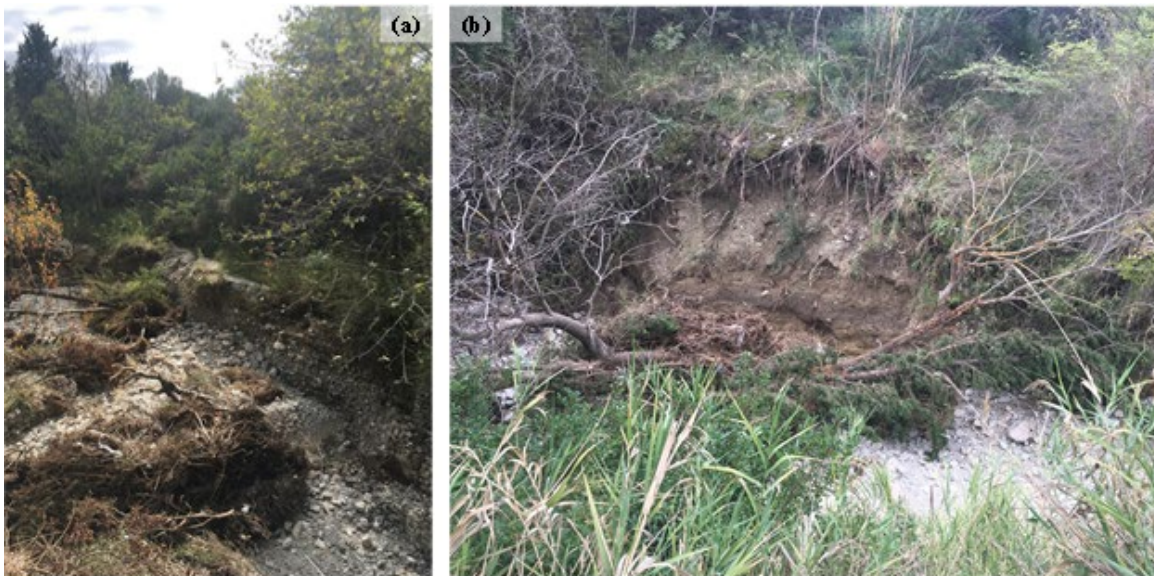
Figure 4.8. Riverbank erosion features in Vasiliki valley, Lefkada: a) 38.6658694°N, 20.6202861°E; b) 38.6638861°N, 20.624483°E

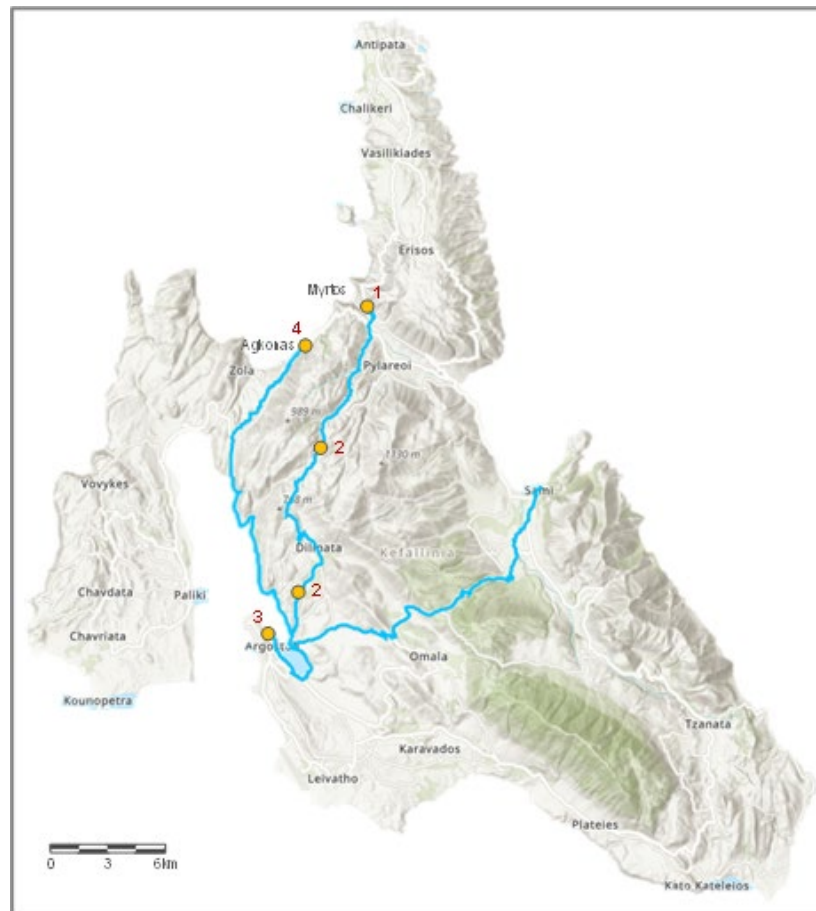
Bridges in Cephalonia island performed generally adequately during Medicane Ianos. Nonetheless, a critical, simple-supported, multi-span, reinforced concrete bridge founded on steep topography and connecting the village of Agkonas with Myrtos beach and Erissos peninsula (point 4 in Figure 4.11), collapsed, impacting the transportation network of the island (Figure 5.1). The structure, better known to the islanders as the “Chimoniko” bridge, was characterized by a width of ~9 m and a length of ~30 m, and was simply supported on two piers with a height of approximately 10 m (east pier) and 13 m (west pier), respectively. The span length was ~10 m, and the piers were founded on shallow footings on a limestone formation.

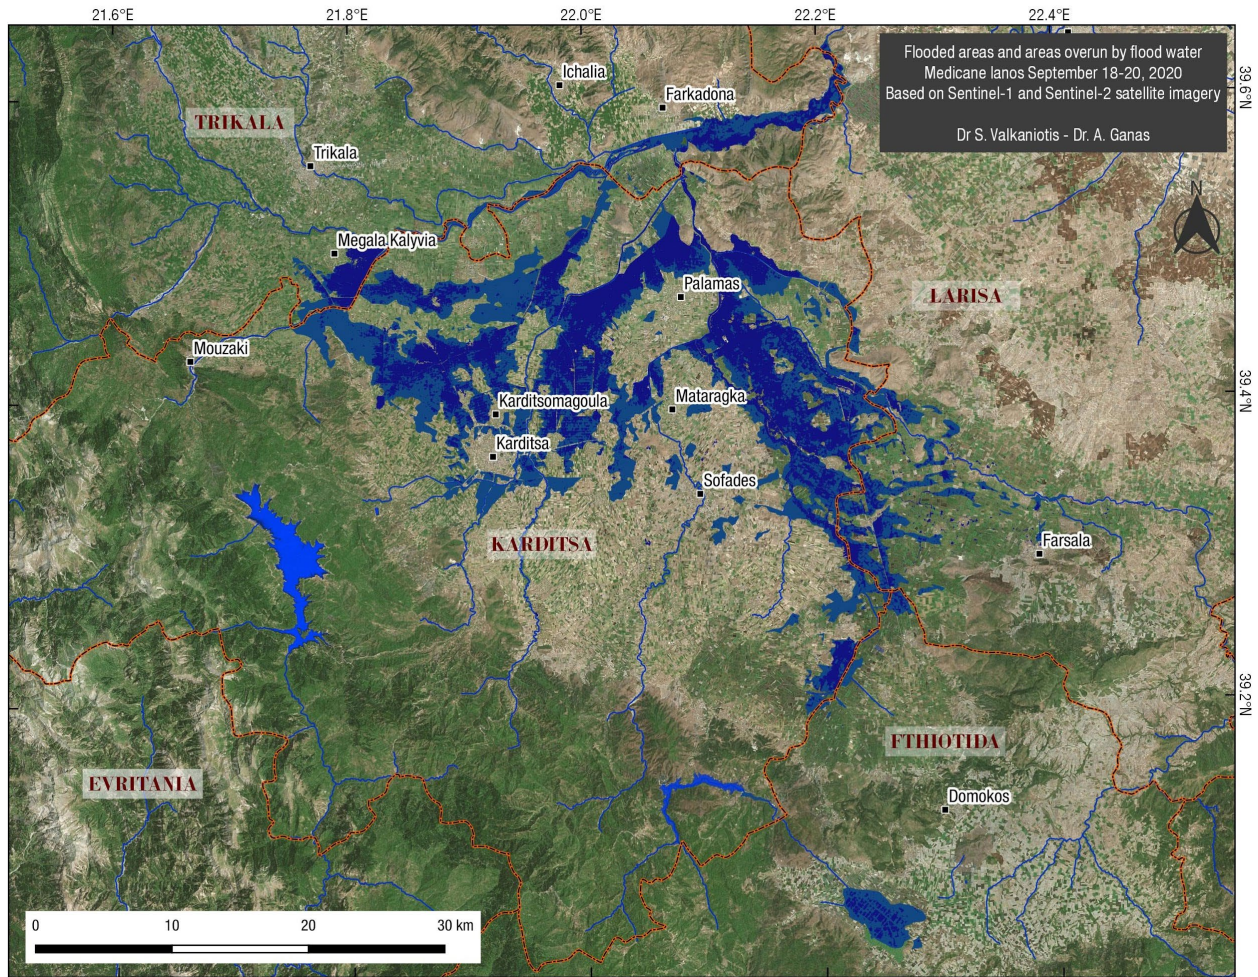
Results are shown in Figure 4.30. Total area that was flooded or overrun by flood waters is calculated as 475,5 km². Area measured includes western Thessaly plain, Pinios gorge between Trikala and Larisa, and Xiniada plain to the south.

Figure 4.30. Flooded areas and areas overrun by flood waters, mapped using Copernicus Sentinel-1 and Sentinel-2 satellite imagery. Dark blue are water inundated areas, while cyan colors mark areas that did not retain significant water but were overrun by flood waters during the flood event. Total area is 475,5 km².

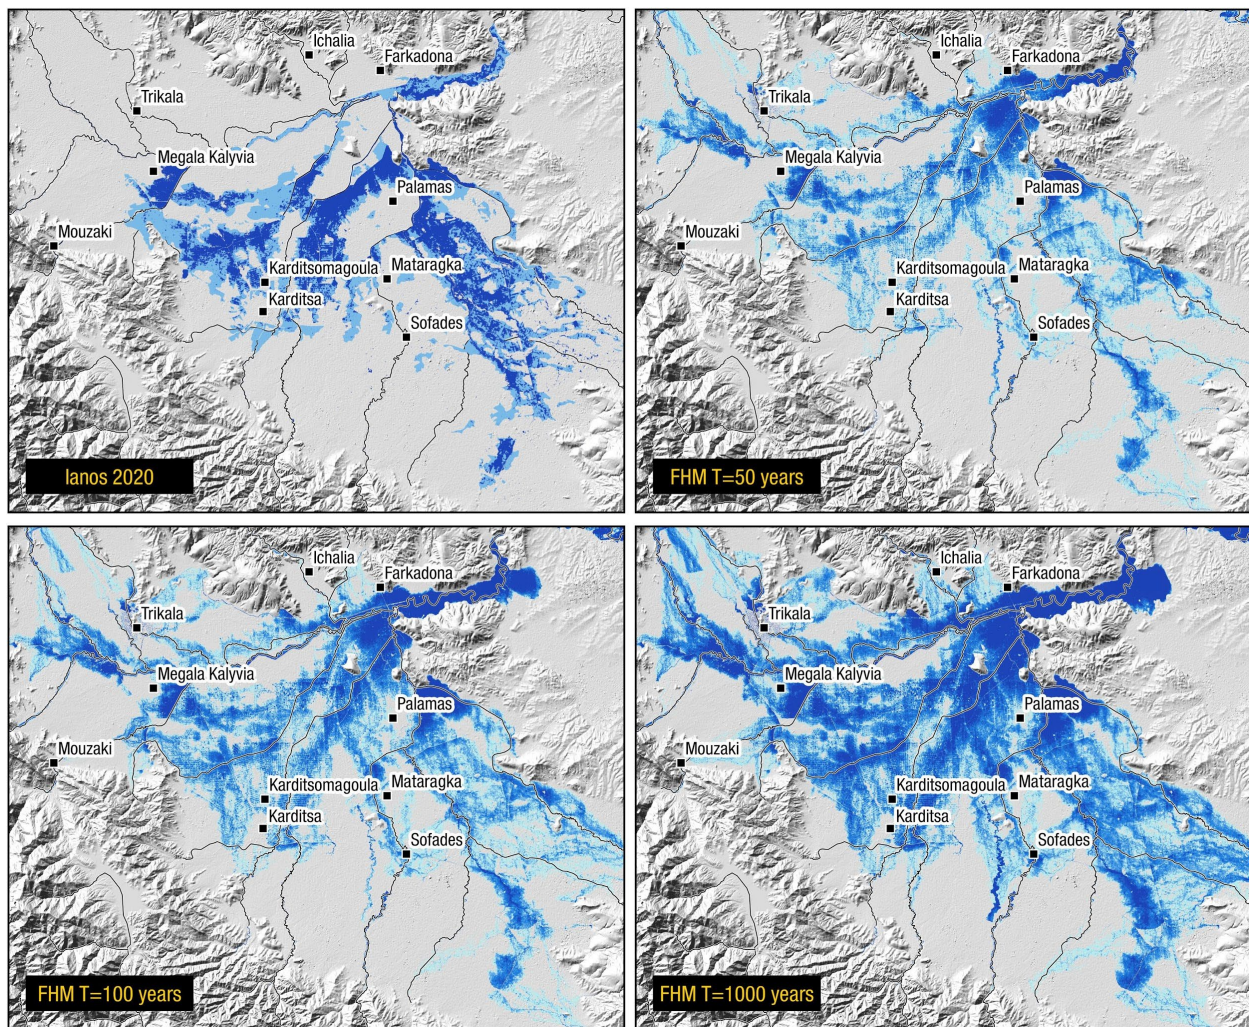
The total extent of the flooded areas in western Thessaly did not exceed the one estimated by the Flood Hazard Management Plan of Thessaly district (FHMP 2018). In Figure 4.31 we show a comparison between the Ianos flood extent and the scenario maps for flooding with return period of $T = 50, 100$ and 1000 years.

Figure 4.31. Comparison of the 2020 Mediane Ianos flooded areas mapping (upper left) with the Flood Hazard Maps for return periods of T=50/100/1000 years (FHMP 2018).

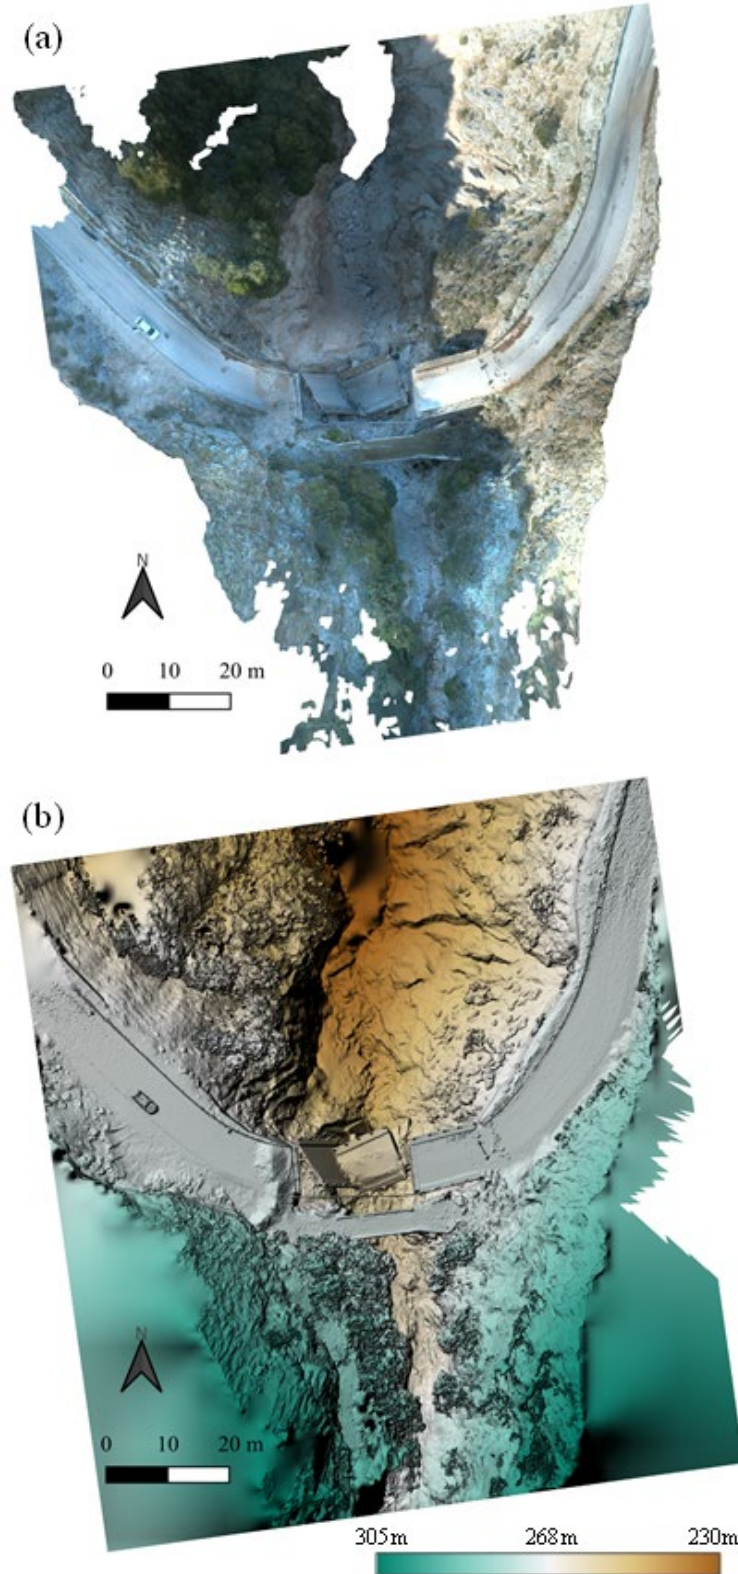
During the post-event reconnaissance, on 10/01/2020, detailed UAV-enabled mapping was conducted to better understand the failure mechanism. Orthophotos and DSM were produced (Figures 5.2 and 5.3), based on which an initial assessment can be made. A visualization of the 3D model of the failed “Chimoniko” bridge can be seen here: <https://skfb.ly/6WyYT>. The prevalent failure mode appears to be the scour of the west pier foundation from extensive gully flooding and debris. Such mechanism is consistent with the translational downstream movement of the foundation body, the pier, and the deck beams (Figure 5.2). Moreover, the failure mode is also supported by the observation that the older (built in 1943), masonry, single-span bridge just upstream of the collapsed structure, did not show any signs of damage. Contrary to the “Chimoniko” bridge, the older bridge was supported on masonry abutments on both sides of the gully. It can be presumed that the new bridge had a significantly reduced flow capacity, due to the presence of the piers. Particularly the west pier was comparatively more vulnerable since it was located more centrally within the flood/debris flow path. (Figure 5.3).

Figure 5.2. UAV-enabled mapping of collapsed bridge on E.O. Argostoliou-Fiskardou ($38.319506^{\circ}\text{N}$, $20.508197^{\circ}\text{E}$): a) top-view Orthophoto, and b) top-view DSM (view 3D model at: <https://skfb.ly/6WyYT>)

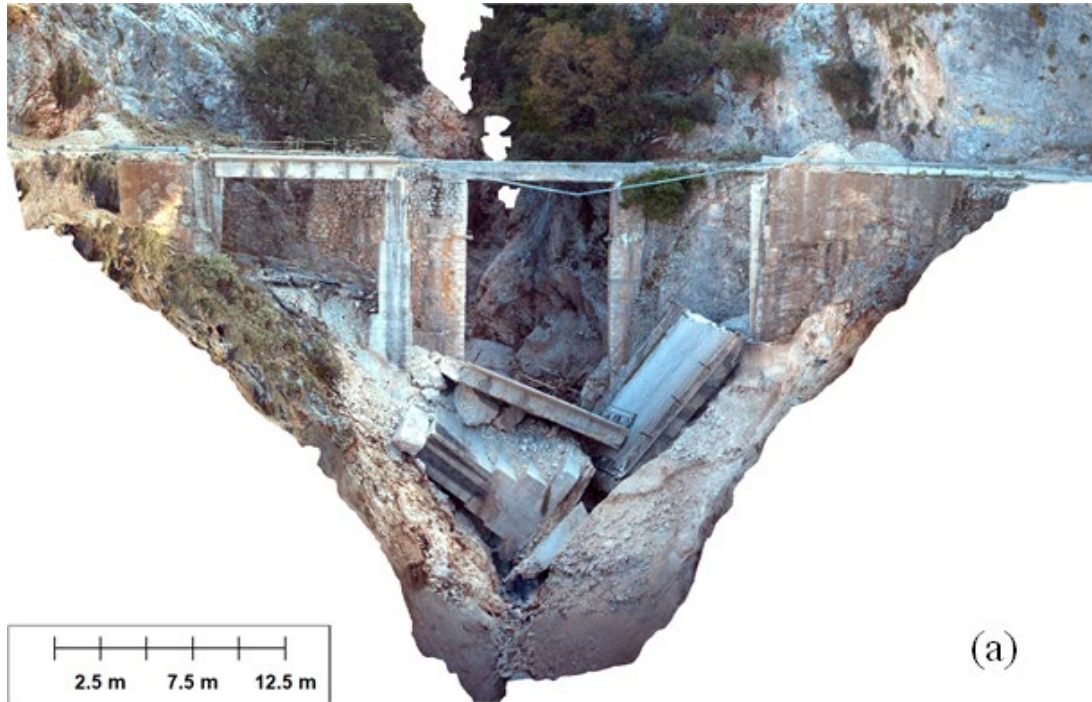
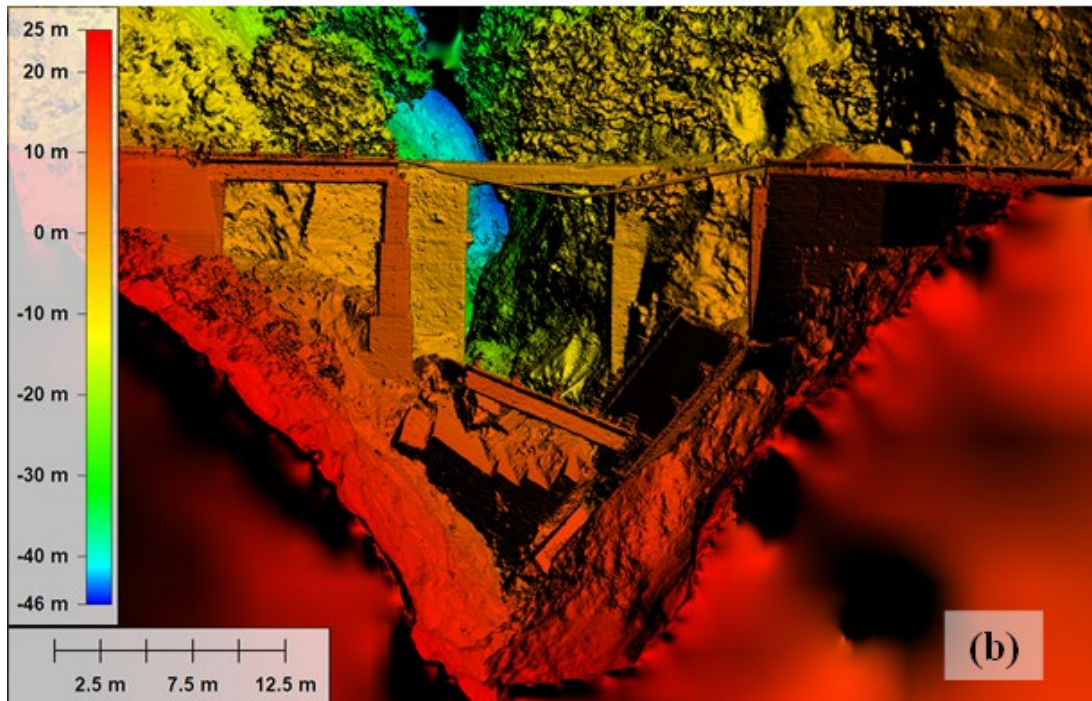
Figure 5.3. UAV-enabled mapping of collapsed bridge on E.O. Argostoliou-Fiskardou ($38.319506^{\circ}\text{N}$, $20.508197^{\circ}\text{E}$): a) front-view Orthophoto, and b) front-view DSM (view 3D model at: <https://skfb.ly/6WyYT>)

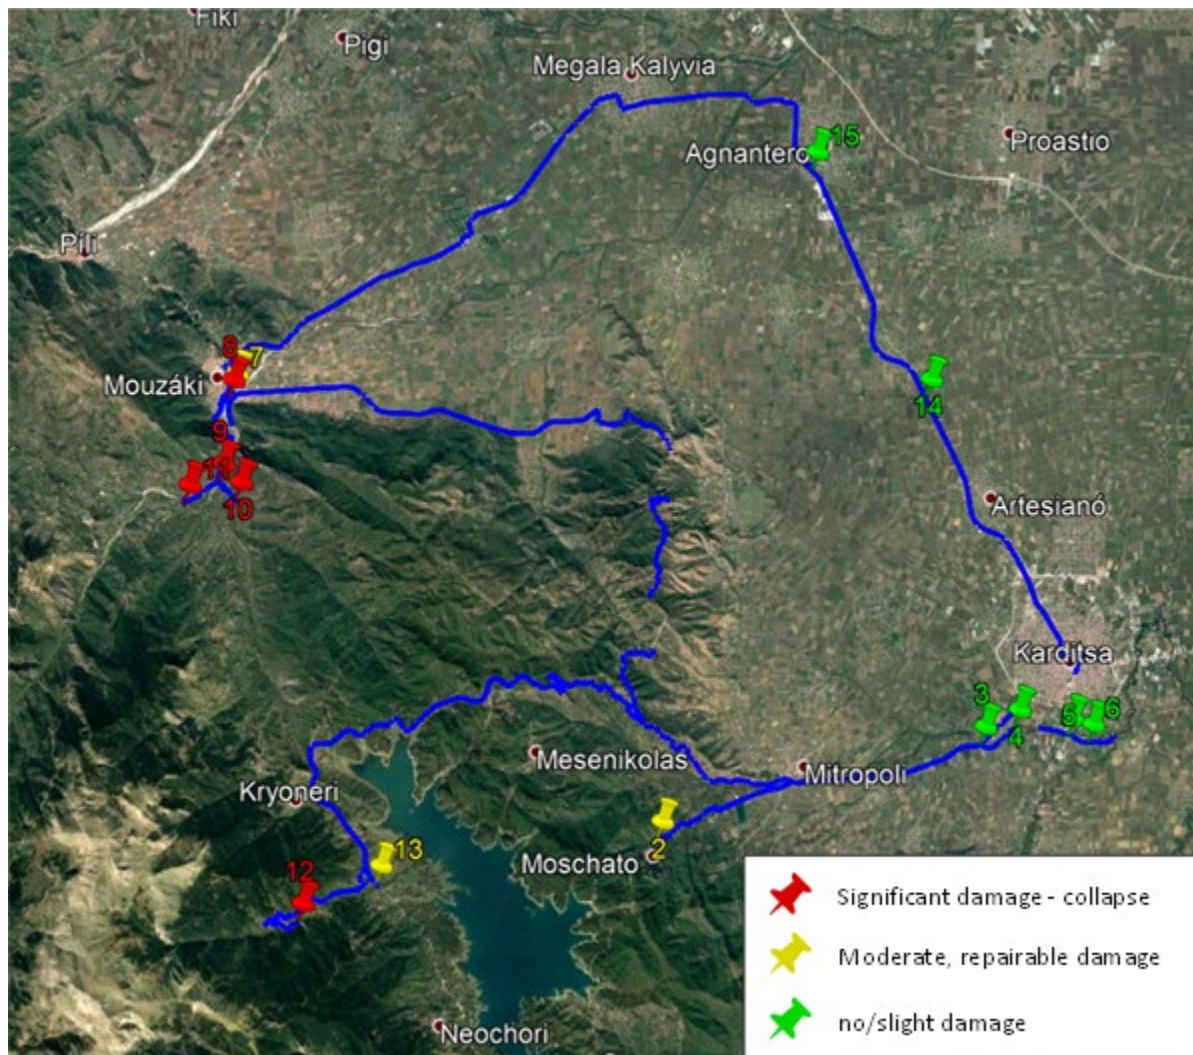
A significant number of bridges were damaged in the mountainous region west of Karditsa, in the perimeter of the Plastiras Lake, and north of it, especially in Mouzaki, causing major traffic disruptions. Figure 5.5 shows a map of a total of 14 bridges inspected during a two-day trip from 2 – 3 October 2020. The color-coded pins indicate the level of structural damage suggesting an evidently milder impact on the bridges of the lowland in comparison to the mountainous areas.

Figure 5.5. Map of bridge inspections carried out during 2 – 3 October 2020 in the area around Karditsa: the route (in blue) and the bridge locations color-coded to indicate the level of damage.

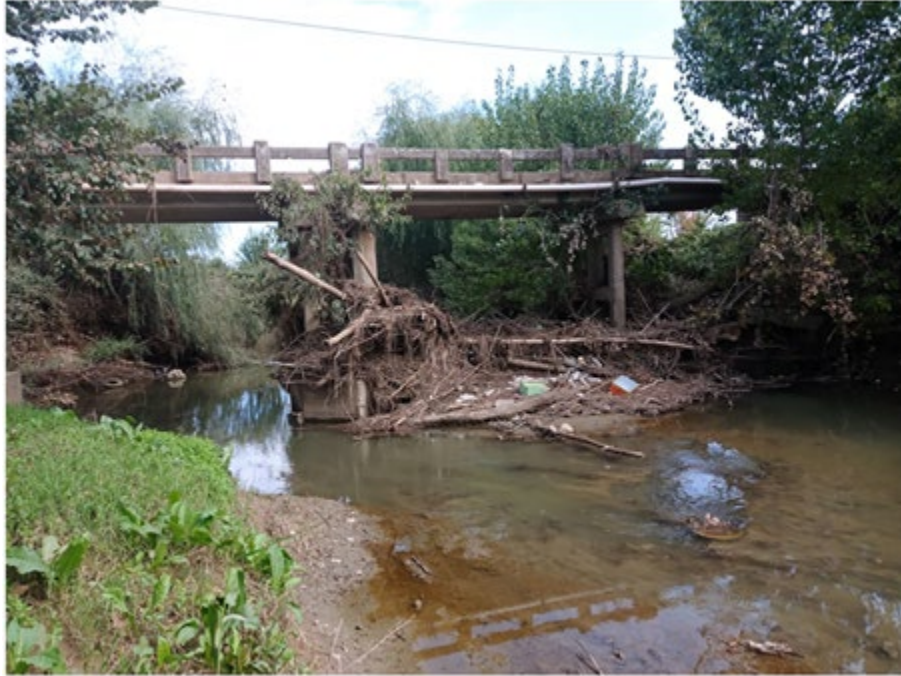
Bridges No. 4 (Figure 5.7), 5 (Figure 5.8), and 6 (Figure 5.9) demonstrated similar response, despite their essentially different structures and their varying ages (as well as maintenance states). All three showed evidence of overflowing and debris built-up, yet without any sign of structural damage or foundation/abutment distress. This was particularly surprising in the case of Bridge No. 6, which is evidently a very old and poorly maintained structure (Figure 5.9b). Although the water level did not allow inspection of its foundation for scour assessment, it would be reasonable to assume that there is no scour otherwise, the structure would have probably collapsed.

Figure 5.7. Photos of Bridge No. 4 of the Gavria Rema (39.348575°N; 21.904591667°E) showing significant debris build-up, but no other damage.

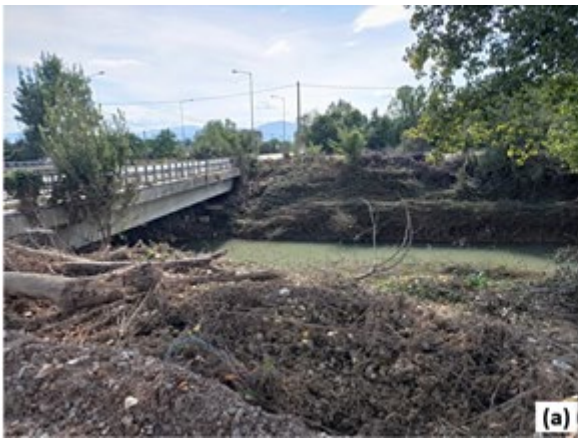
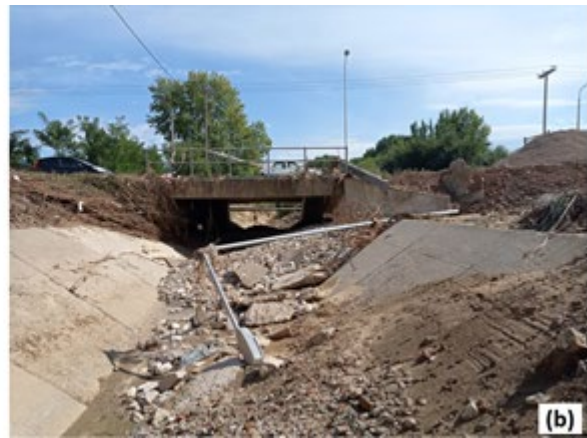
Figure 5.8. Photos of Bridge No. 5 (39.346522222°N; 21.920672222°E): (a) debris has been moved to the side; (b) debris built up in front of the neighboring overpass of the irrigation trench.

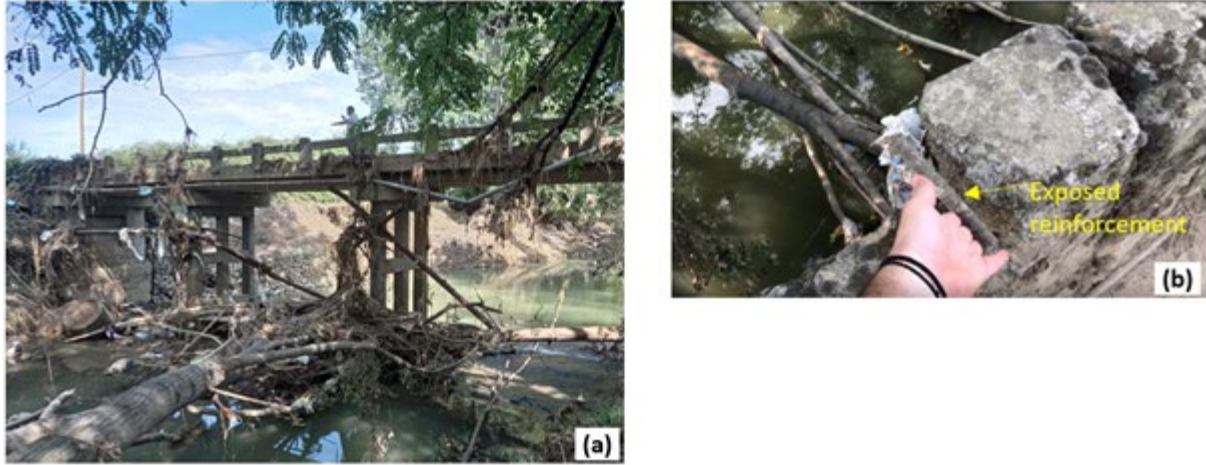
Figure 5.9. Photos of Bridge No.6 (39.344589222°N; 21.894189833°E): (a) debris has been moved to the side; (b) no evidence of flood induced damage despite the bridge being old and poorly maintained with exposed reinforcement.

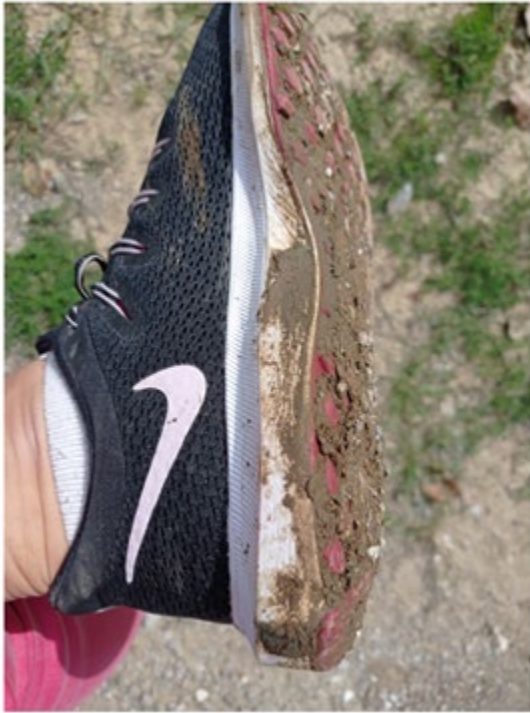
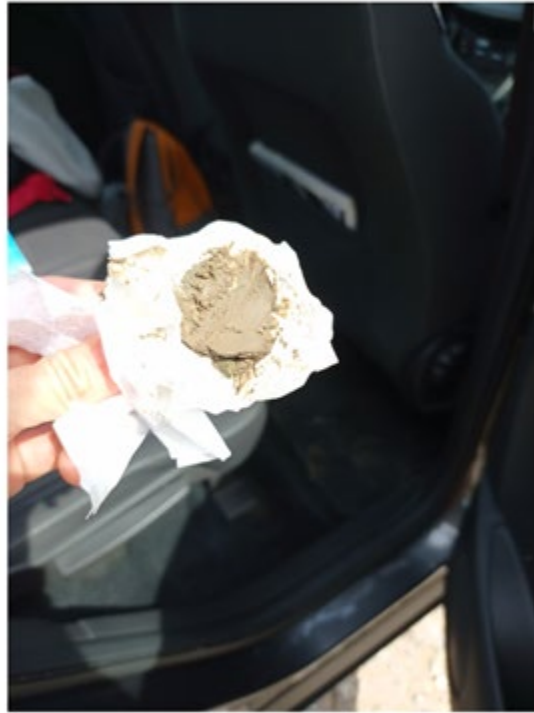
High plasticity clays, the dominant soil type in the lowlands (Figure 5.11), are much less erodible than the cohesionless sediments found in Mouzaki's riverbanks (Govindasamy 2009; Briaud 2008).

Figure 5.11. Examples of the lowland's cohesive soil.

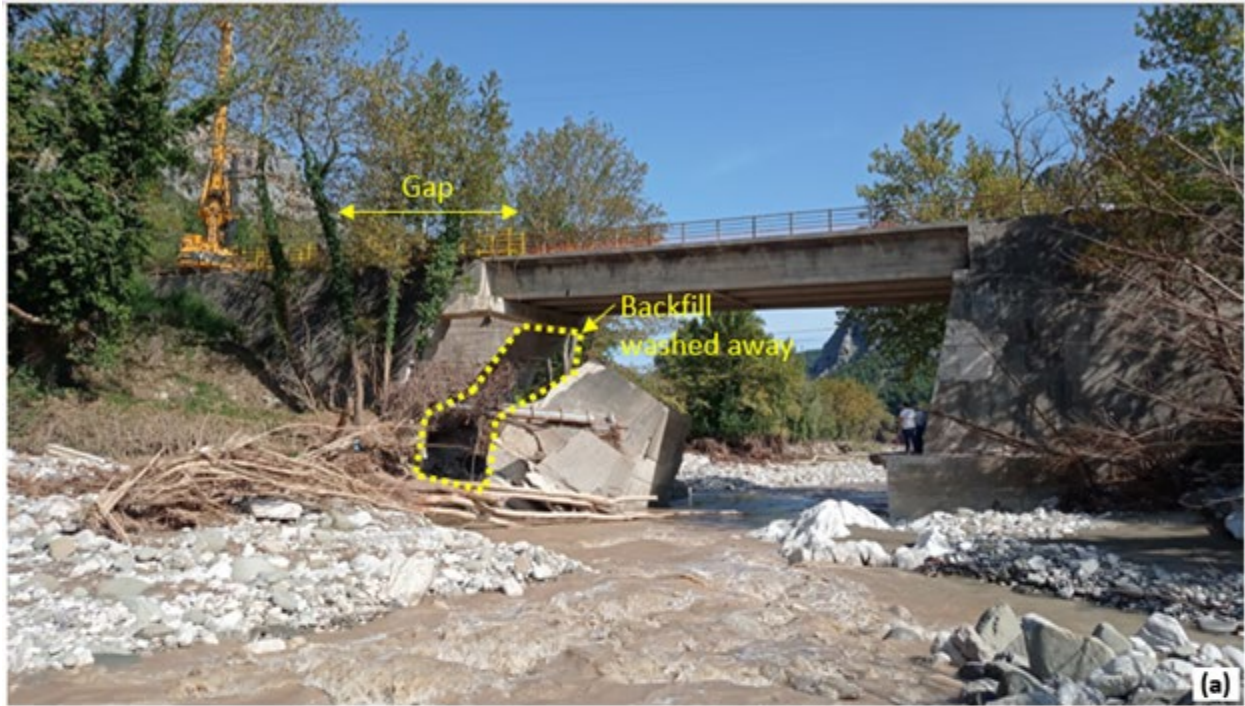
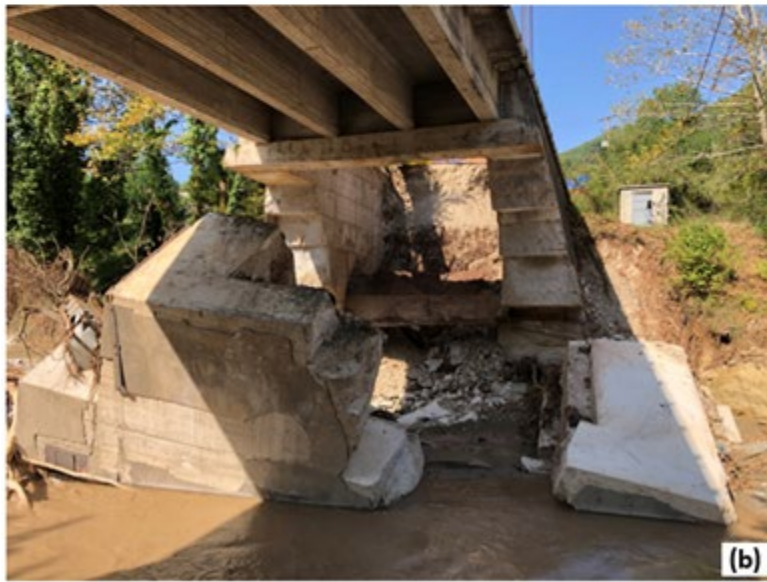
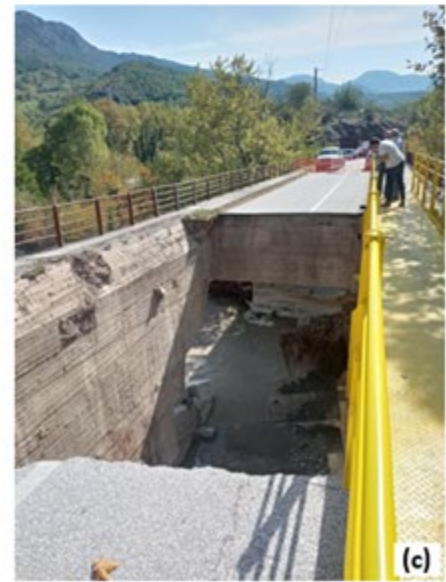
-Bridge No. 9 (39.406108333°N; 21.663150000°E) is shown in Figure 5.12:

Its abutments consist of unreinforced concrete gravity walls supported on shallow foundation slabs. According to testimonies, the foundation of the left wall was affected by scouring prior to the event. On September 18, 2020, flooding caused a complete wash-away of the backfill material and excessive scouring of its foundation, leaving the abutment walls unsupported. The latter collapsed (Figure 5.12b) as a result of material capacity failure, causing collapse of the overlying roadway segment and, therefore, a large gap in the road (Figure 5.12c). To investigate further the failure mechanism, on 13 October 2020, UAV-enabled mapping was performed. A visualization of the 3D model of the bridge can be seen here: <https://skfb.ly/6VXHW>.

Figure 5.12. Photos of the collapsed Bridge No. 9 crossing Pamisos river about 2 km north of Mouzaki ($39.406108333^{\circ}\text{N}$; $21.663150000^{\circ}\text{E}$): (a) side view indicating abutment backfill erosion and the location of the collapsed roadway segment; (b) closer view of failed abutment wall; and (c) the roadway gap.

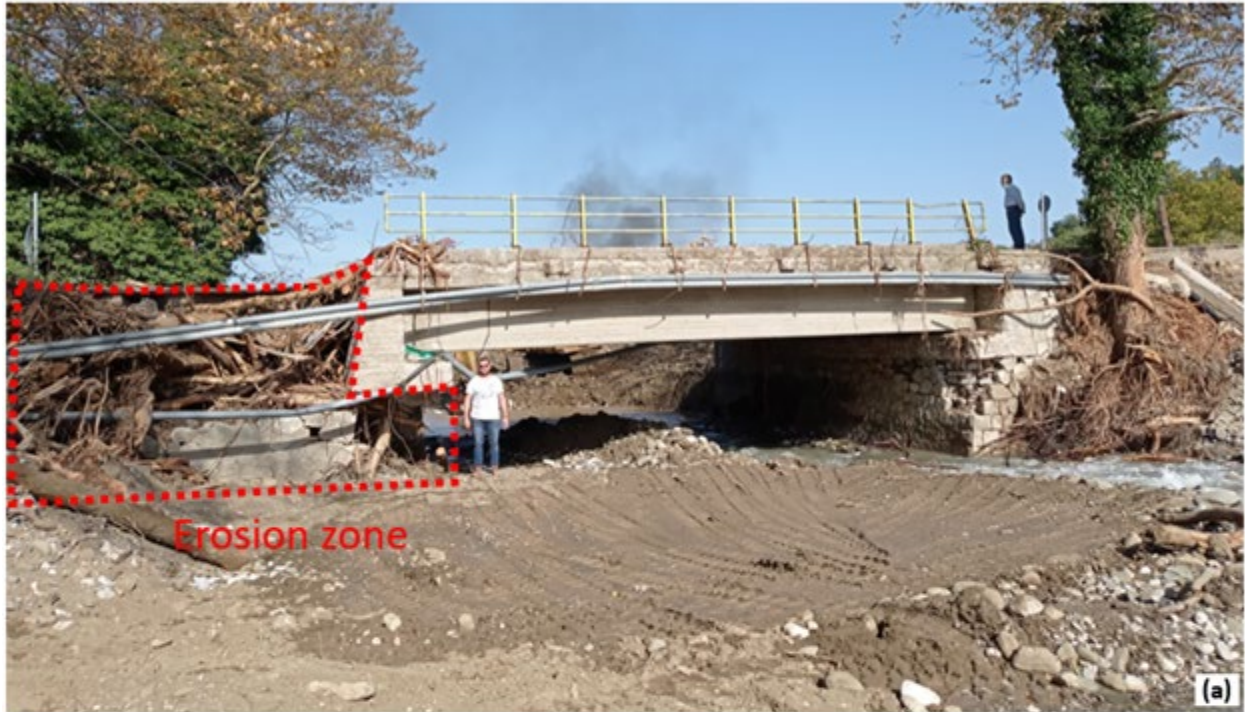
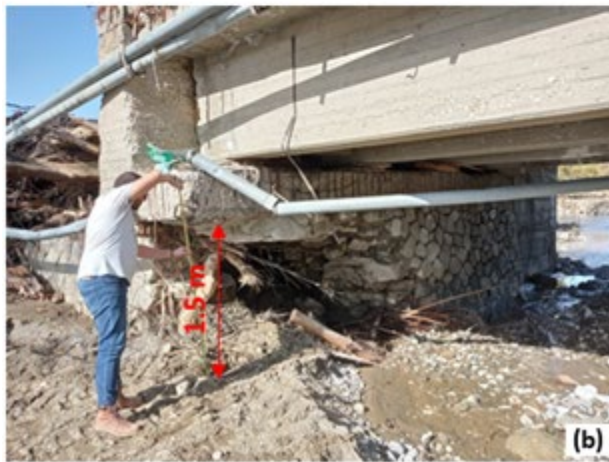
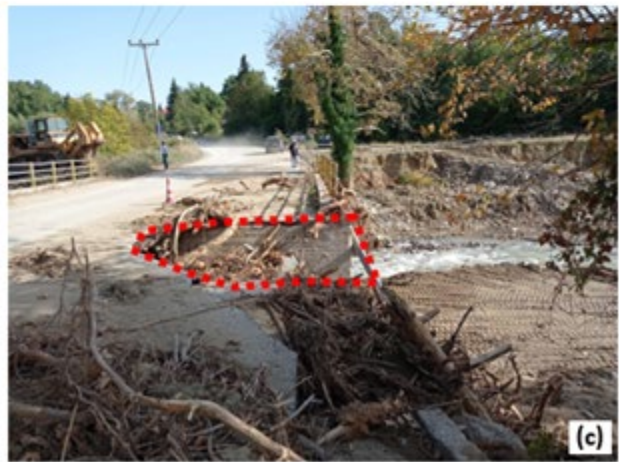
-Bridge No. 13 (39.309563356° N; 21.710816055° E) - Figure 5.14:

This bridge consists of a RC beam supported on (possibly) older masonry walls that function as abutments. Its southern abutment was partially washed away, leaving a significant part of the deck unsupported (Figure 5.14b) while backfill erosion led to the formation of a 4 m wide gap in the roadway.

Figure 5.14. Photos of Bridge No. 13 located east of the Plastiras lake ($39.309563356^{\circ}\text{N}$; $21.710816055^{\circ}\text{E}$): (a) side view indicating debris built-up and (b) significant abutment scouring and (c) backfill erosion that leads to the partial collapse of the roadway.

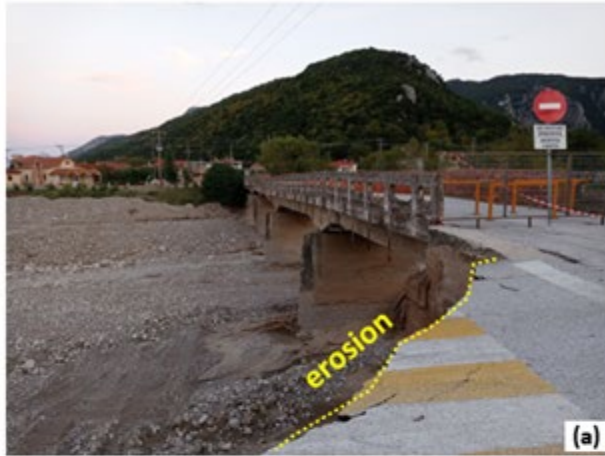
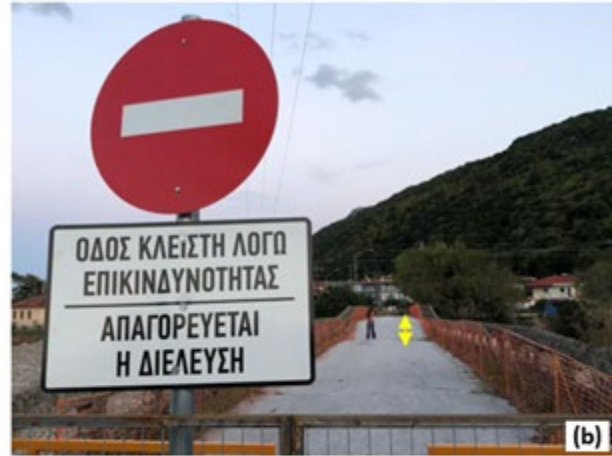
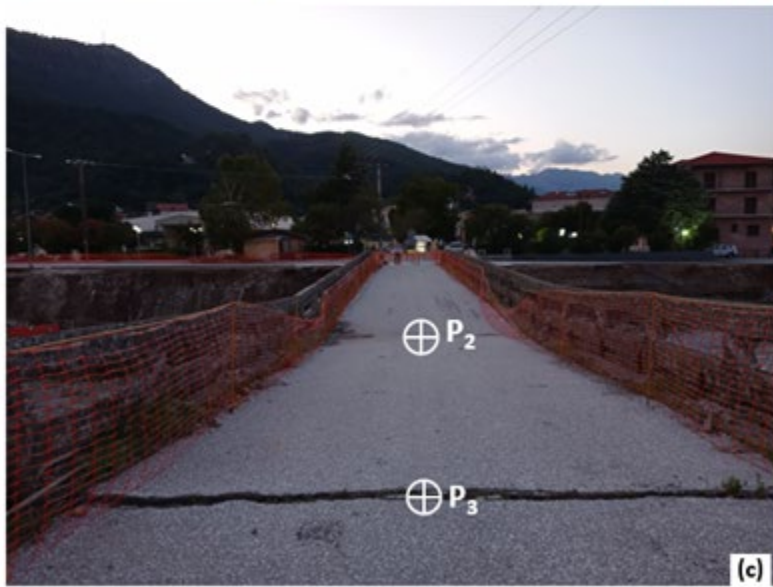
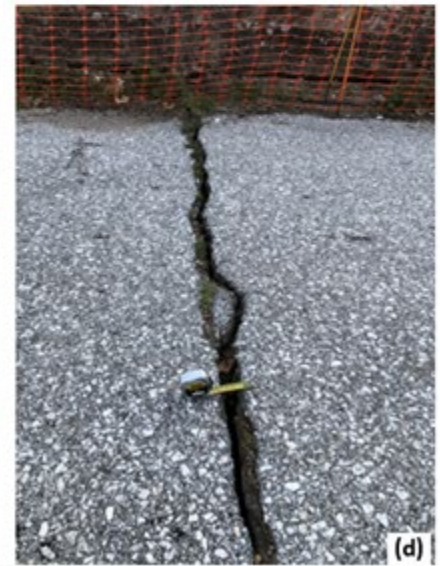
The damage of Bridge 8 (Figure 5.18) is quite severe, probably irreparable, and the structure remains inaccessible. Figure 5.19 elucidates the mechanics behind the observed asymmetry between left and right river banks, in terms of erosion and general damage. In fact, such asymmetry is typically the case in meandering rivers, as flow around such channel bends leads to increased velocity and erosion of the outer, concave bank (meander effect).

Figure 5.18. Photos of Bridge No. 8 taken from the level of the roadway: (a) abutment erosion; (b) settlement induced step; (c) – (d) extension cracks over Pier 3.

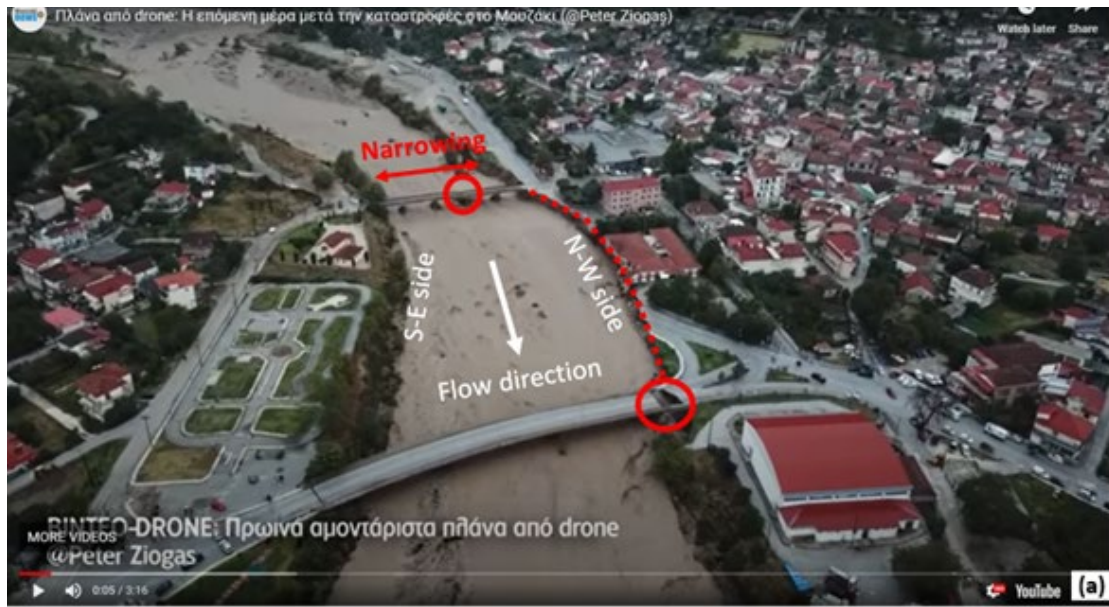
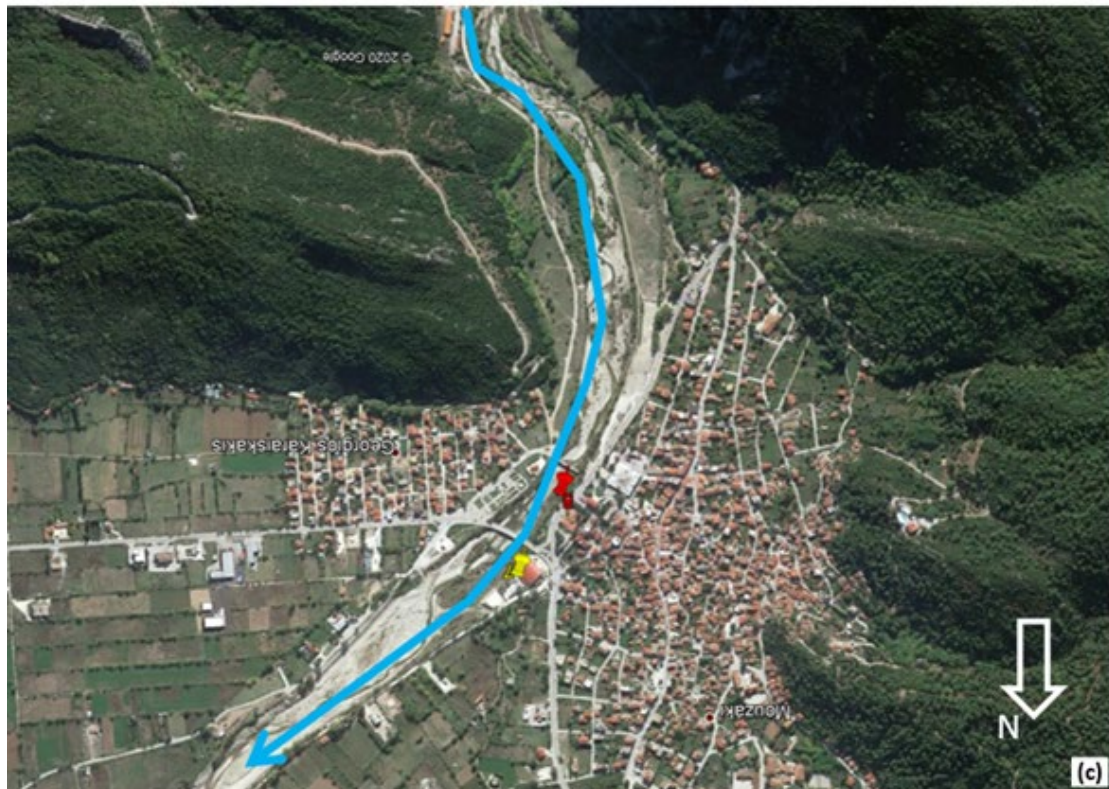
Figure 5.19. (a) Drone footage captured on September 19, 2020 (source: <https://www.youtube.com/watch?v=3bqDobqMuC0>) showing that erosion damage was concentrated on the left (N-W) riverbank while the right (S-E) side remained unaffected; (b) river course geometry that helps explain the scour of the exterior bank of the river..

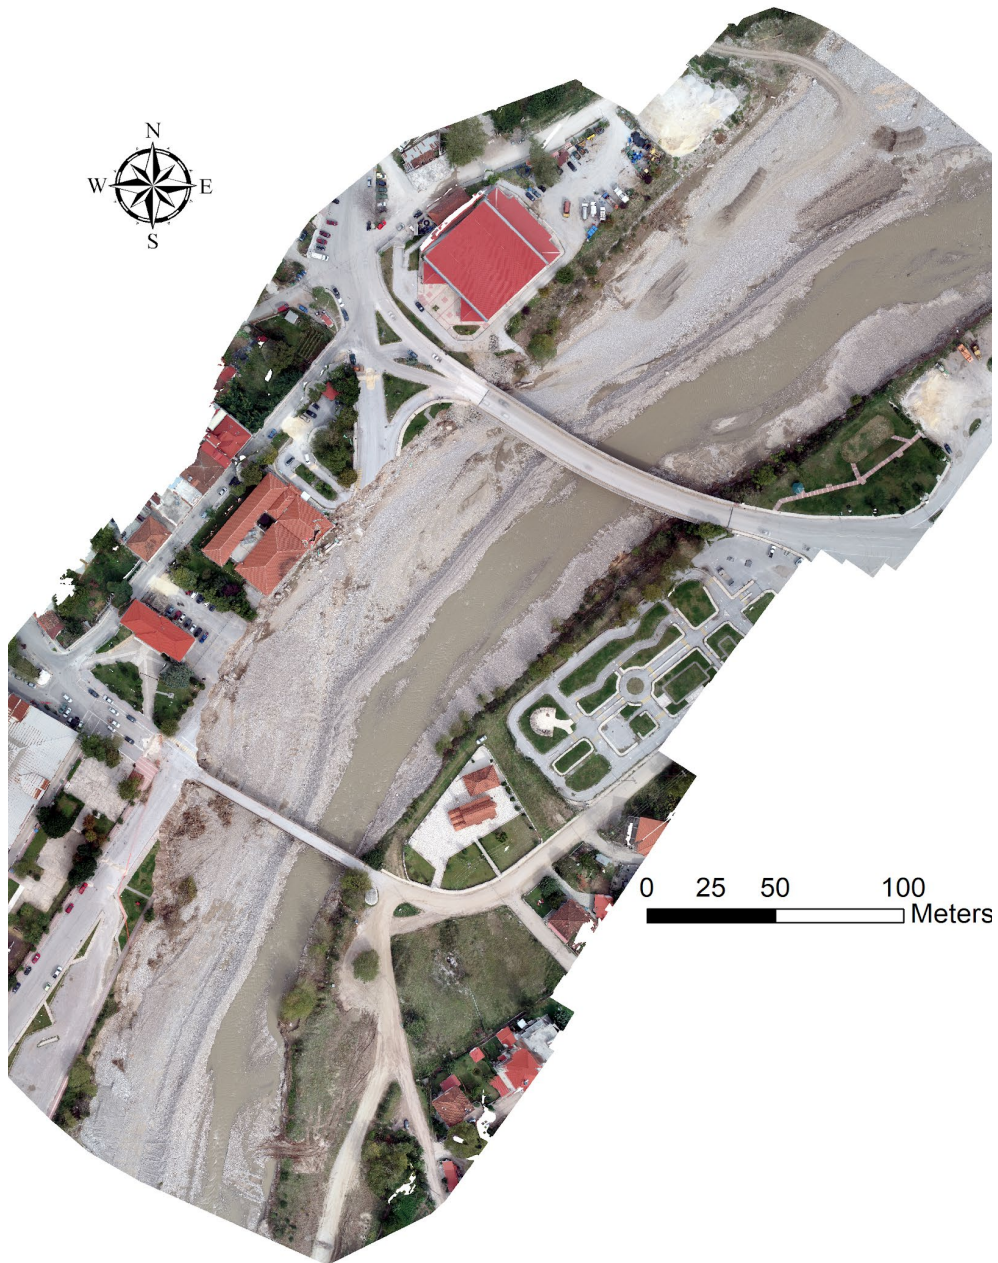
Figure 5.20. Orthophoto of bridges No. 7 and 8 at the village of Mouzaki (2 October 2020).

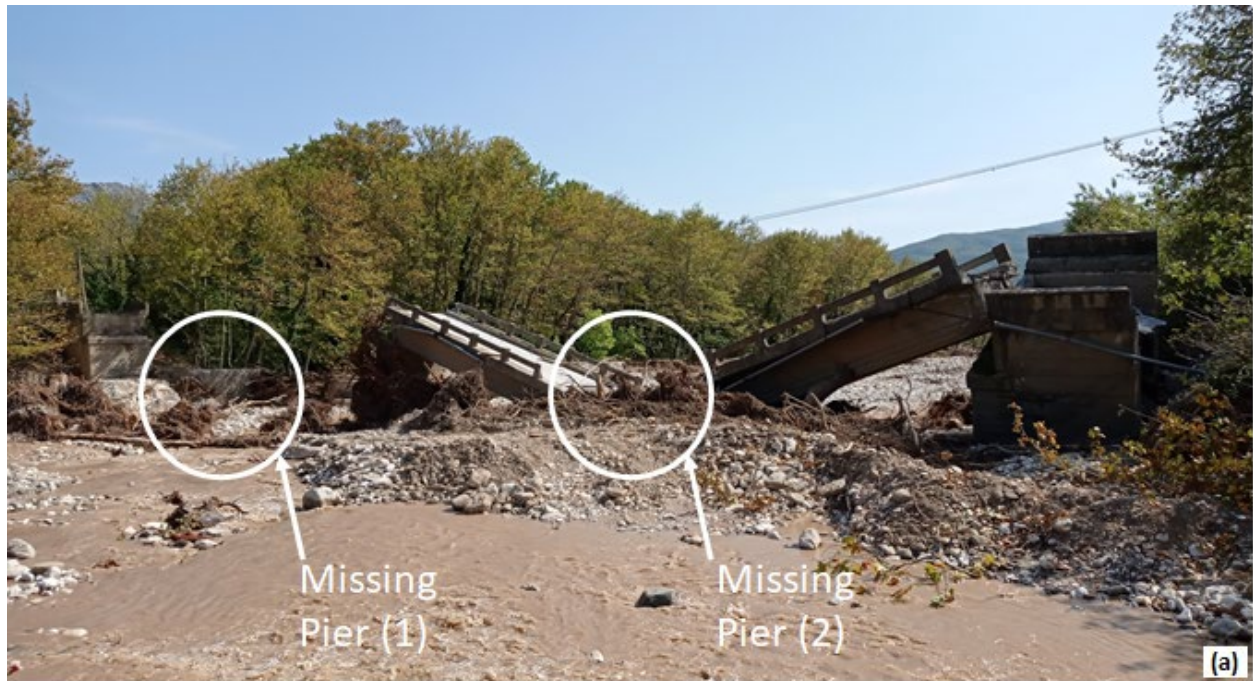
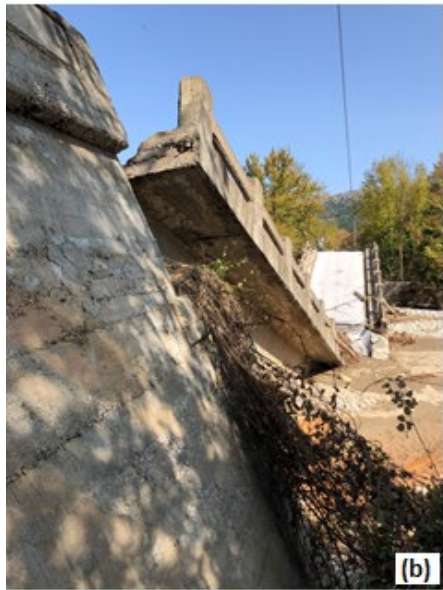
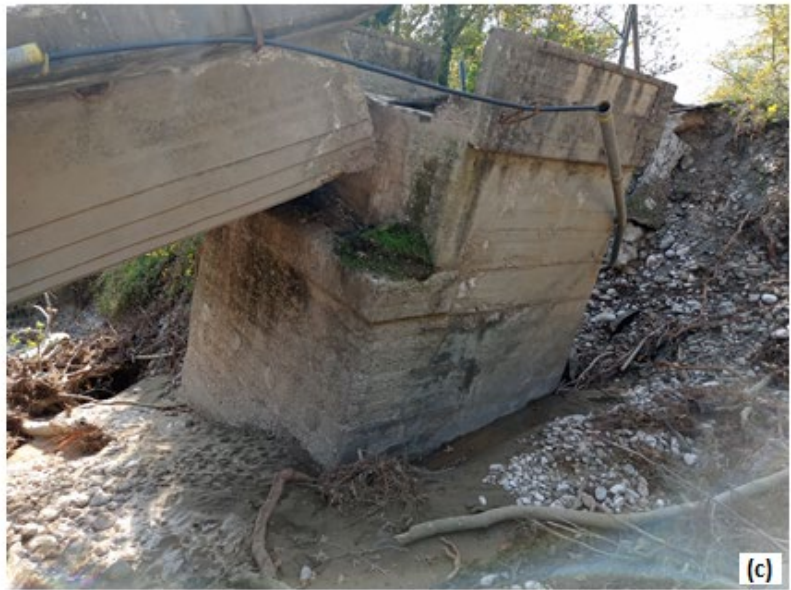
- Bridge No. 11 (Figure 5.21) crosses Pamissos at a horizontal distance of 3.2 km from Mouzaki, upstream. The bridge collapsed completely as a result of pier scour and abutment erosion. Based on the deformation of the deck, it is reasonable to deduce that there were two additional piers (i.e. a total of 3 piers) at the locations indicated in Figure 5.21a, which likely suffered significant rotation due to scour, similar to the abutment (Figure 5.21c). Yet, we could not locate these piers when we visited on October 3, 2020. Likewise, we could not locate the middle span of the deck, which is evident in footage that appeared in the local media the day after the event (see screenshot in Figure 5.22).

It is important to note that Bridge No. 11 was known to have suffered scour induced deformation prior to this medicane (observed during inspections carried out in August 2020). In August 2020, it was decided to replace it soon with a new bridge, constructed upstream. Construction was ongoing next to Bridge No.11 during our visit on October 3, 2020 (Figure 5.23), which according to workers' testimonies had begun prior to the event.

Figure 5.21. Photos of Bridge No. 11 ($39.401172611^{\circ}\text{N}$; $21.652868250^{\circ}\text{E}$) which evidently collapsed due to a combination of abutment and pier scour: (a) side view, (b) - (c) bearing capacity failure of the abutment and deck collapse.
