The September 18-20 2020 Medicane Ianos Impact on Greece

Phase I Reconnaissance Report

Geotechnical Extreme Events Reconnaissance Association

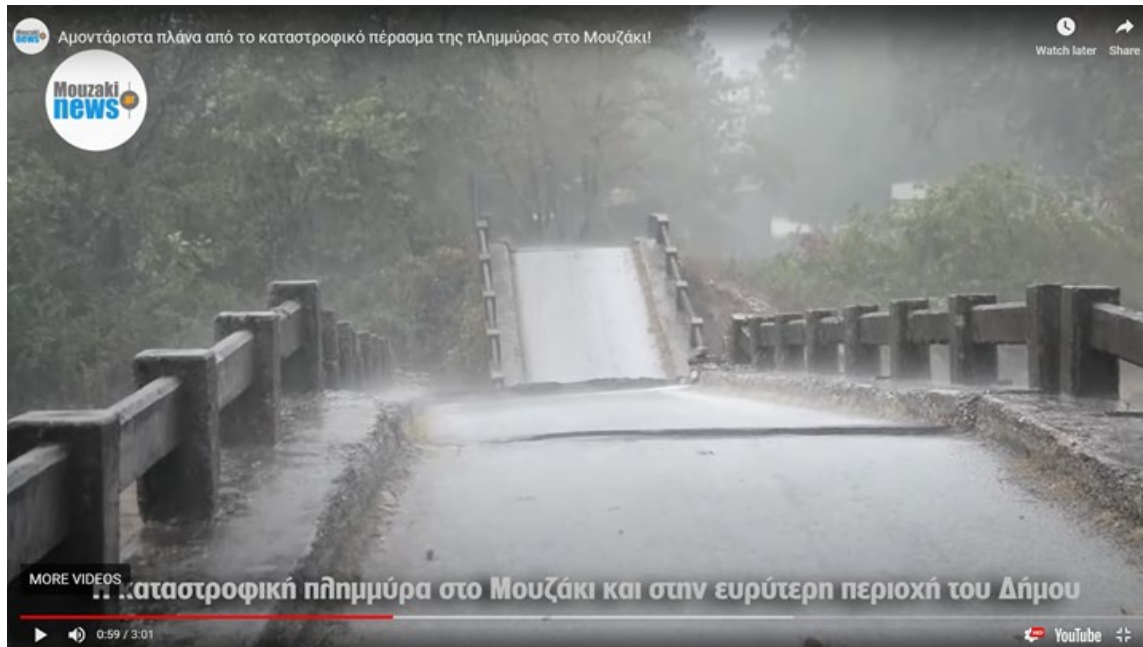
Figure 5.22. Footage of Bridge No.11 in the local news on September 19, 2020 (source: <https://www.youtube.com/watch?v=hLP3NdMF9SI>).

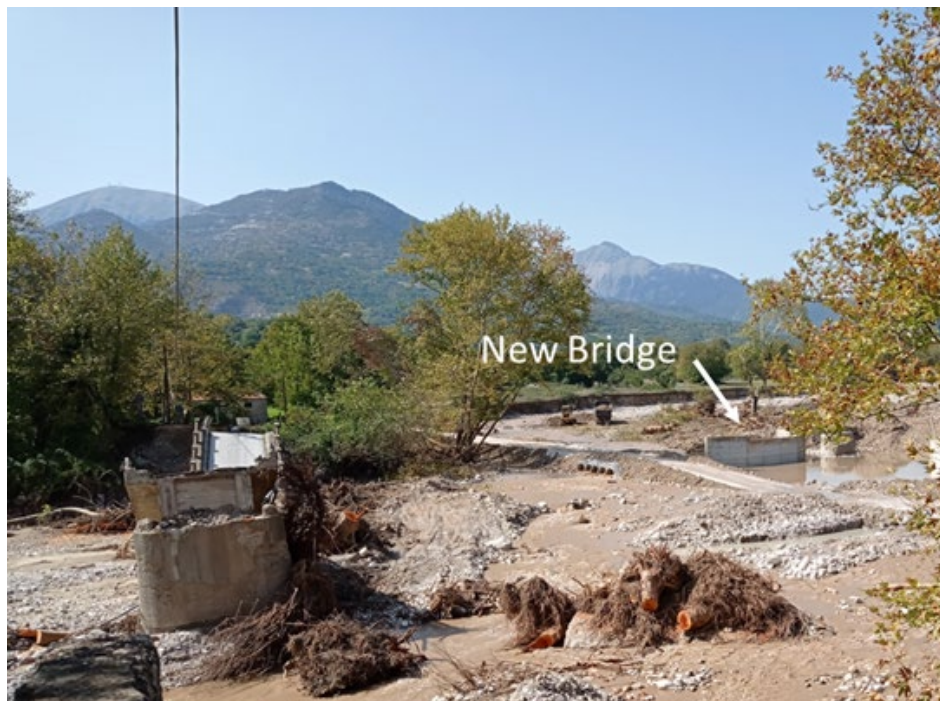
Figure 5.23. New bridge being constructed next to the collapsed bridge No. 11.

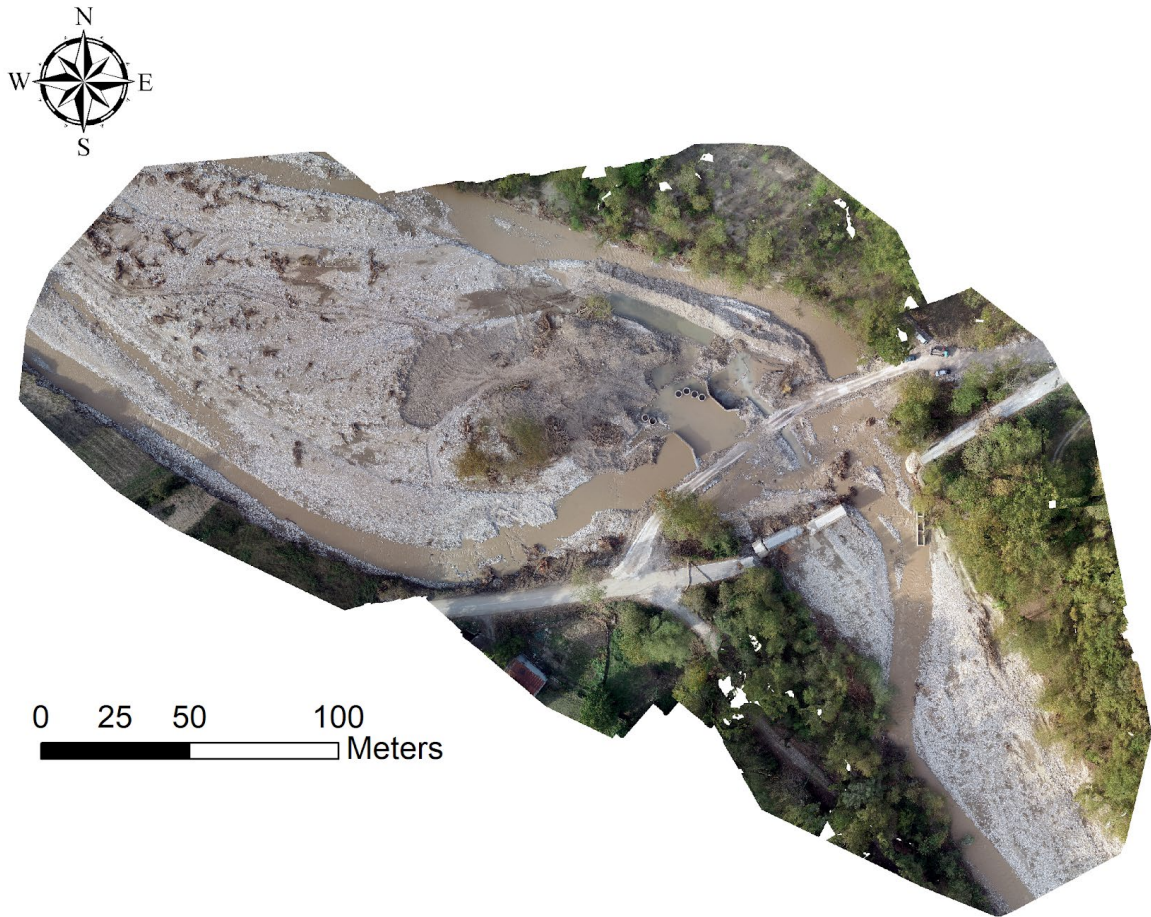
Figure 5.24. Orthophoto of bridge No. 11 near the village of Mouzaki (2 October 2020).

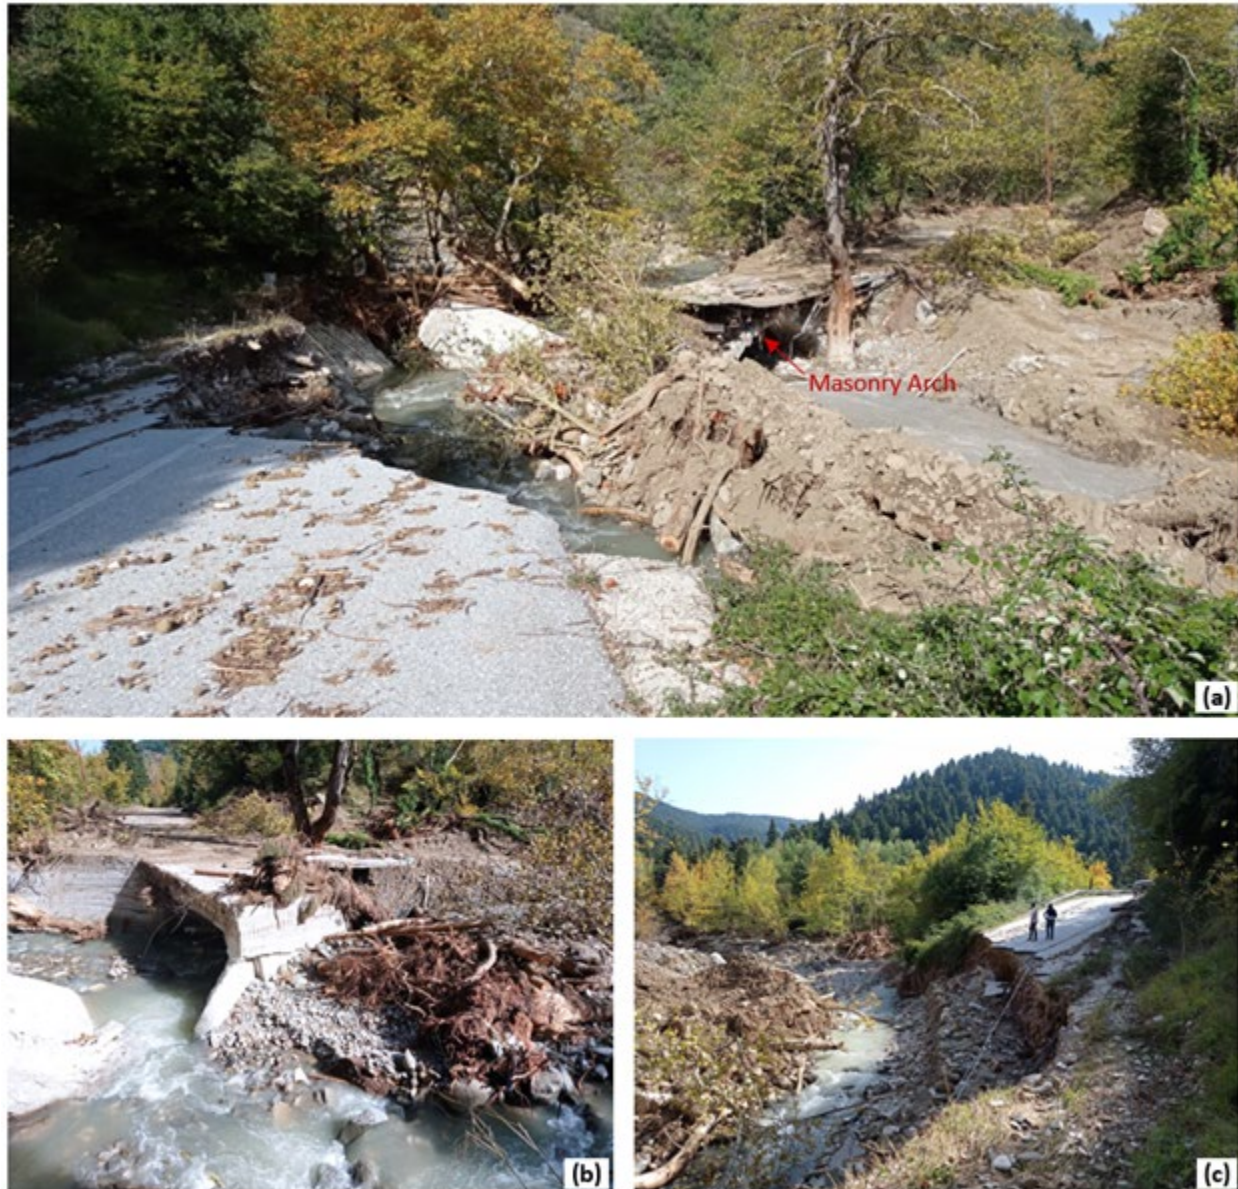
Similar to the previously discussed single-span RC bridges, the response of two old masonry arches found in the area was dominated by abutment erosion (Figures 5.25 and 5.26). Particularly interesting is the case of Bridge No. 2 (Figure 5.25), which is considered a cultural monument with an estimated age of 300 years. Its integrity was certainly undermined by the modern, narrower overpass located at a close distance upstream (Figure 5.25). The latter, presumably, caused contraction of water flow leading to increased flow velocities impacting Bridge No.2.

Figure 5.26. Photos of Bridge No.12, a masonry arch located on the way from Filakti to Pezoula ($39.303508426^{\circ}\text{N}$; $21.686573208^{\circ}\text{E}$): (a) – (b) suffering extended abutment and riverside erosion that lead to (c) collapse of the roadway.

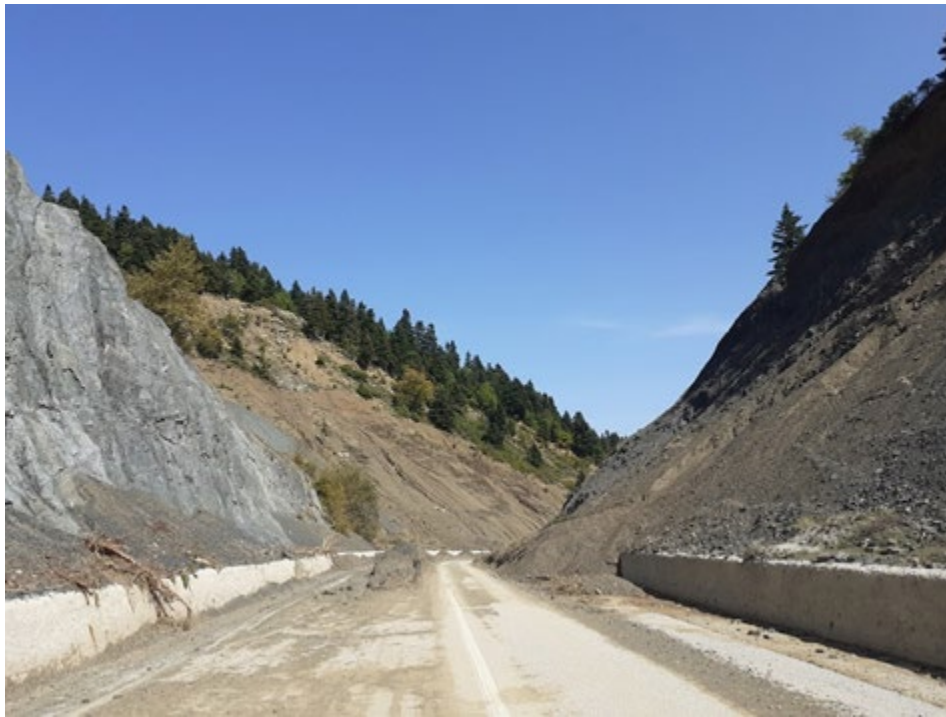
In this area, along the road section between Kastania and Rachoula (total length of about 10 km), extensive sliding occurred. The flysch type consists mainly of shales. During the time of the visit the road was covered with slipped material on either side, but remained accessible (see Figure 5.31).

Figure 5.31. Landslips from side slopes along the Kastania – Rachoula section (39.2314830°N, 21.8016040°E)

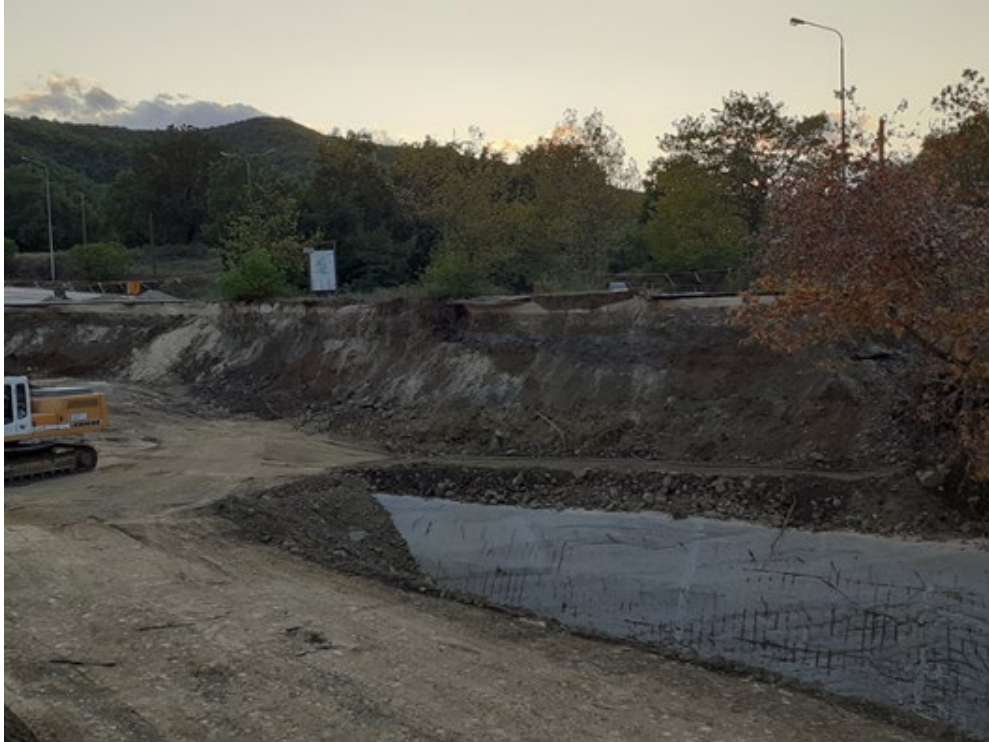
At the location before Rachoula village, the road was completely damaged due to the extensive erosion in the riverbed and the impact of the transported materials on the road (see Figure 5.32). The riverbank erosion was accompanied by a complex rotational-type slope failure in sandstone flysch. The height of the landslide's crown was about 30 m and material travelled at a distance of around 200 m (Figure 5.33).

Figure 5.32. Damaged road near Rachoula due to impact of transported materials (39.2494490°N, 21.8889110°E)

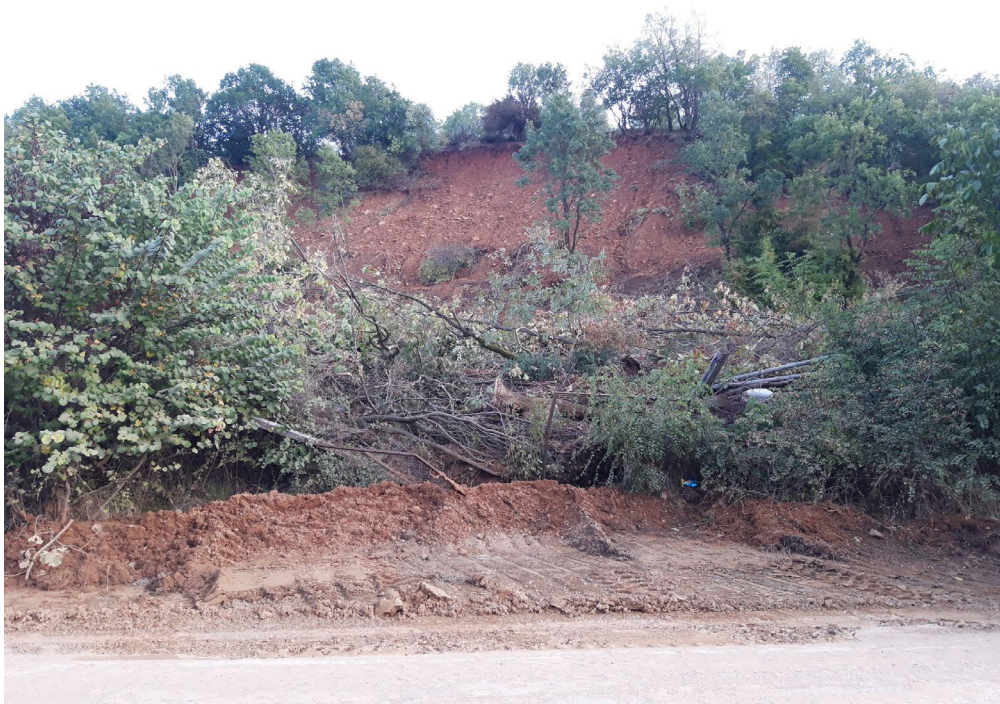
Figure 5.33. Complex rotational-type slope failure near Rachoula (39.2494490°N, 21.8889110°E)

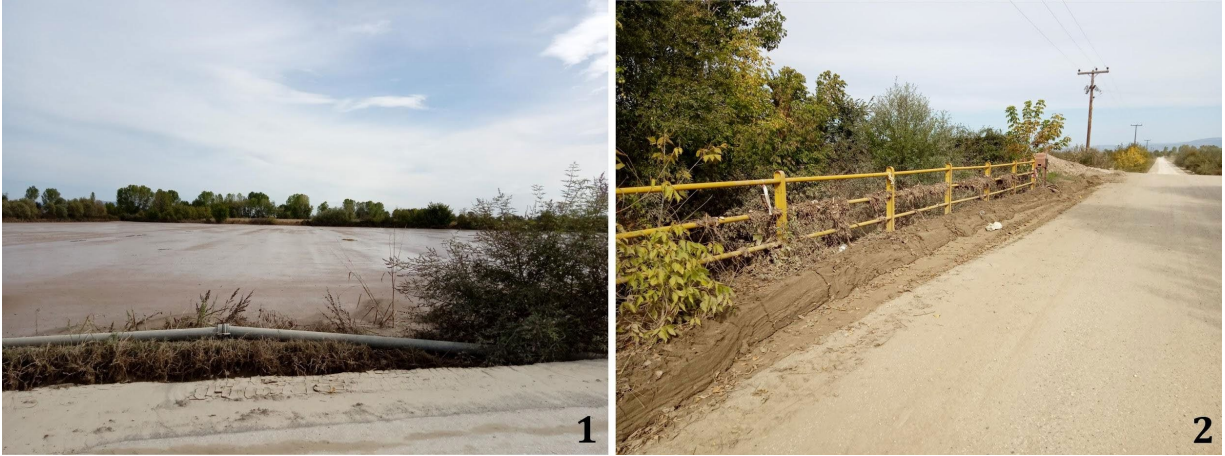
Figure 5.38. 1) Flooded areas south of Megala Kalyvia, Trikala (39.4765°N, 21.7887°E). 2) Road bridge over an irrigation canal (39.4694°N, 21.7907°E). Debris and flood deposits over the deck (upstream view) show that the maximum flood level exceeded the bridge height.

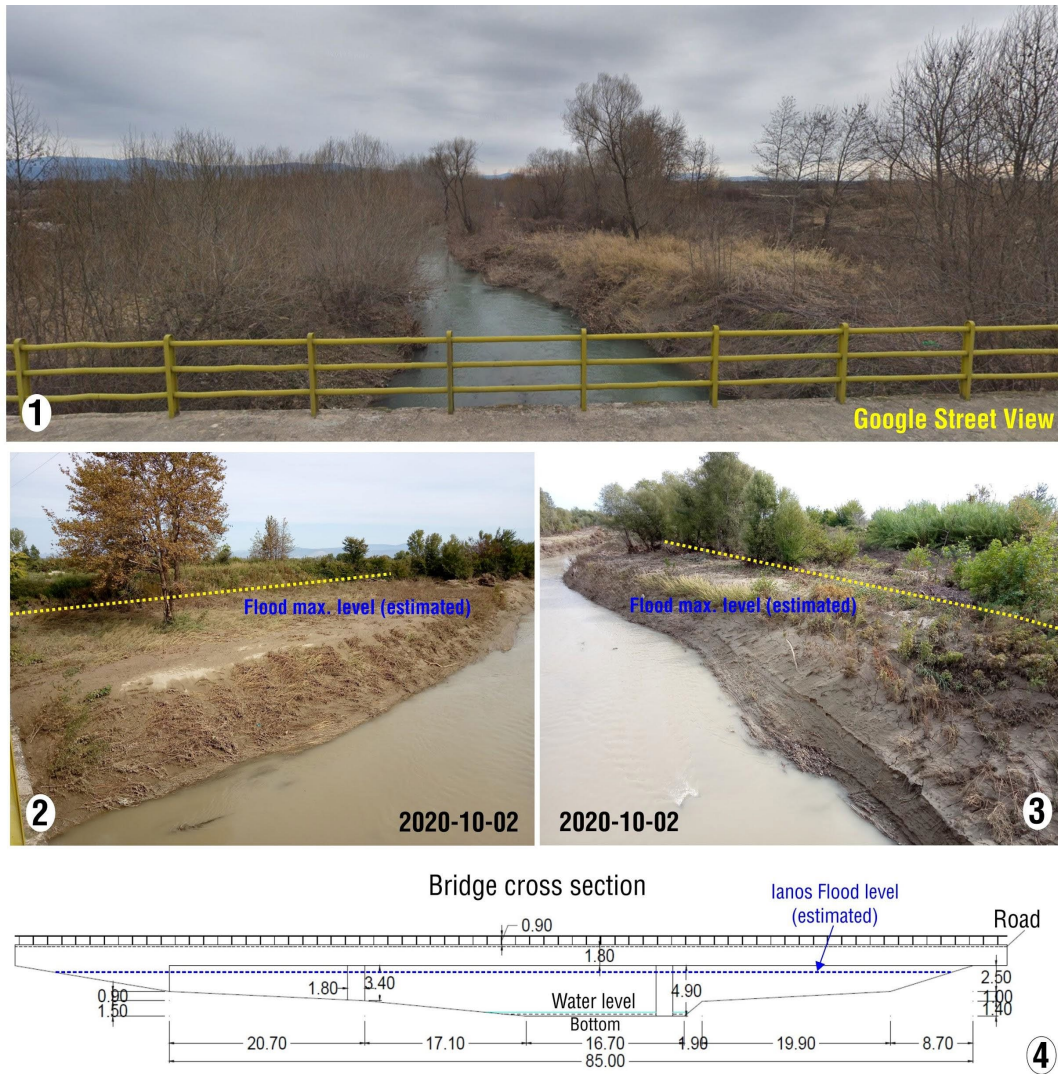
Figure 5.39. Road bridge over Pamisos canal, view to the east - downstream (39.46341°N, 21.79944°E). Field photos (2,3) compared with pre-event Google Street View image (1) and technical cross section. Maximum flood level did not overtop the bridge, but is estimated close to ~4 meters from the bottom.

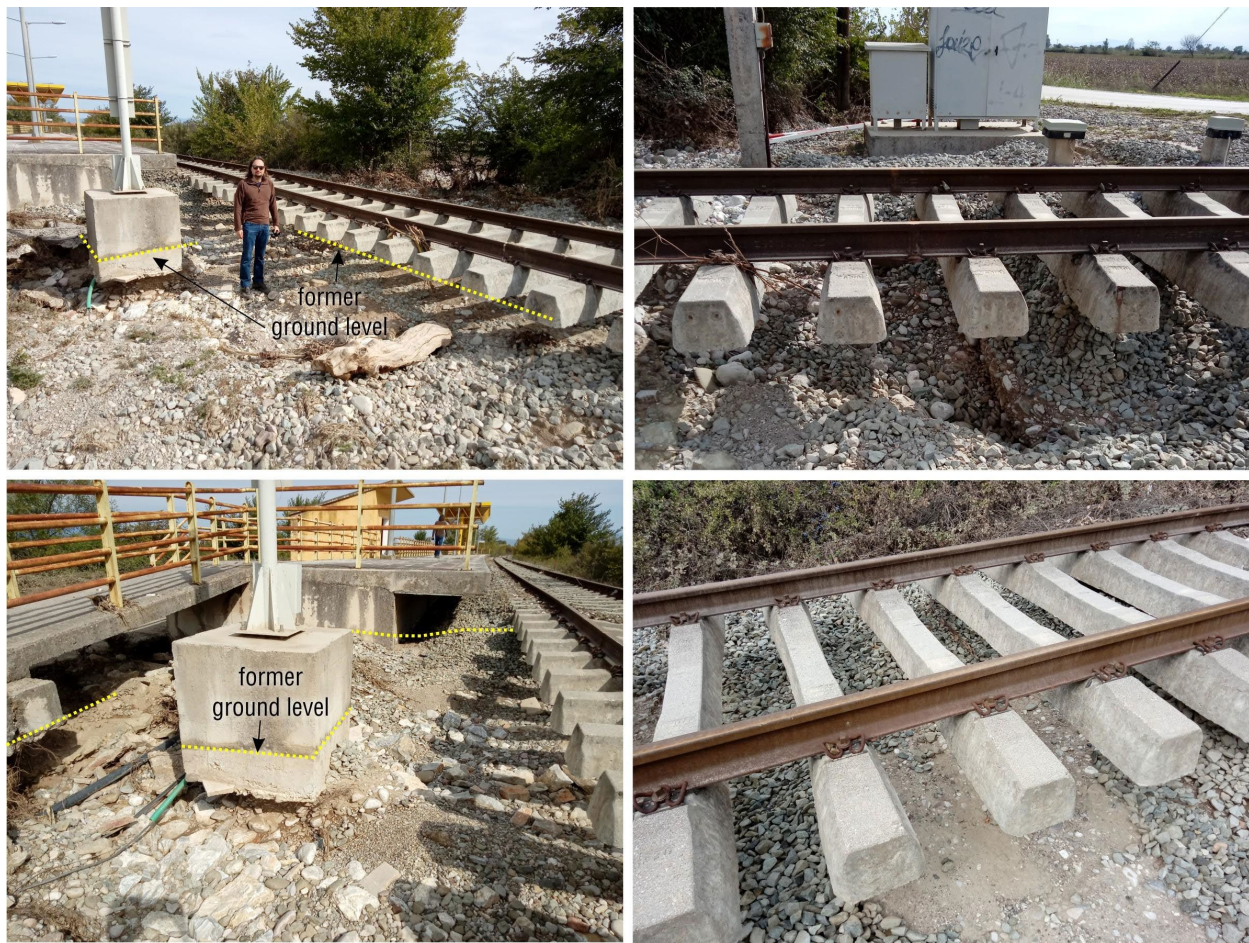
Severe flooding outburst by Pamisos river discharged large amounts of water towards two directions: to the north, flooding the area around Megala Kalyvia, and to the east towards Magoula. Field survey of Magoula train station and rail track showed severe ballast scouring that deformed the rail line along significant parts of the line. The rail track is composed of metal rail lines and cement sleepers, over a ~0.5m thick ballast underbed, over an earth embankment. Flood waters breached and eroded the ballast, deforming the rail line and leaving parts of the rail track hanging. The direction of the flood water flow towards east, is evident by oriented remnant vegetation, and the direction of ballast washout towards the east side of the rail track. Figures 5.37 through 5.47 document in detail the observations made at the Magoula Station Site.

Figure 5.40. Railway embankment & ballast scouring at Magoula train station (39.45127°N, 21.78824°E).

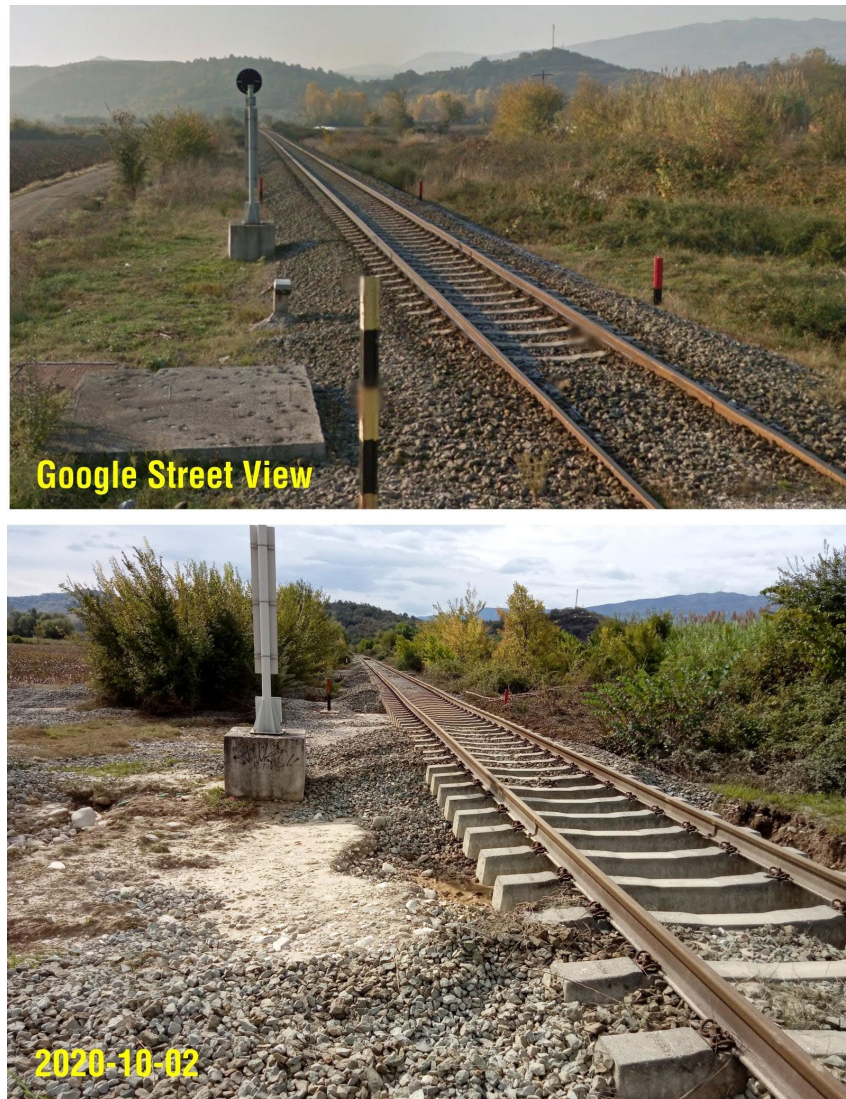
Figure 5.41. Railway embankment & ballast scouring along Paleofarsalos-Kalabaka line, near Magoula (39.45127°N, 21.78824°E). Comparison of field photo (bottom) with pre-event Google Street View image (top).

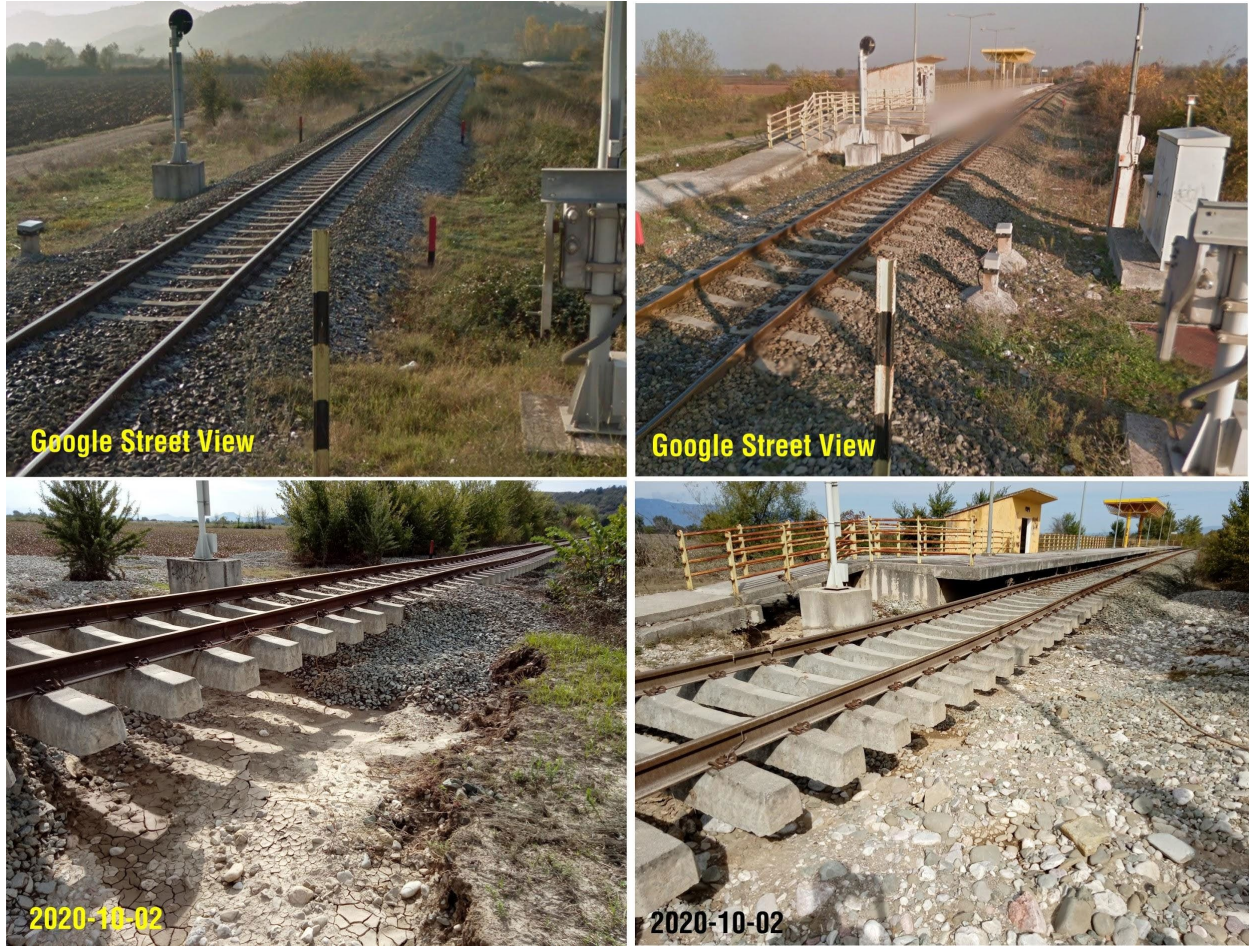
Figure 5.42. Railway embankment & ballast scouring along Paleofarsalos-Kalabaka line, Magoula station (39.45127°N, 21.78824°E). Comparison of field photo (bottom) with pre-event Google Street View image (top).

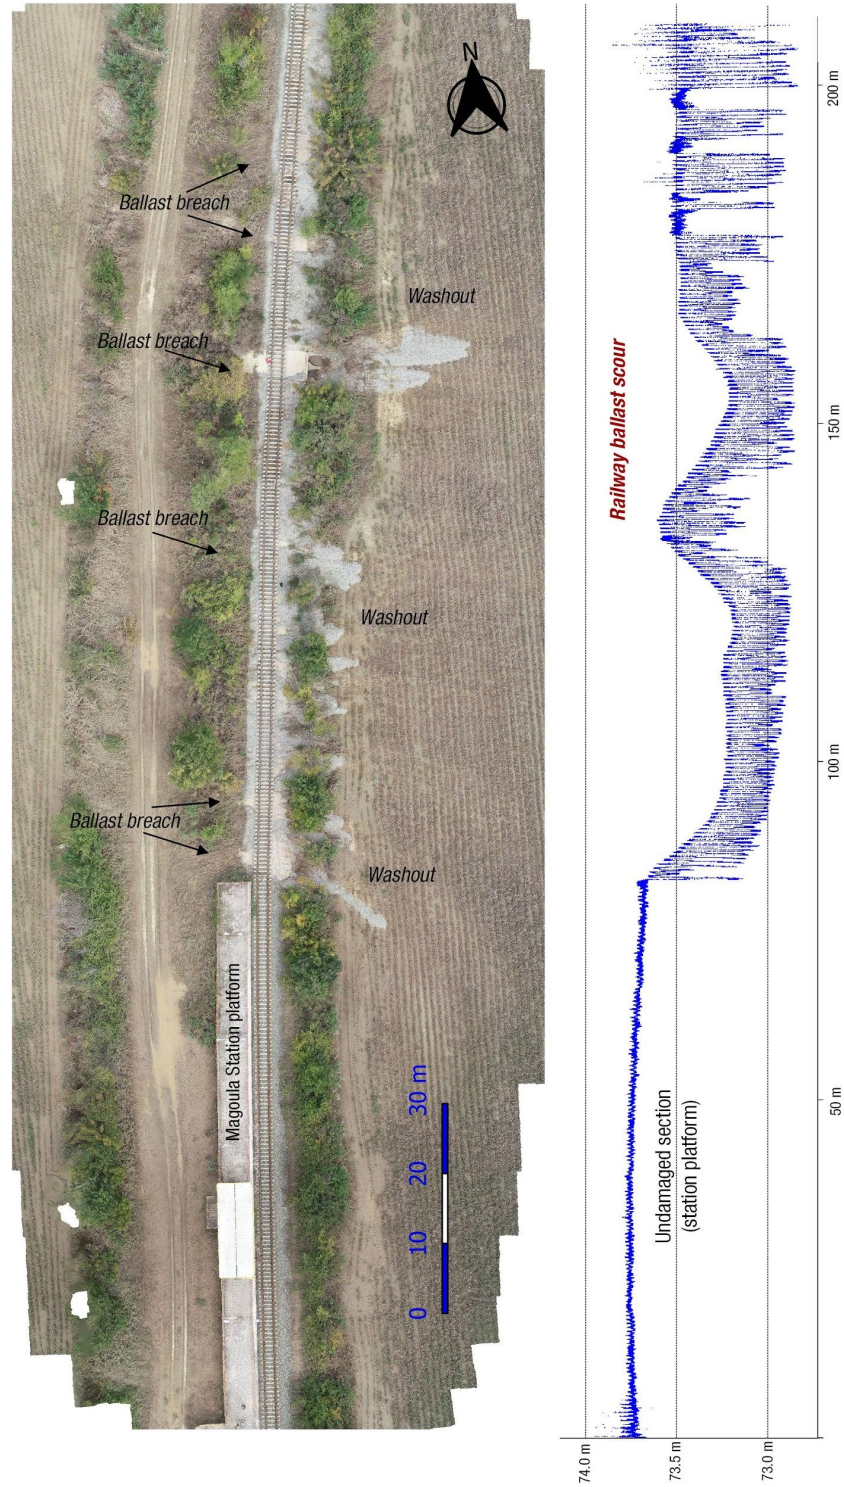
Figure 5.43. Orthophotomap (left) from the UAV survey in Magoula Station site and point cloud profile along the rail track (right) that shows deformation of the rail line due to ballast scouring.

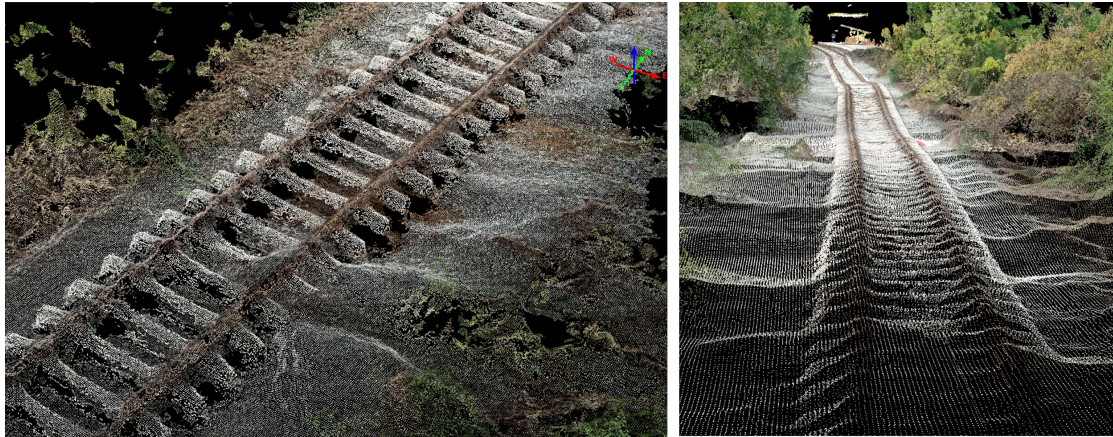
Figure 5.44. 3D Point cloud views of railway ballast breach (left) and rail line deformation (right).

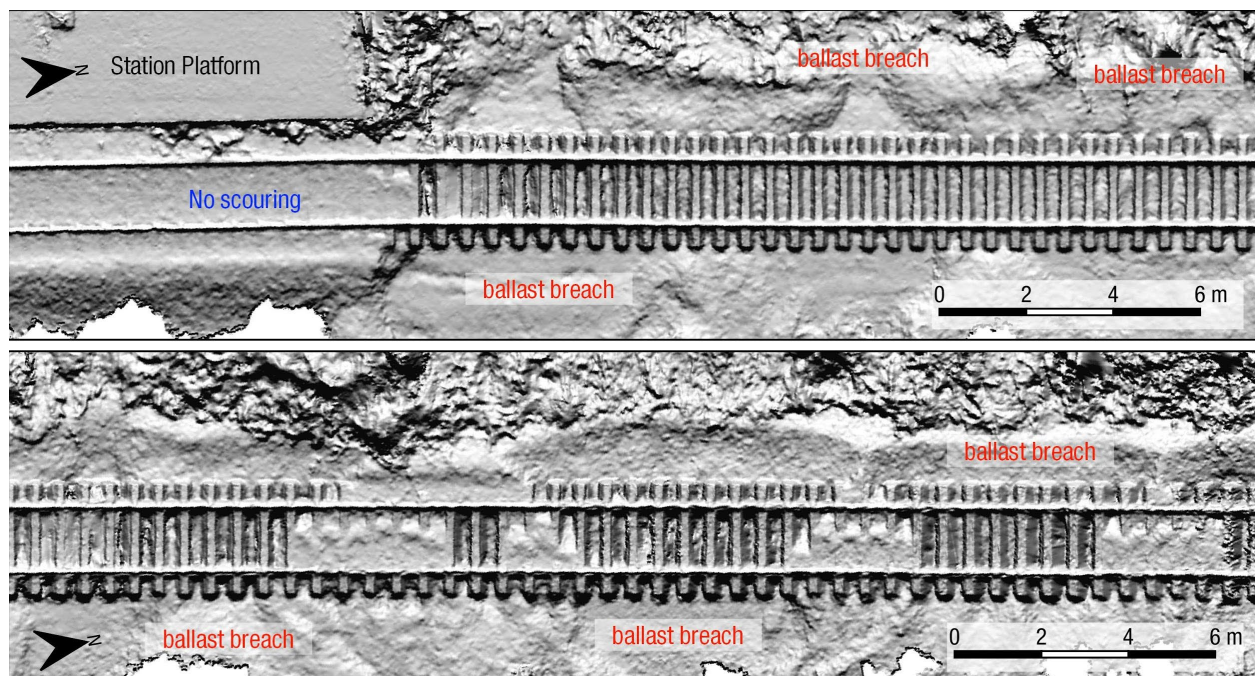
Figure 5.45. Close-ups of digital surface model (from UAV survey) along the rail track bed. Removal of ballast is visible as has created empty space between and below the sleepers. The protection of the track bed from scouring, due to the presence of the (cement) station platform, is visible in the top figure.

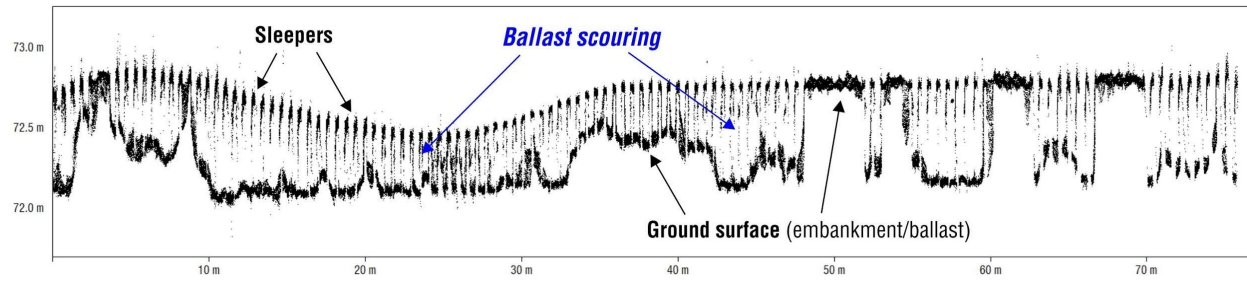
Figure 5.46. Point cloud swath profile, between the rails, along a part of the track near Magoula station. Ballast scouring in various spots is visible, that has left the sleepers and lines hanging.

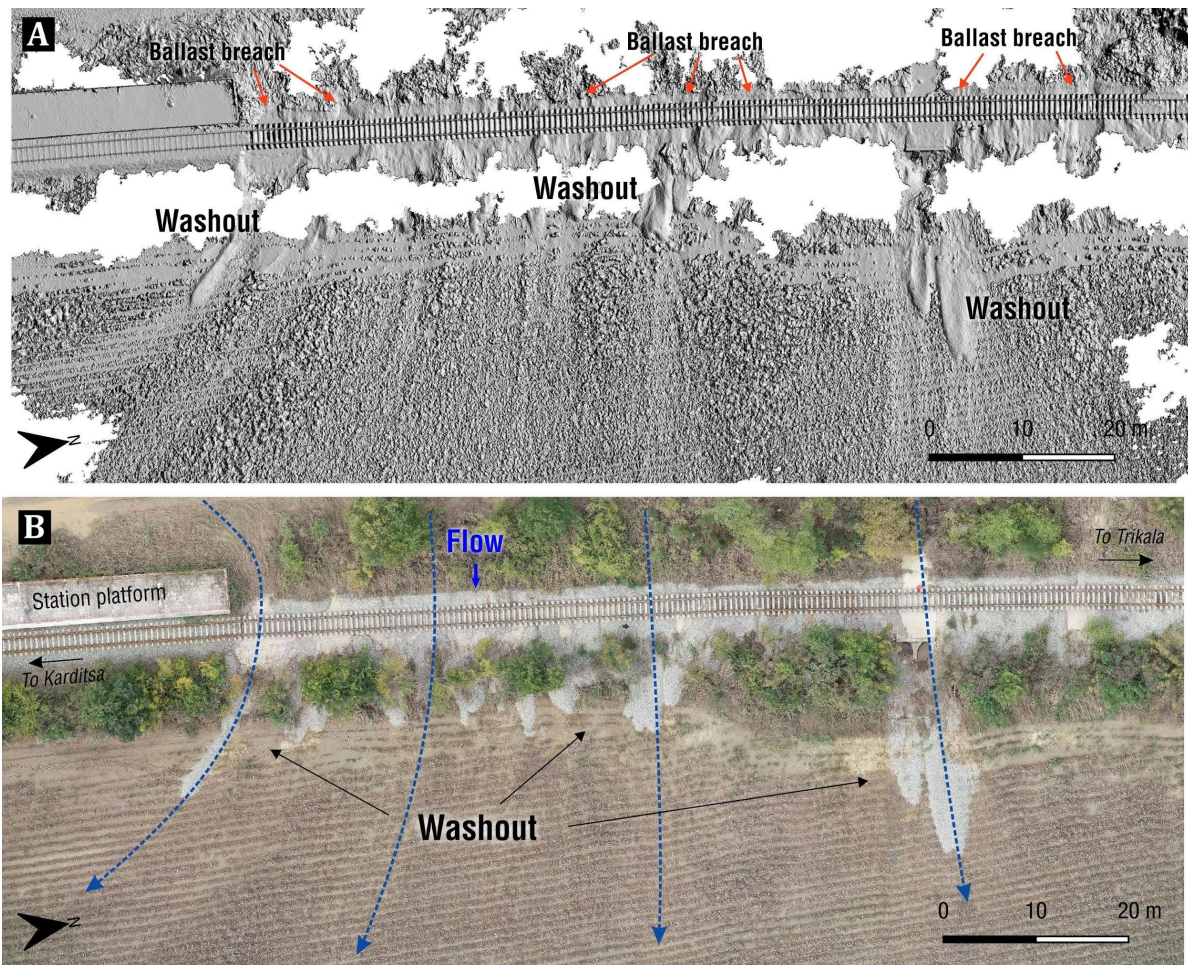
Figure 5.47. Railway ballast scouring effects in Magoula Station site. Flood water flow can be inferred from oriented overrun vegetation and the morphology/distribution of washout ballast in the eastern side of the rail line embankment. Top: digital surface model from UAV survey, bottom: UAV orthophoto.

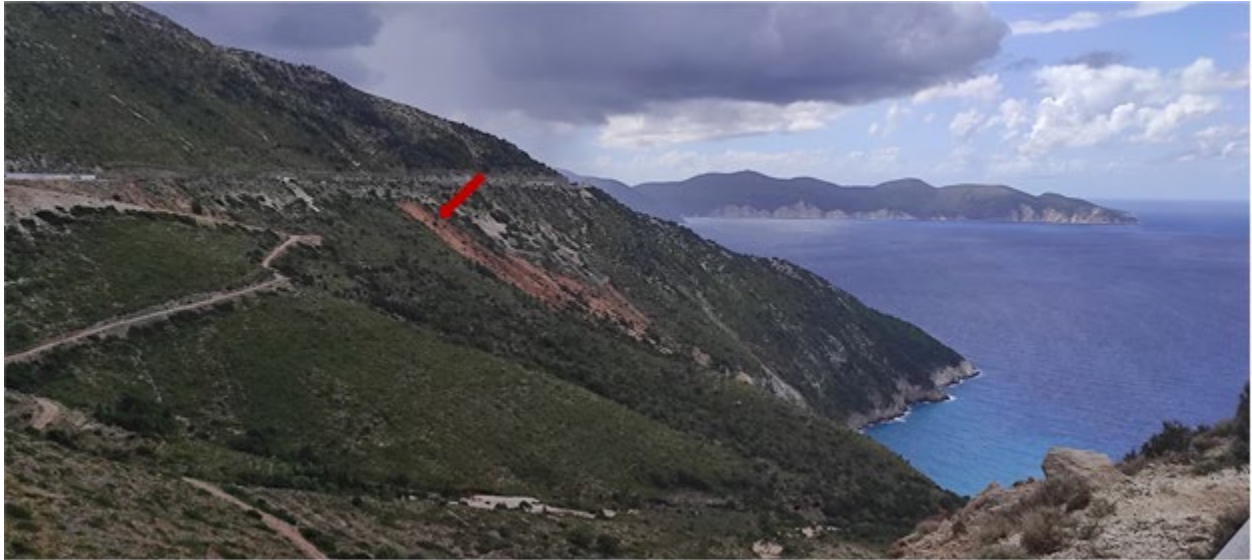
A landslide was identified along the steep western slopes of Cephalonia, near the village of Assos (Figure 6.1) and engaged the soils and weathered limestone/dolomite formations. Due to the steep topography the slipped material traveled a long distance. A few rotational landslides were identified along the road leading to Myrtos beach, through the village of Divarata (Figure 6.2). Access to Myrtos beach was impossible due to landslides and debris covering the roadway. Thus, mapping using UAVs revealed several landslips and related features (ex. debris). Figure 6.3 illustrates a comparison between a pre-event (May 24 2016), UAV-enabled, 3D textured mesh of Myrtos beach and its post-event counterpart. A 3D model of the area is visualized here: <https://skfb.ly/6WyR6>.

Figure 6.1. Landslide on limestone/dolomite weathered bedrock (38.354888°N, 20.5537649722°E)

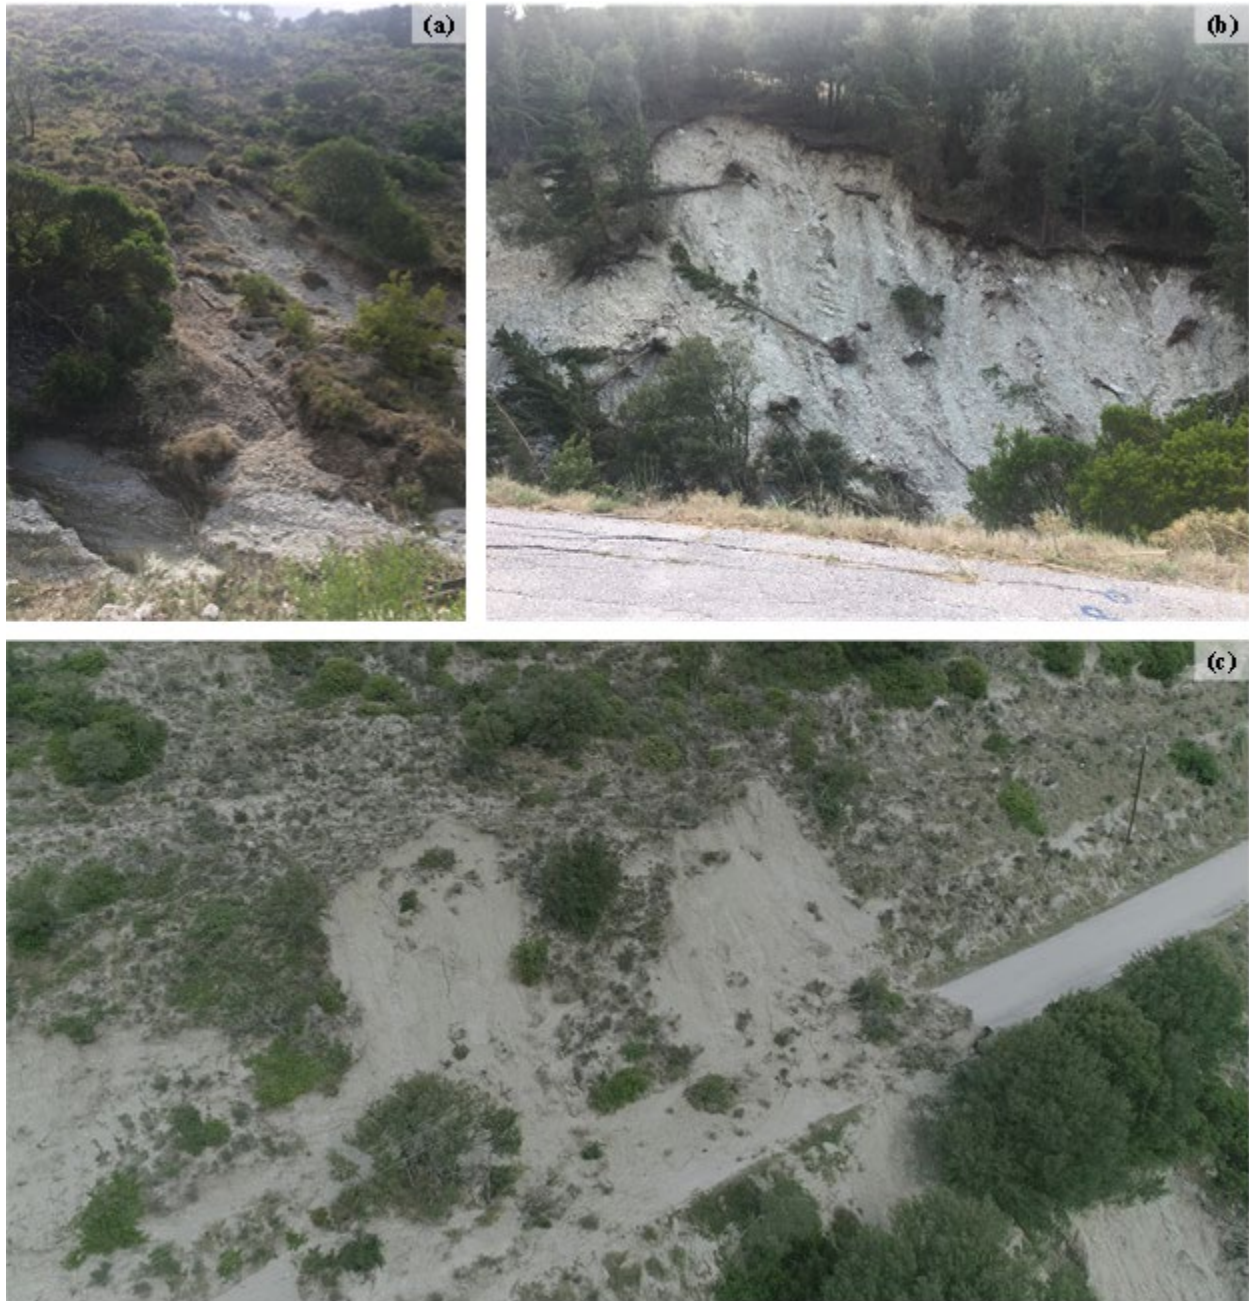
Figure 6.2. Rotational slides along the road to Myrtos beach through Divarata village: a) 38.33571944°N, 20.543633°E; b) 38.3365027°N, 20.5427166°E, c) 38.337106°N, 20.541785°E

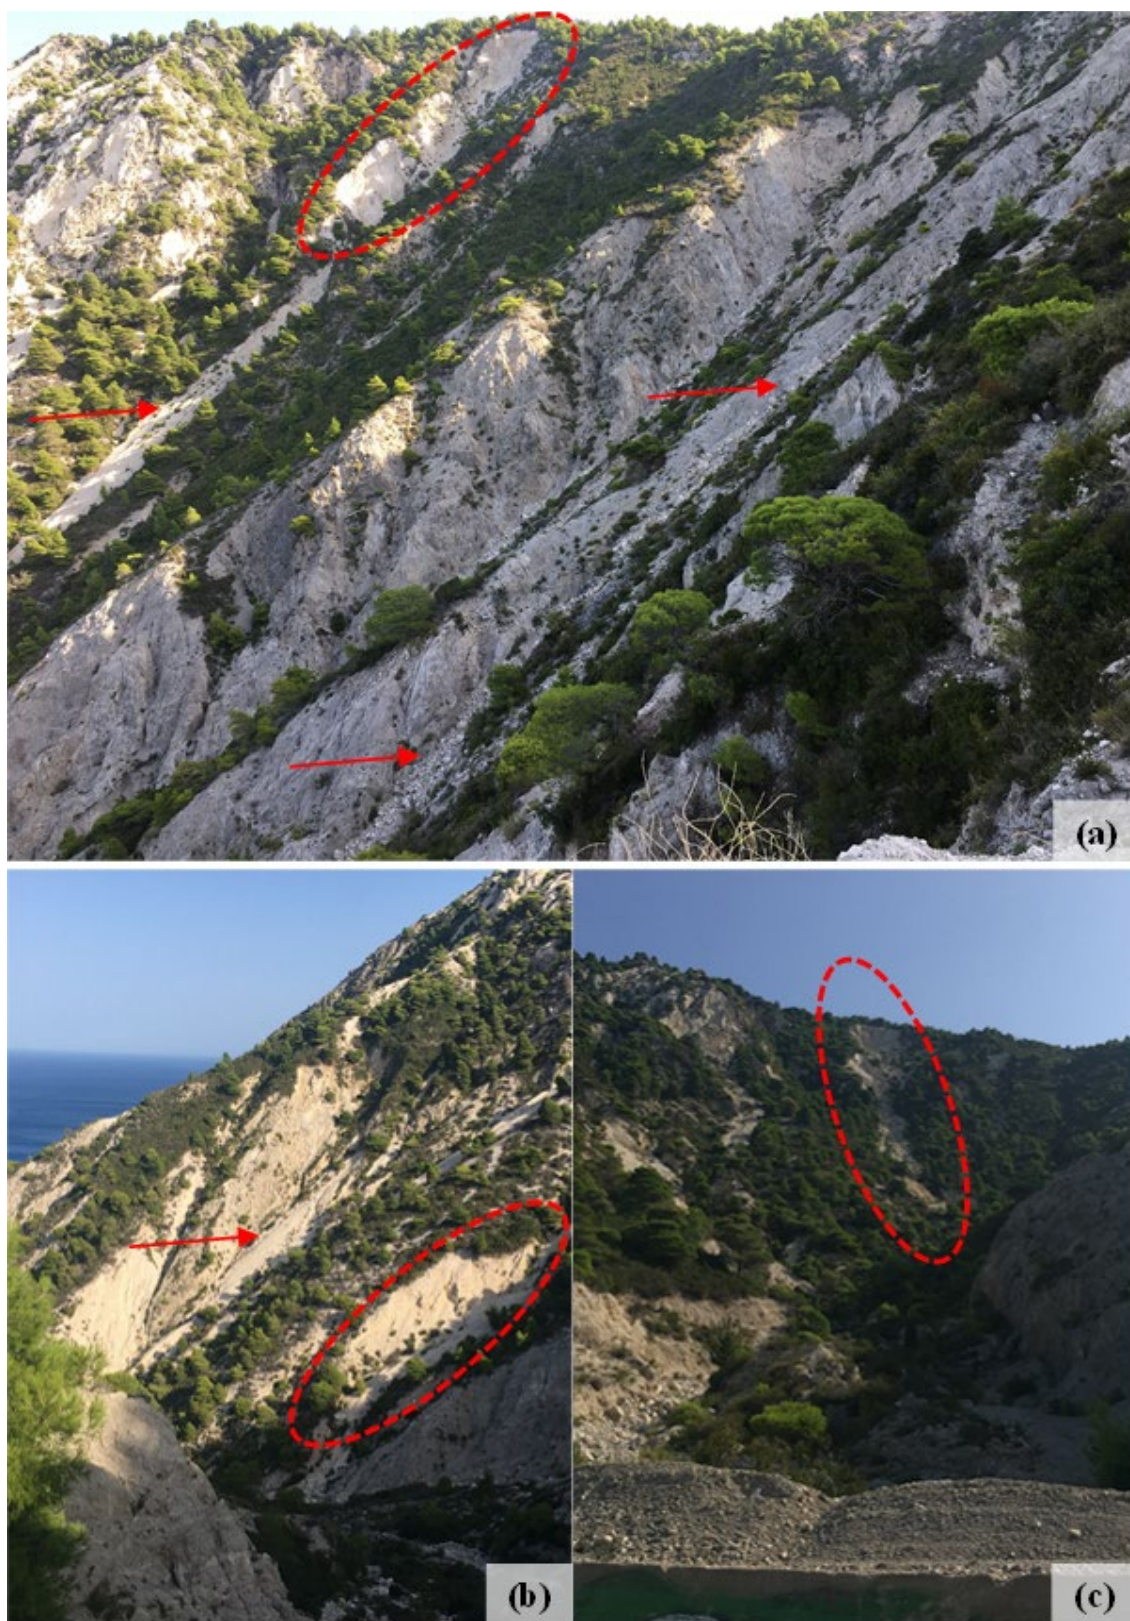
In Lefkada, the unfavorable wind conditions did not allow for UAV deployment for mapping purposes and thus imagery was collected primarily from the ground. Landslides along the coast were identified in several instances (Figure 6.4) and especially along the western coastline of Lefkada that had most recently experienced numerous landslides during the 2015 earthquake. These areas were affected by the precipitation with fresh sediment and debris found on the roads and at the beach (Figure 6.5). Previous mapping in the area last year had shown that the landslides remained active and thus, mapping the coastline to quantify that activity is valuable.

Figure 6.4. Evidence of mass movement along the steep western coastline of Lefkada island: a,b) 38.672194°N, 20.5629639°E, c) 38.67467°N, 20.55967°E
