The September 18-20 2020 Medicane Ianos Impact on Greece

Phase I Reconnaissance Report

Geotechnical Extreme Events Reconnaissance Association

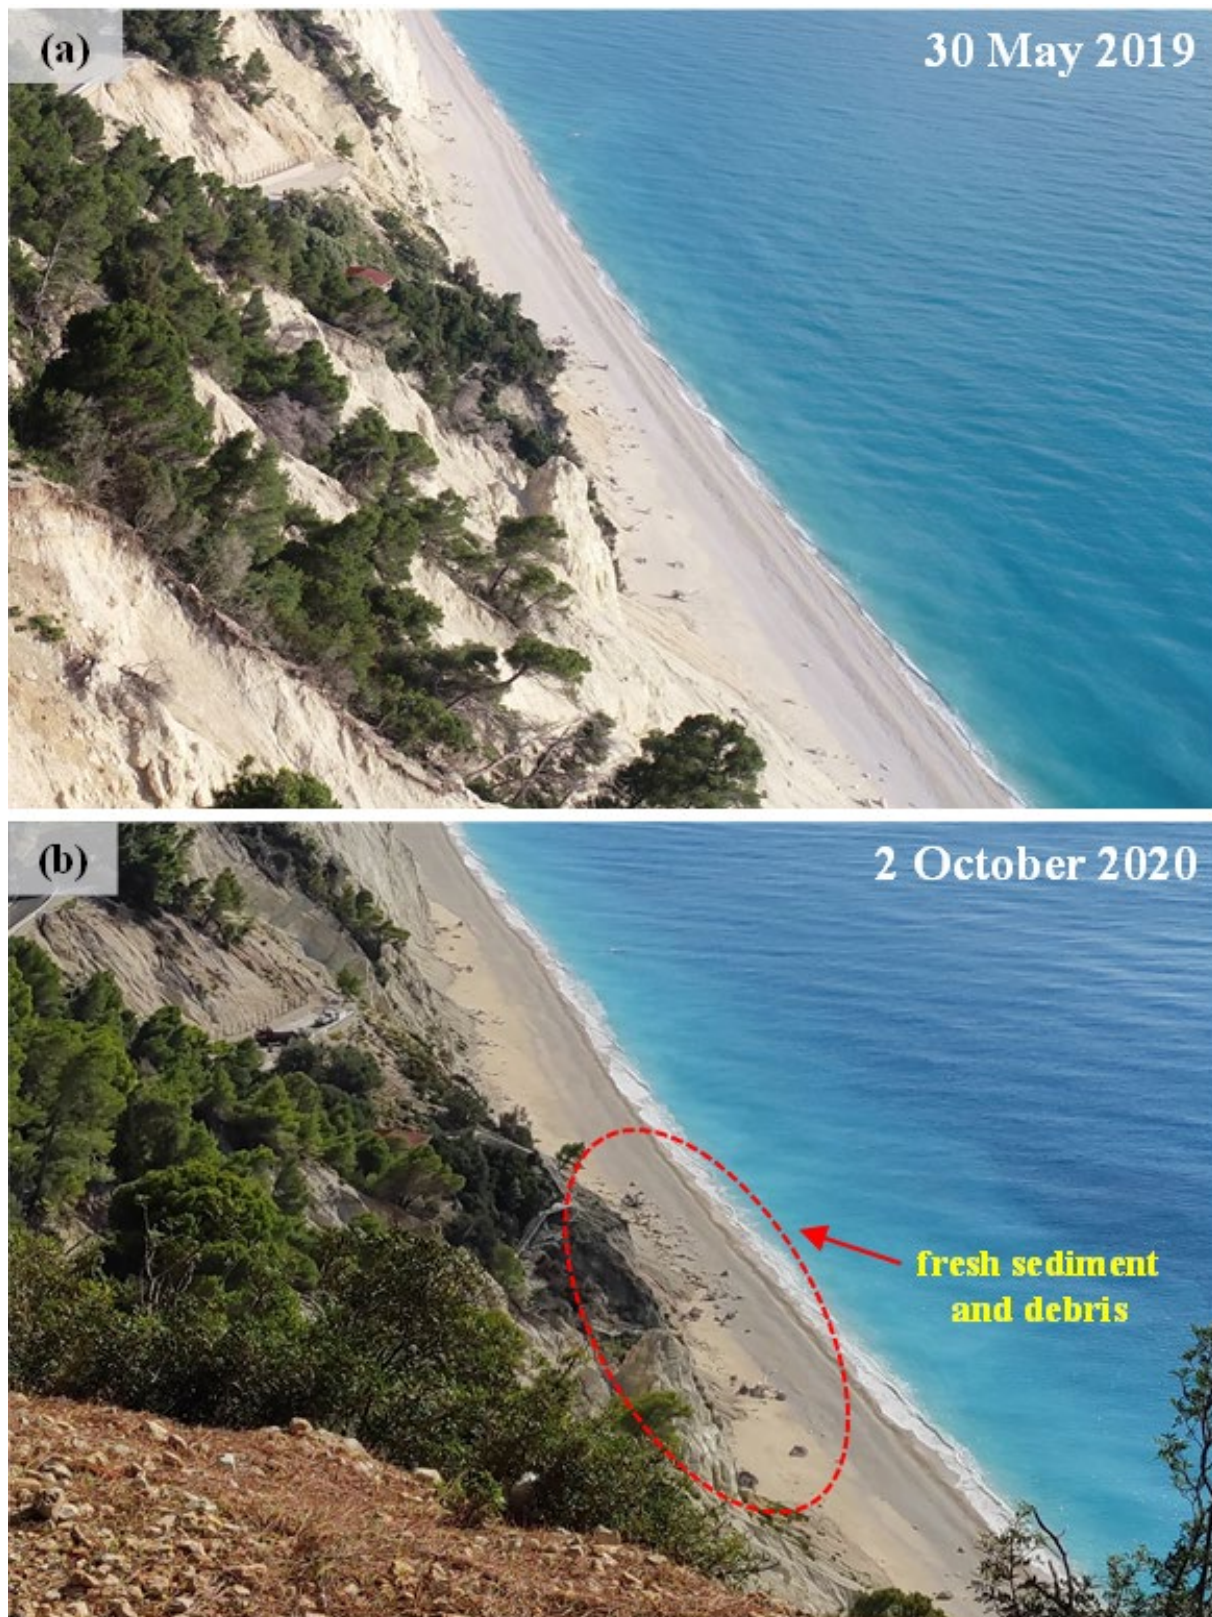
Figure 6.5. Evidence of fresh rockslide sediment and debris along the steep western coastline of Lefkada island ($38.637676^{\circ}\text{N}$, $20.558488^{\circ}\text{E}$): a) pre-event photo, b) post-event photo.

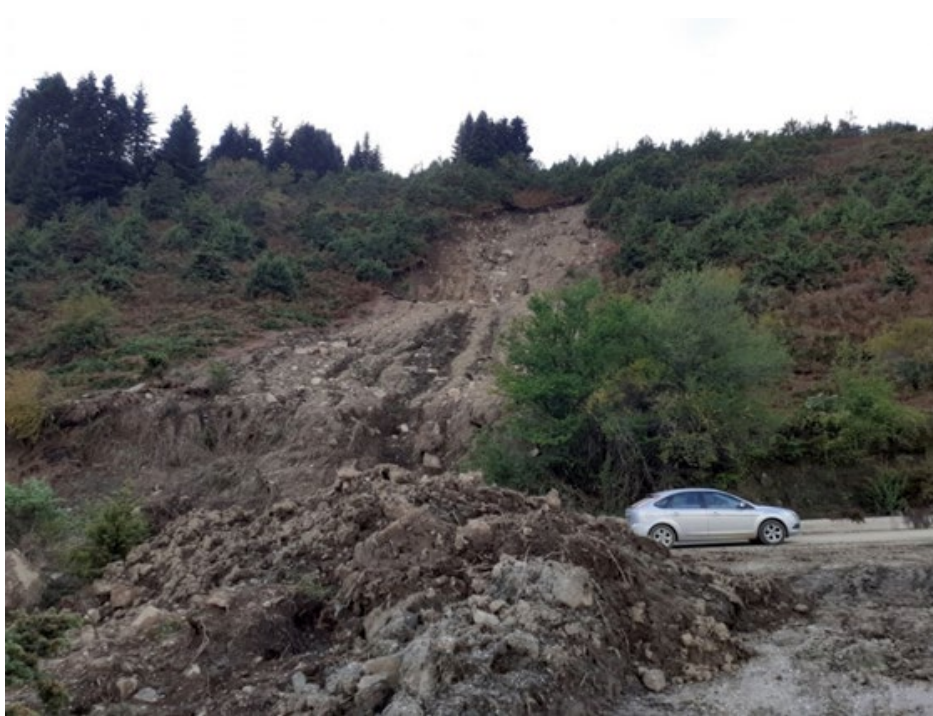
Figures 6.6 to 6.20 are characteristic examples of rotational slumps mainly formed in shale flysch, in conglomerates (flysch) and in weathered flysch. More specifically, the slope failure which occurred in location 41 (Figure 4.22) was formed in the weathered mantle of sandstone flysch (Figure 6.6). The complex sliding mechanism includes a rotational failure followed by an earth flow that has impacted the roadway. The slump is considered deep-seated with an estimated height and length of 30 and 50 m, respectively. Another example is the complex slope failure in location 50 (Figure 6.7) which consisted of one of the most extensive landslides that was detected during this expedition. Its height and length were calculated at 70 and 150 m, respectively. The landslide is relatively shallow (7-10 m deep) and is formed in two parts: 1) a rotational landslide at the upper part and 2) an earth flow at the lower part. This slope failure occurred in shale flysch. In Figure 6.20, another significant rotational slide in the weathered mantle of sandstone flysch was documented. The landslide resulted in the collapse of the road. The length and depth of the slide were 10 meters.

Figure 6.6. Complex slide (slump – earth flow) in mixed type flysch (39.3118220°N, 21.5960140°E)

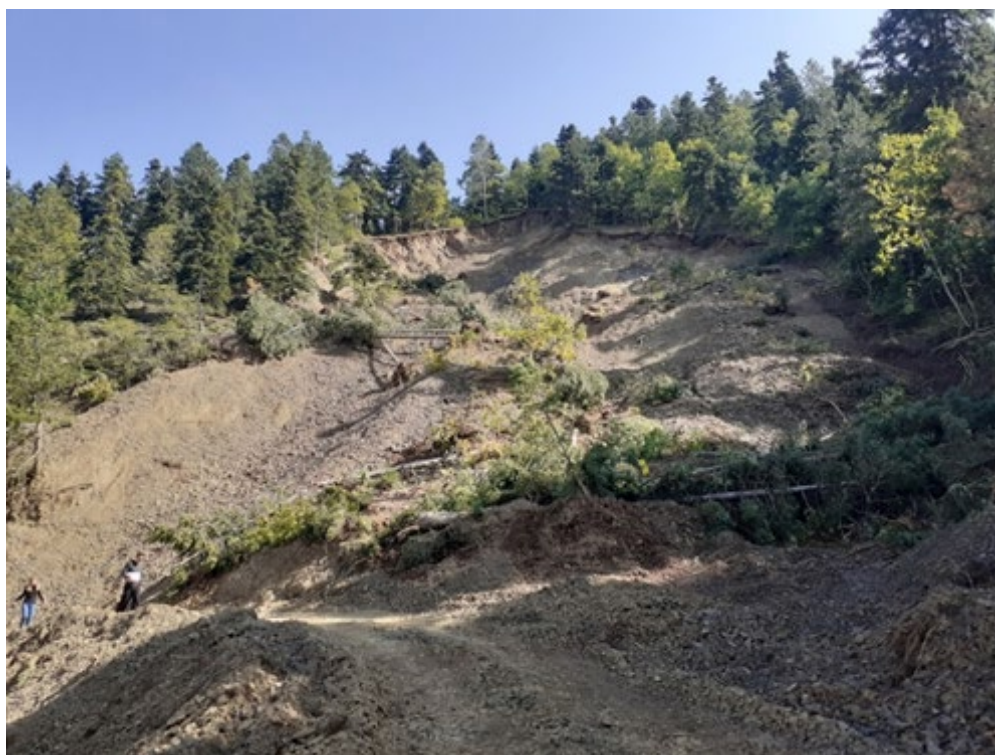
Figure 6.7. Complex slide (rotational and earth slide) in shale dominant flysch. The slipped material has completely covered the road (39.2116910°N, 21.7942940°E)

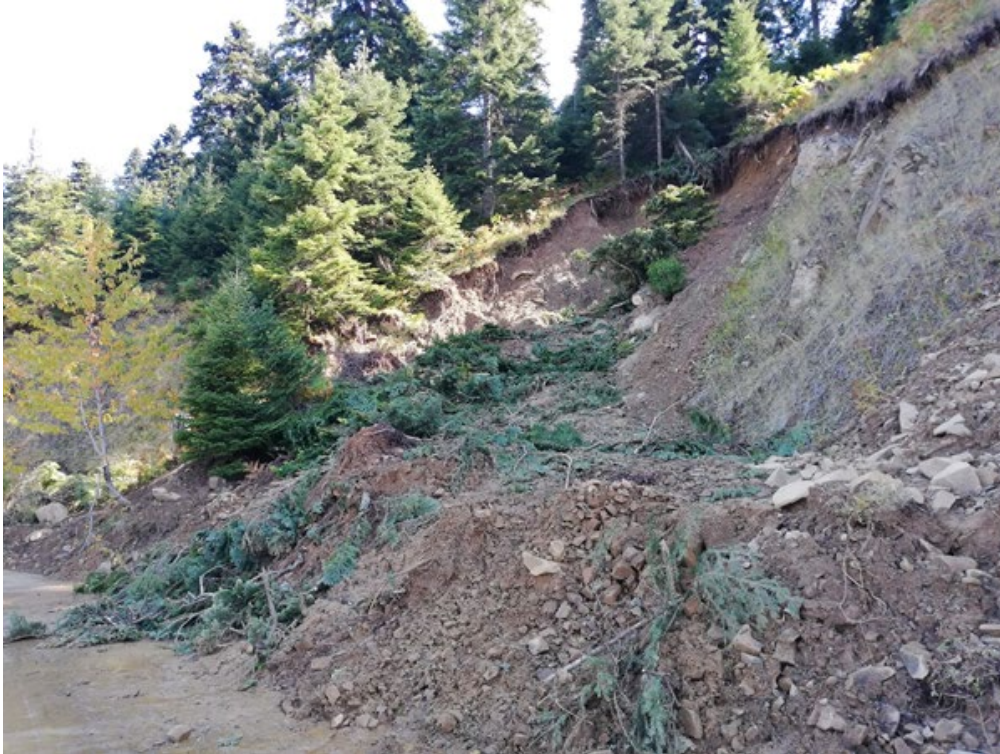
Figure 6.8. Complex slide (slump – earth flow) (39.28353°N, 21.68537°E)

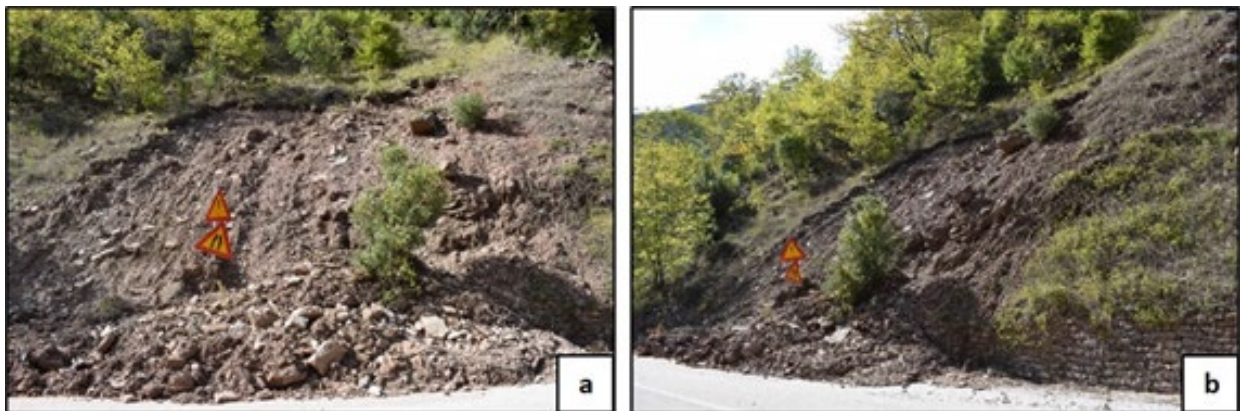
Figure 6.9. Rotational slide along the Argithea to Zervo village road (39.351111°N, 21.521389°)

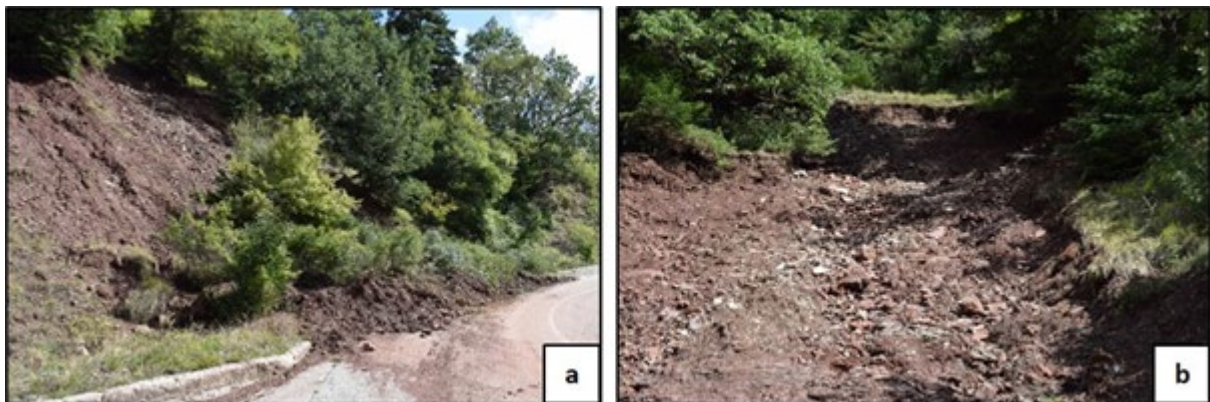
Figure 6.12. Rotational slide in Eastern Argithea area (39.363889°N, 21.538611°E).

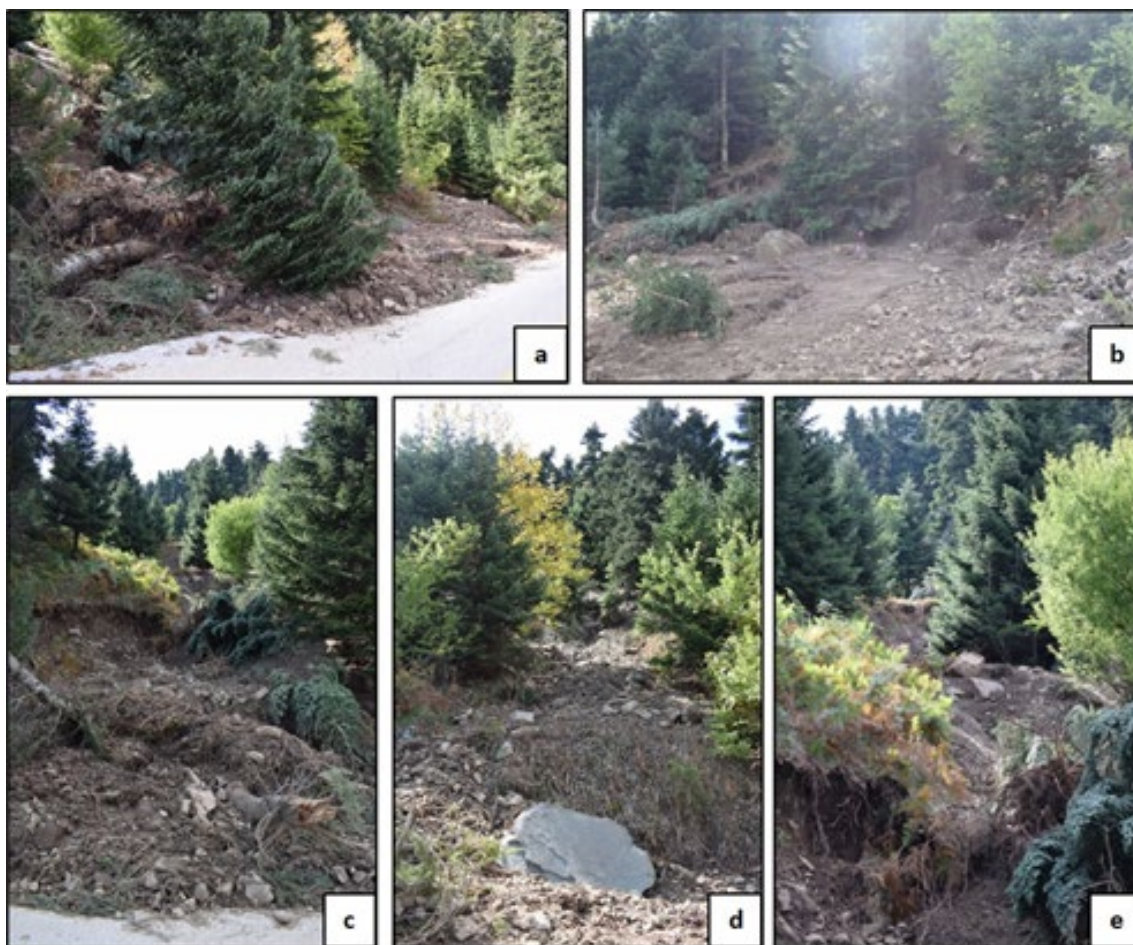
Figure 6.13. Rotational slide on the road to Oxya village (39.366667°N, 21.592222°E)

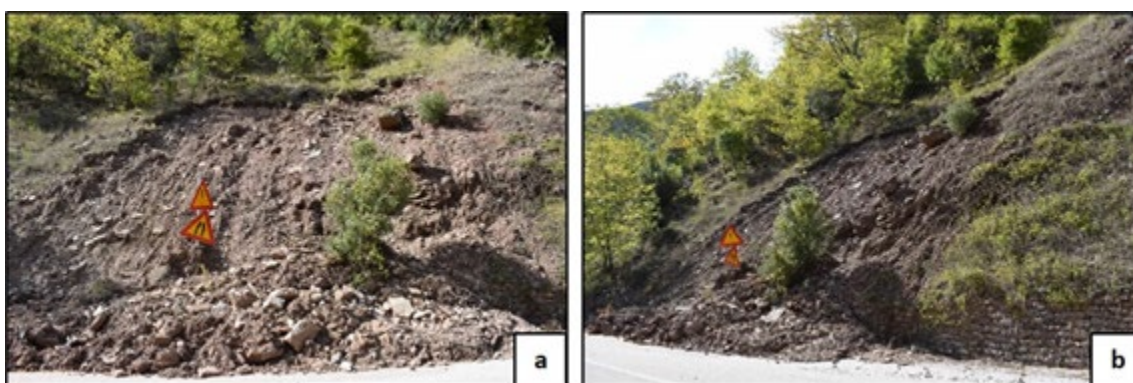
Figure 6.14. Rotational slide at Argitheia to Zervo road (39.351111°N, 21.521389°E).

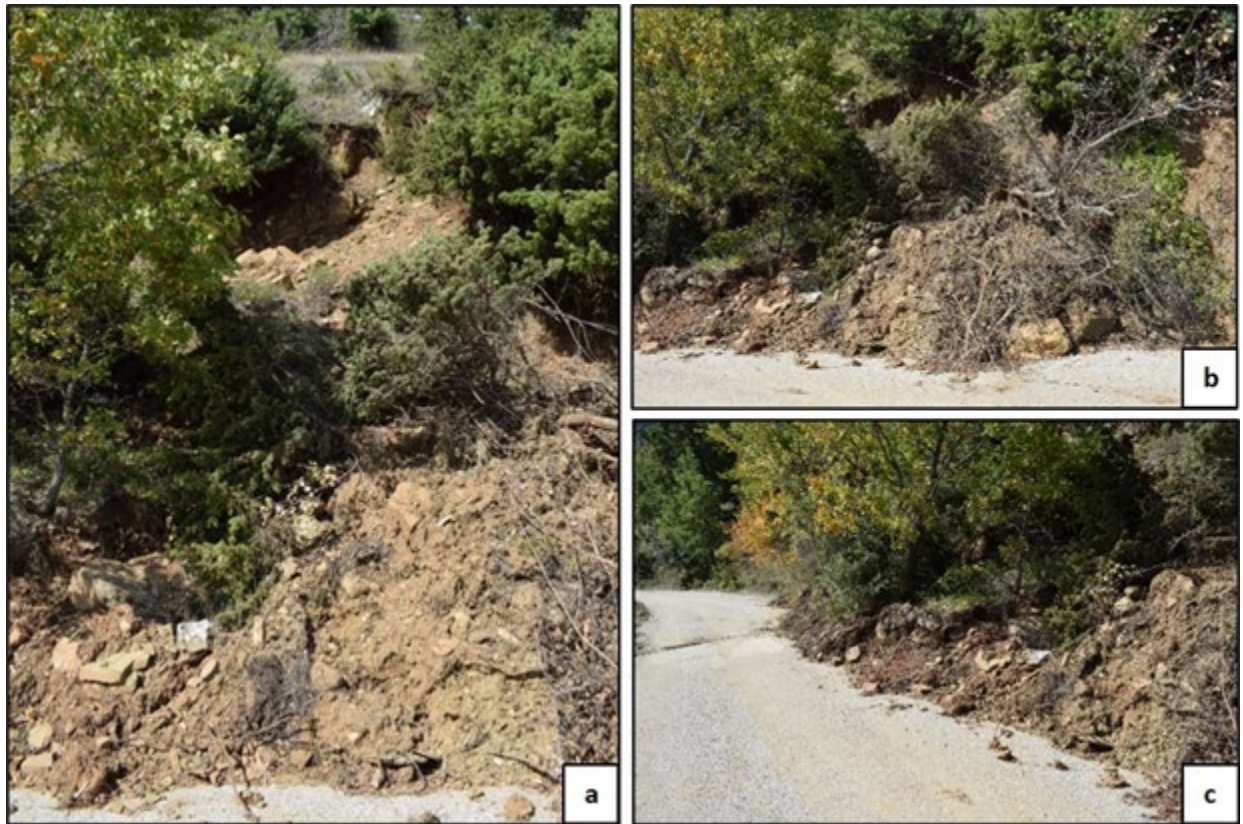
Figure 6.15. Rotational slide on the road to Oxya village (39.36°N, 21.591944°E)

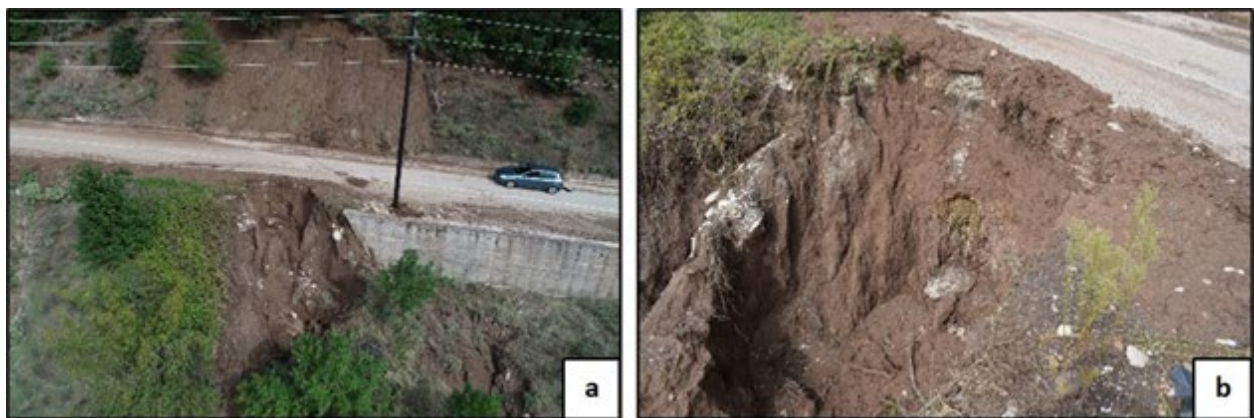
Figure 6.16. Rotational slide towards Porti village (39.425833°N, 21.665556°E)

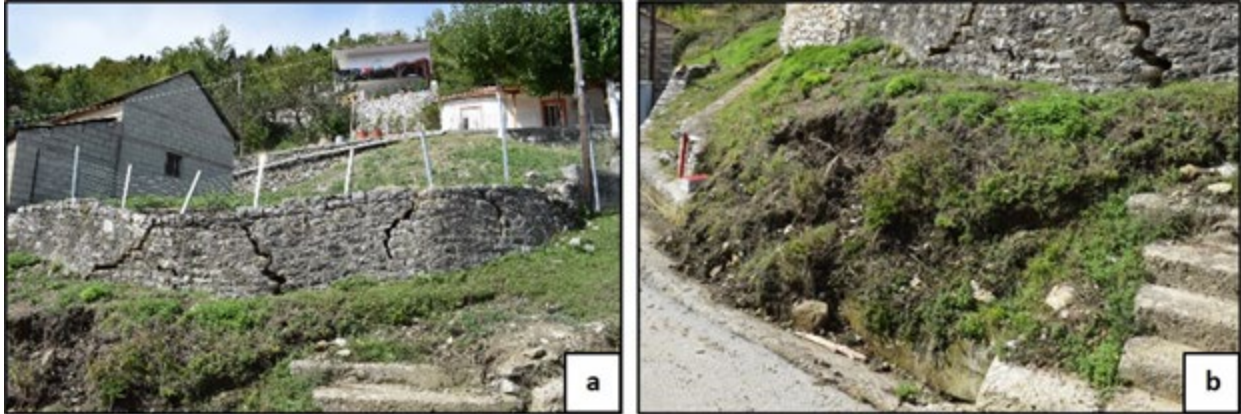
Figure 6.17. Rotational slide on the road to Oxya village that damaged a retaining wall (39.358889°N, 21.596111°E)

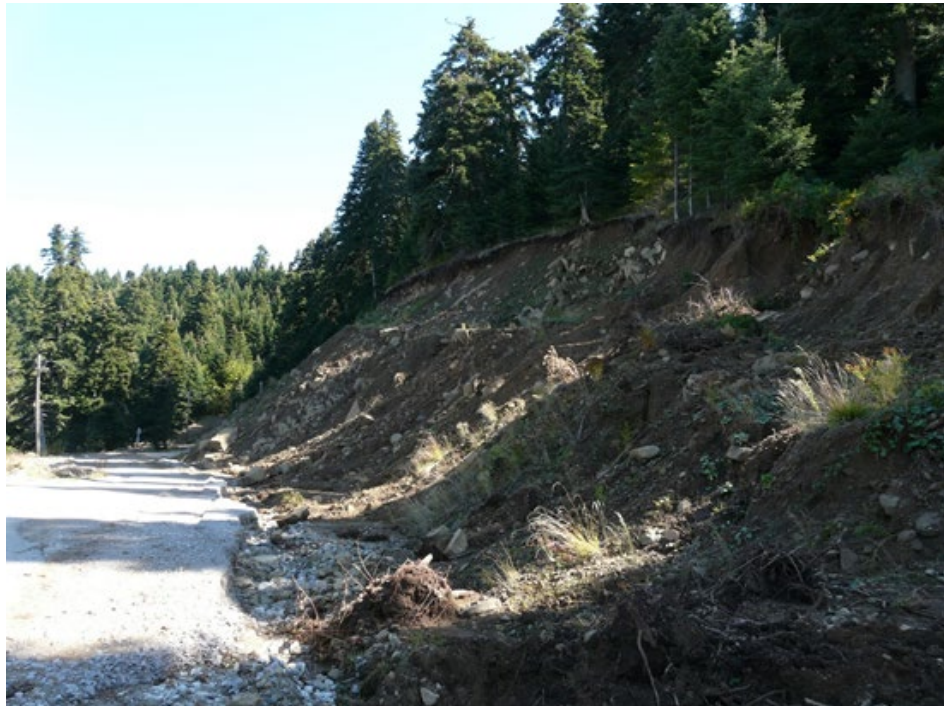
Figure 6.19. Rotational slide inducing damage on the road network (39.28596°N, 21.69099° E)

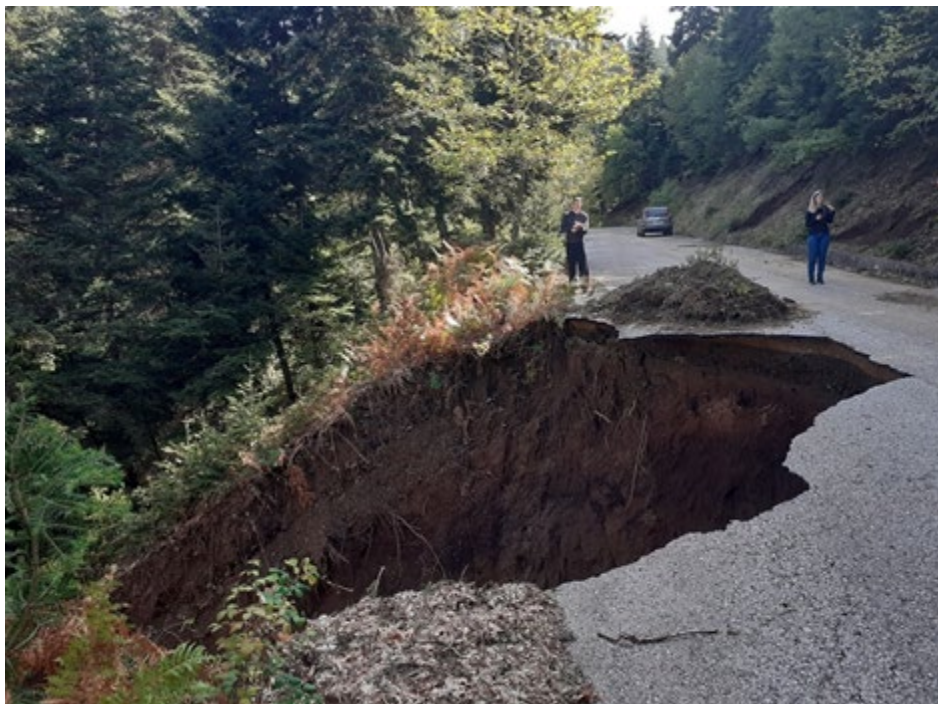
Figure 6.20. Rotational slide in weathered mantle that caused damage to road (39.2174890°N, 21.7949870°E)

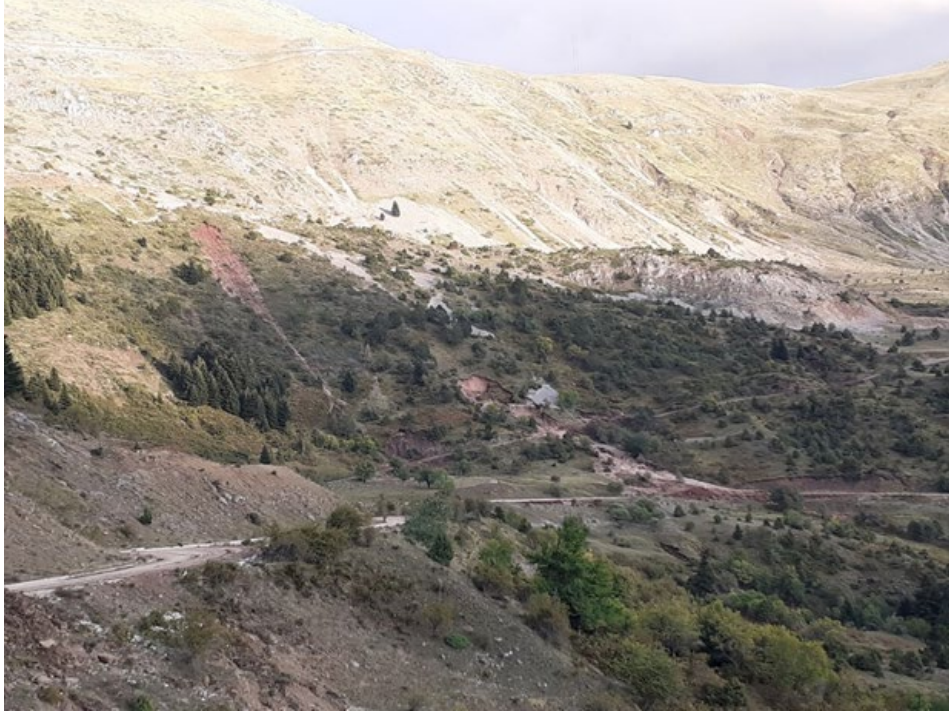
Moreover, landslides involving soil/earth material are formed in the weathered mantle of the flysch or in the shale dominant flysch. Their characteristic is that the slipped earth material has a long travel distance, up to 150 m. They have affected the road network in some places but in relatively narrow zones. Thus, the problems encountered due to earth flows are not very severe. Examples are presented in Figures 6.21 through 6.23. The maximum thickness of the accumulated debris material at the base of the slope was estimated at 3 meters while the width of the deposit area at 25 meters.

Figure 6.21. Earthflow in weathered mantle of shale flysch (39.3115490°N, 21.6142420°E)

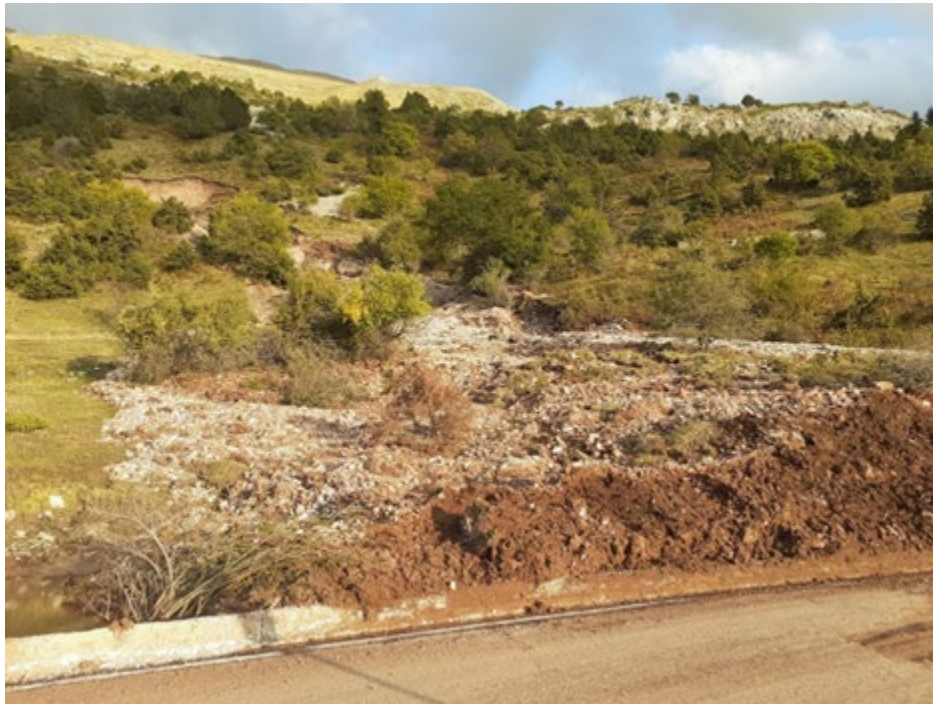
Figure 6.22. Accumulated earth material at the road level (39.3115490°N, 21.6142420°E)

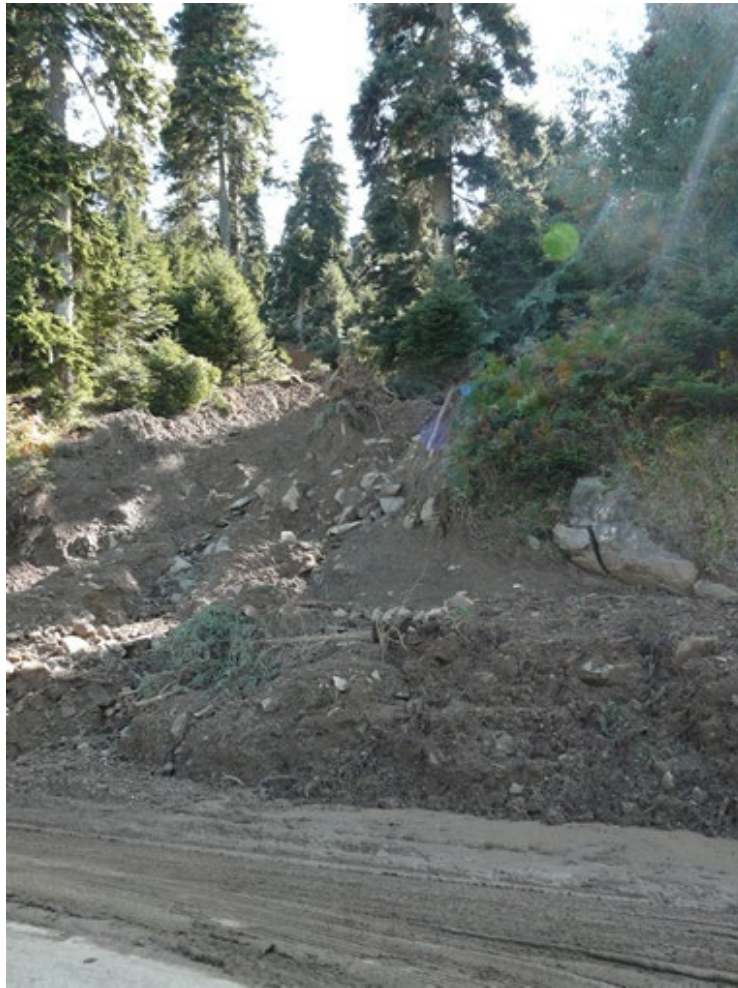
Figure 6.23. Accumulated earth material at the road level (39.28709°N, 21.69355°E)

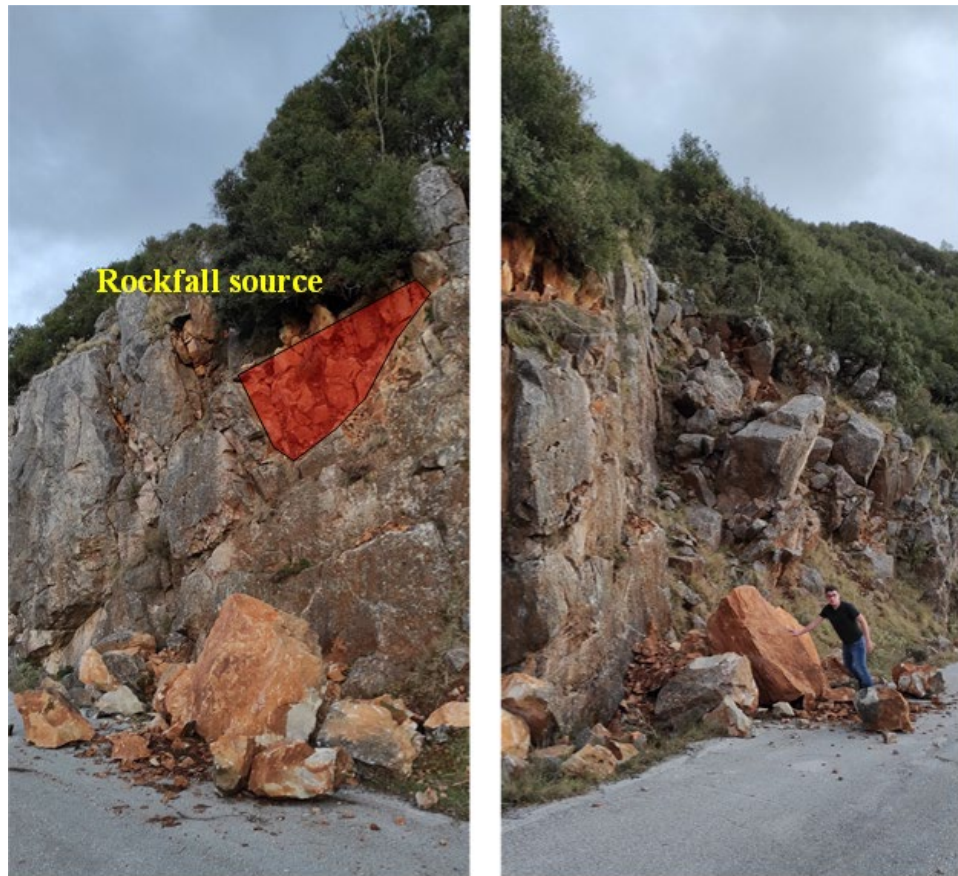
A single rockfall was encountered along the road network, during the reconnaissance deployment to Cephalonia (Figure 6.24). The limestone rock wedge had a size of approximately 2m×1.5m×1.5m. Another rockfall example from Lefkada is shown in Figure 6.25. Moreover, the western coastline of Lefkada that had most recently experienced numerous landslides during the 2015 earthquake was affected by the precipitation with fresh rockslide sediment and debris found on the roads and at the beach (Figure 6.26).

Figure 6.24. Rockfall in Cephalonia island ($38.36995197^{\circ}\text{N}$, $20.5684499722^{\circ}\text{E}$)

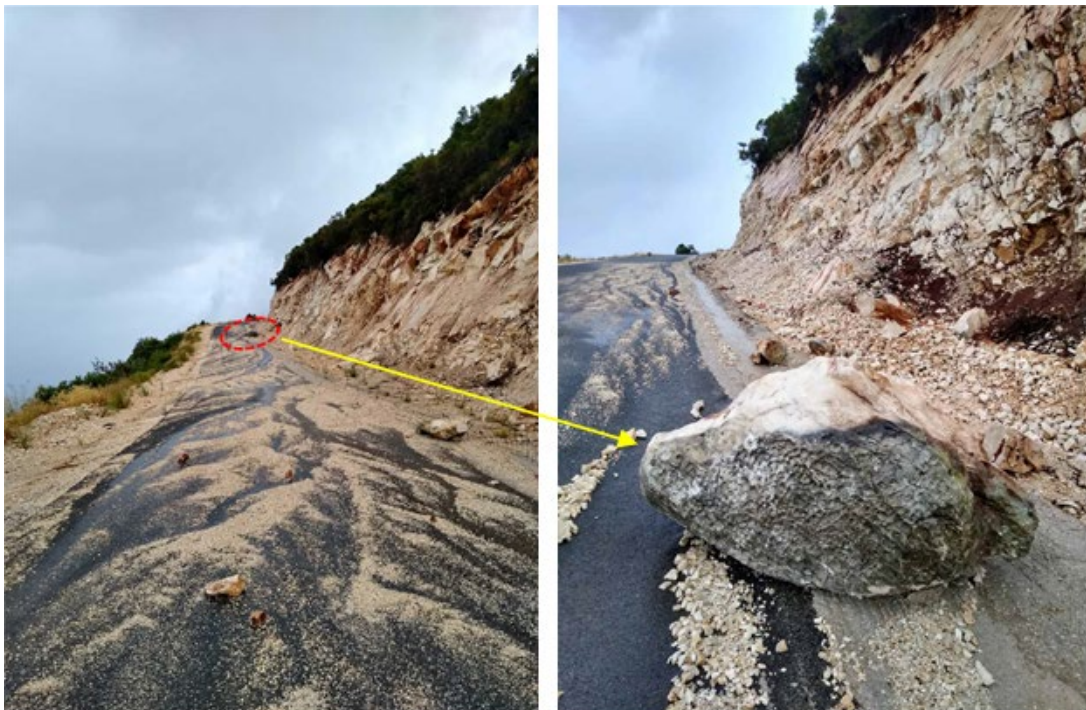
Figure 6.25. Rockfall in Lefkada island ($38.616356^{\circ}\text{N}$, $20.57904167^{\circ}\text{E}$)

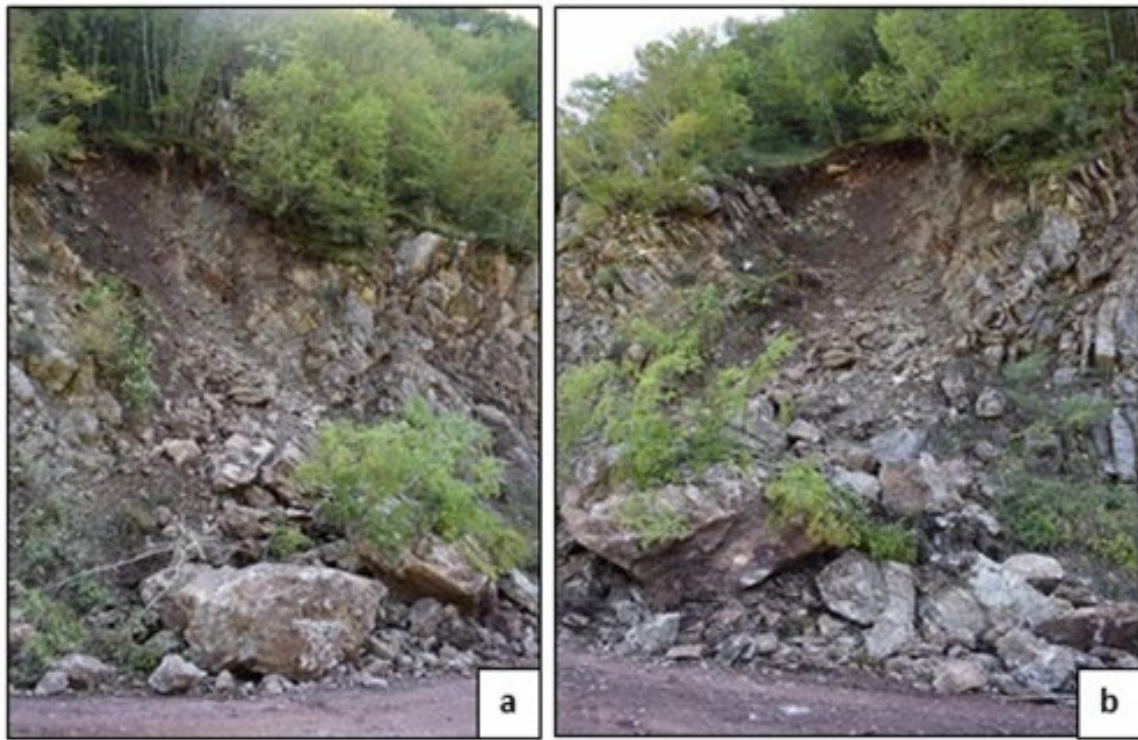
Figure 6.27. Rockslide failure at the area of Karpenisi - Vraggiana

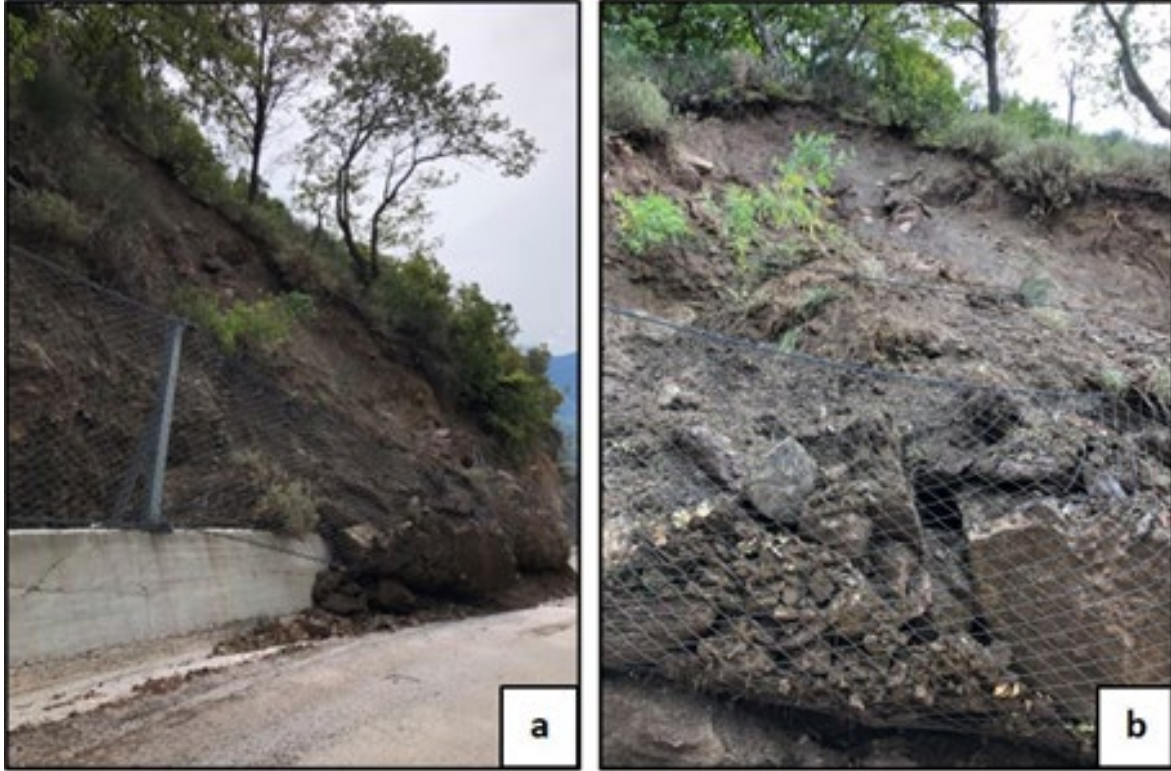
Figure 6.29. Rockslide towards Porti village (39.410556°N, 21.658611°E)

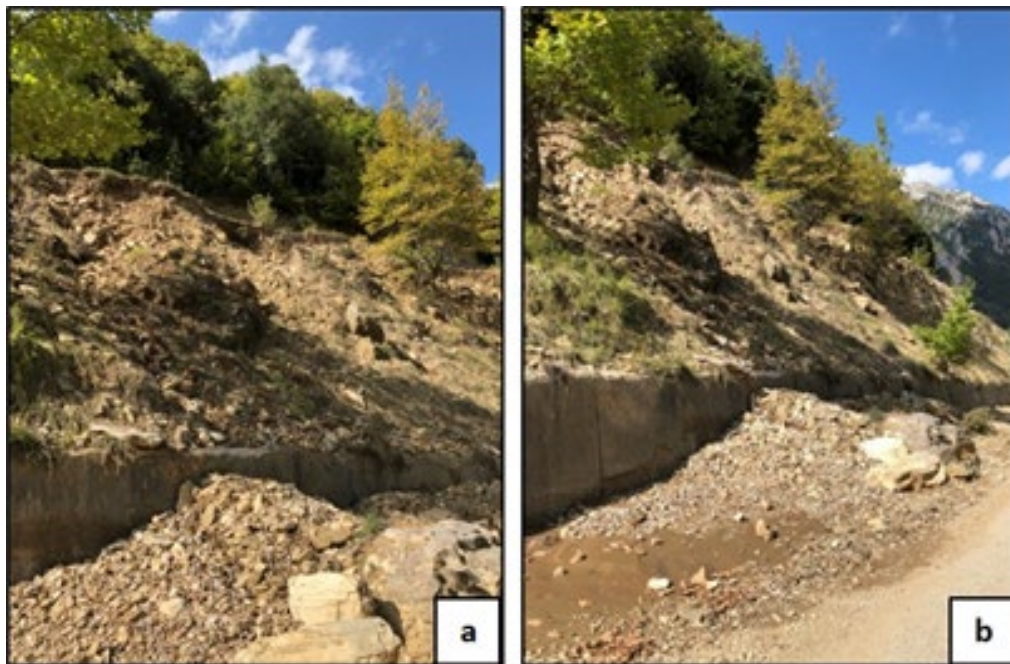
Figure 6.30. Rockslide along the road from Argitheia to Zervo village road (39.3425°N, 21.514167°E)

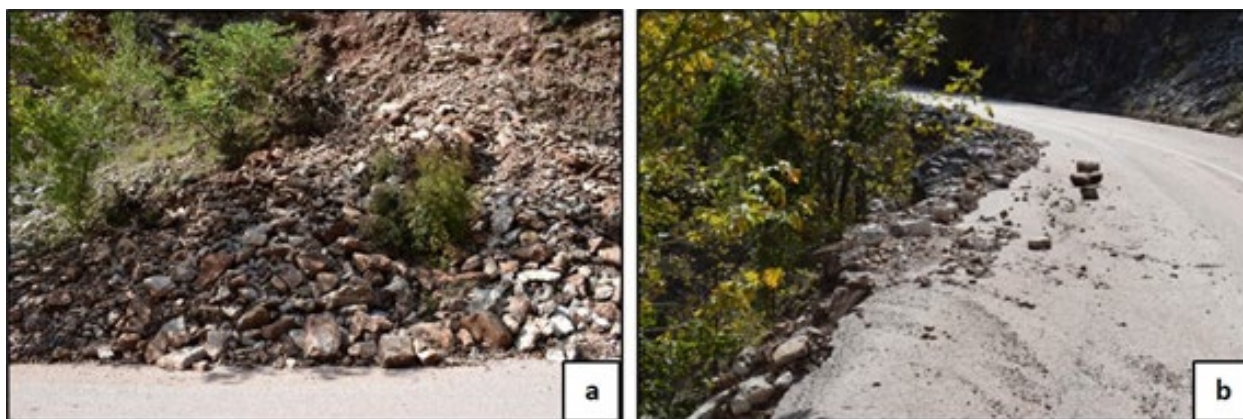
Figure 6.31. Rockslide along the road from Argithea to Zervo village road (39.348333°N, 21.517222°E)

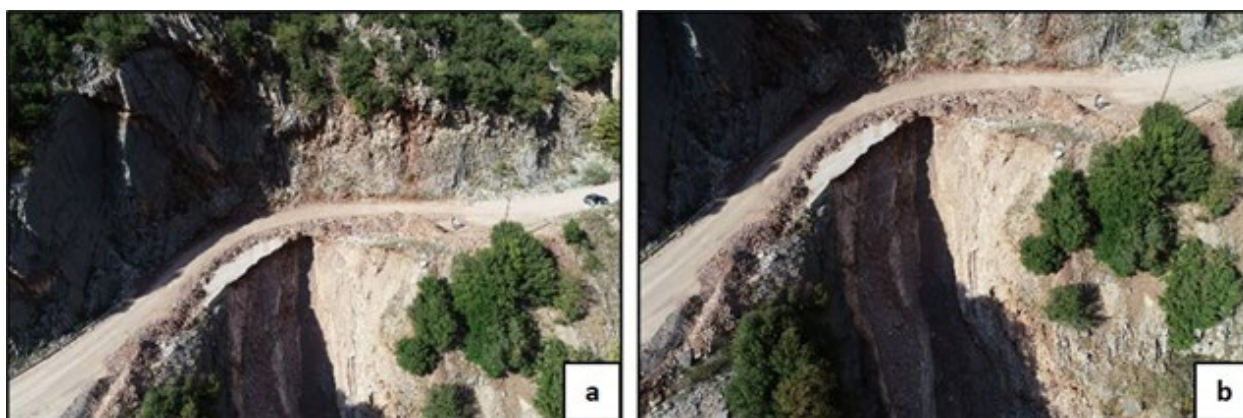
Figure 6.32. Rockslide along the Argithea to Zervo road network (39.354167°N, 21.5175°E).

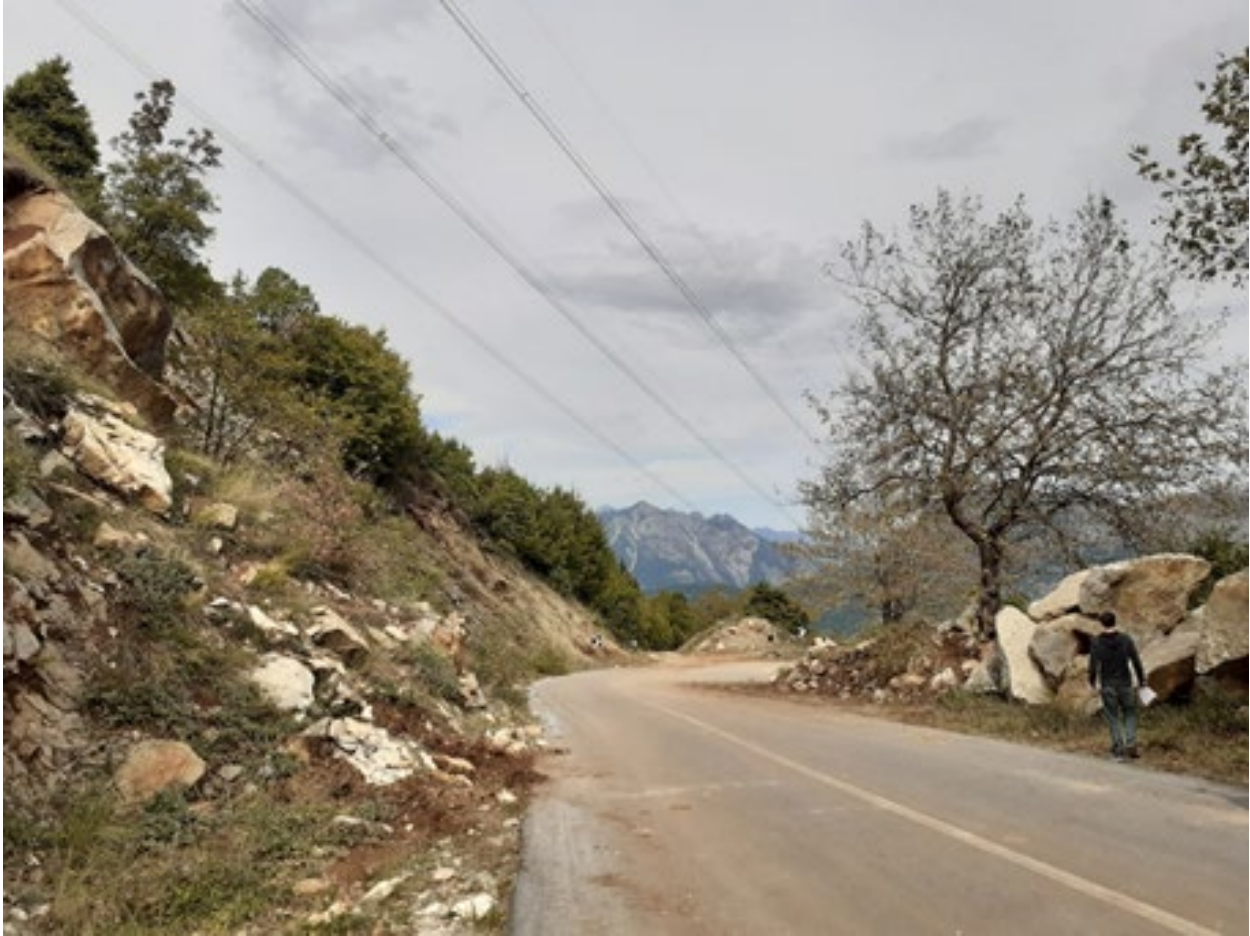
Figure 6.35. Planar sliding and rockfalls in limestone rockmass. Road to Oxia. (39.3895330°N, 21.6145240°E)

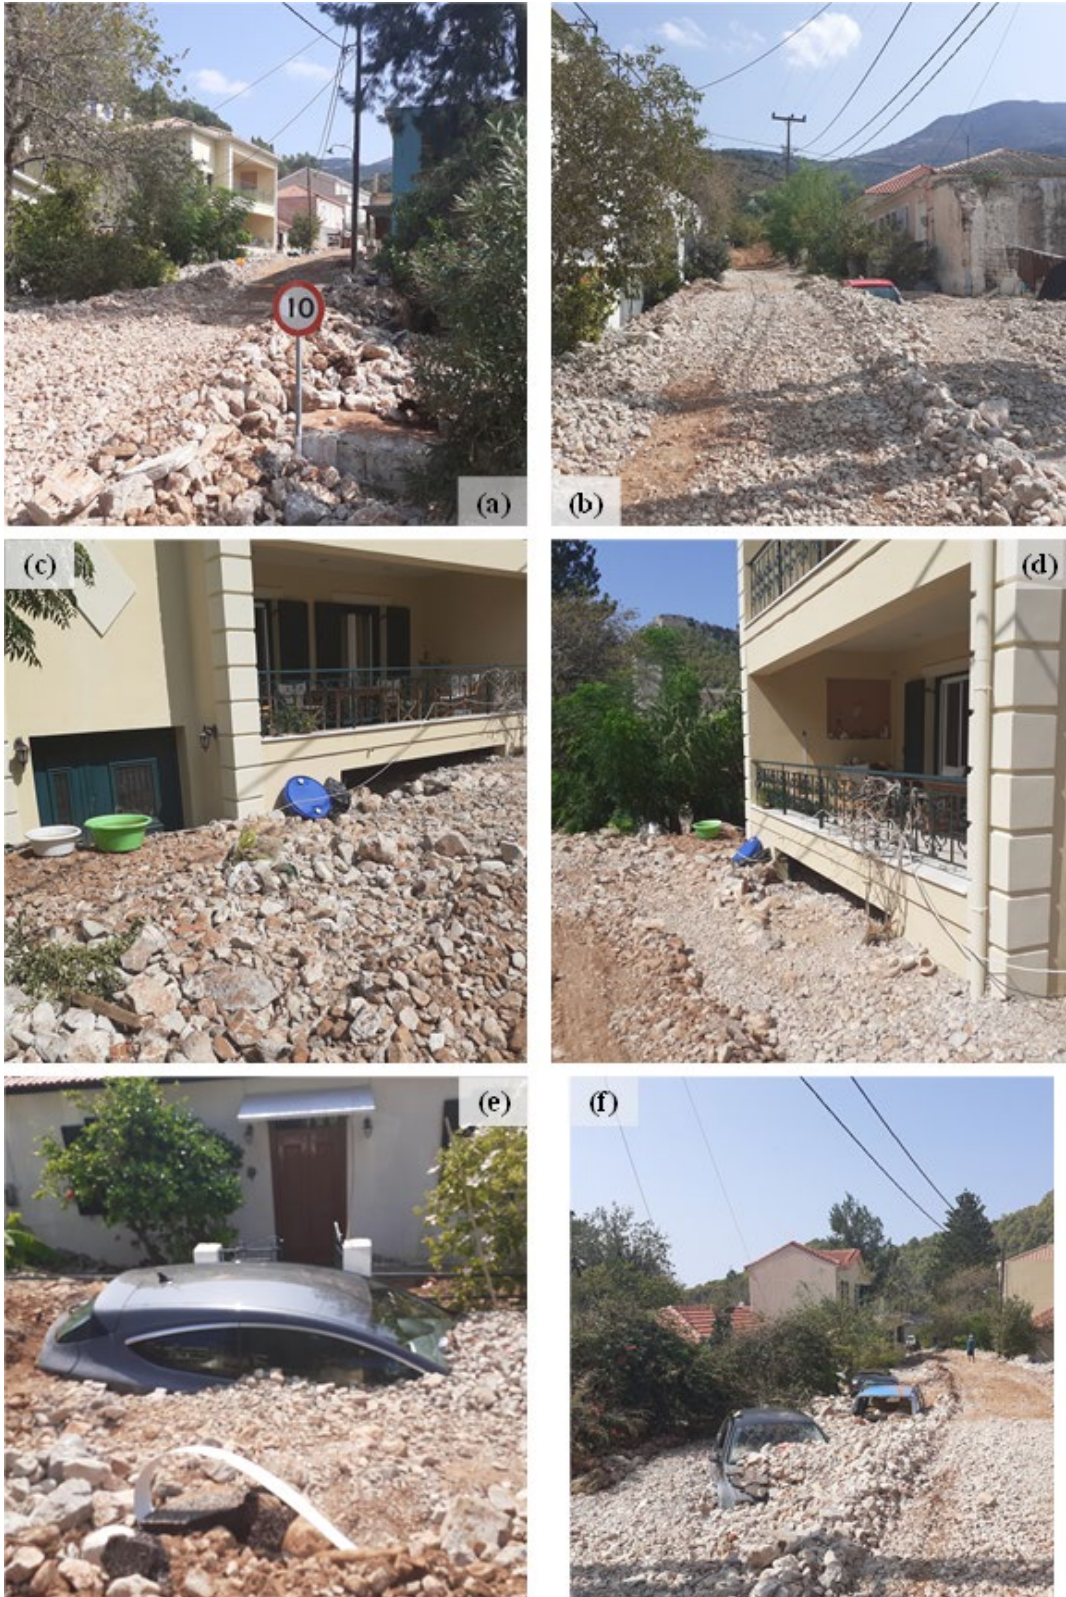
Figure 6.37. Debris flow within the village of Assos ($38.319506^{\circ}\text{N}$, $20.508197^{\circ}\text{E}$), as of 9/22/2020

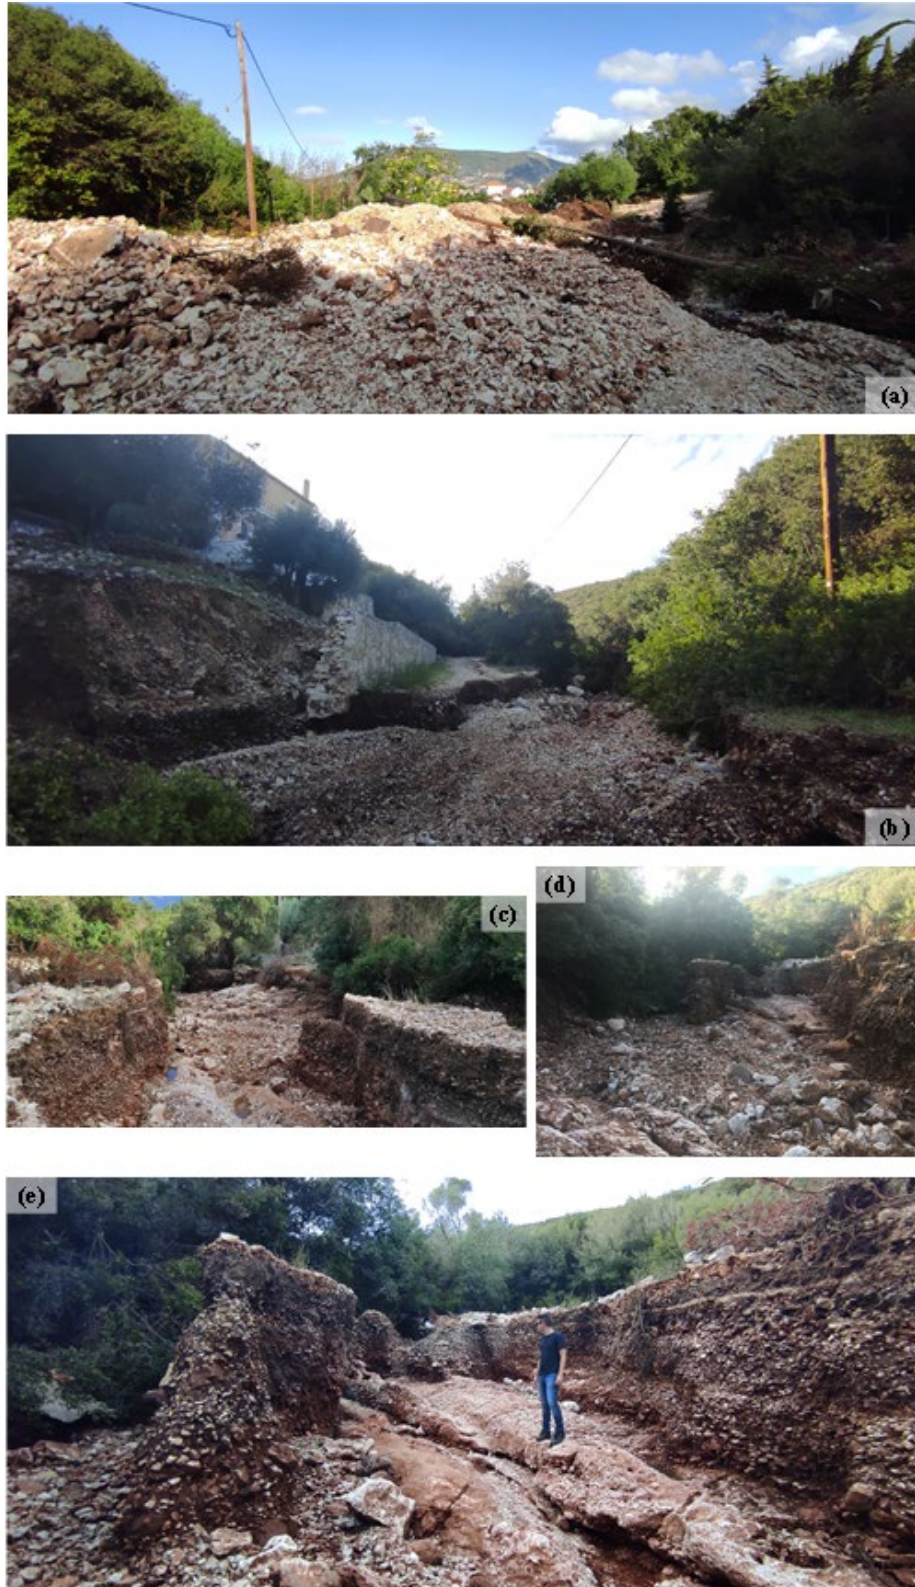
Figure 6.43. Manifestation of debris flow outside of Fiskardo village: a) 38.459158972°N, 20.573128°E; b) 38.459304°N, 20.57232°E; c,d, and e) 38.459501°N, 20.57179499°E
