The September 18-20 2020 Medicane Ianos Impact on Greece

Phase I Reconnaissance Report

Geotechnical Extreme Events Reconnaissance Association

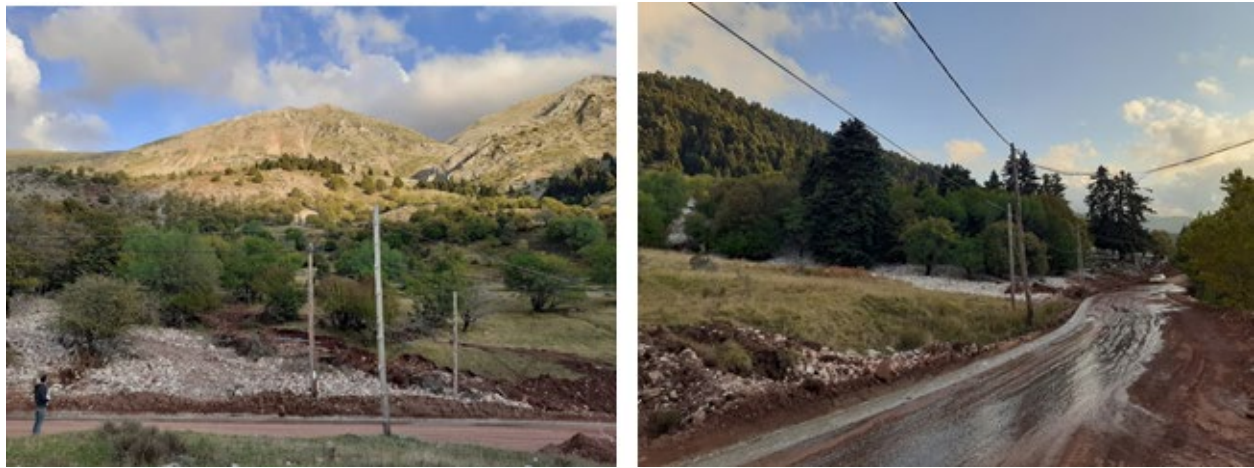
An example from Livadia is shown in Figure 6.49. The thickness of the accumulated debris material at the base of the slope was up to 5 meters while the width of the deposit area was about 300 meters. Additional examples are shown in Figure 6.50 to 6.57.

Figure 6.49. Debris flow at Livadia. (39.3036610°N, 21.6068020°E)

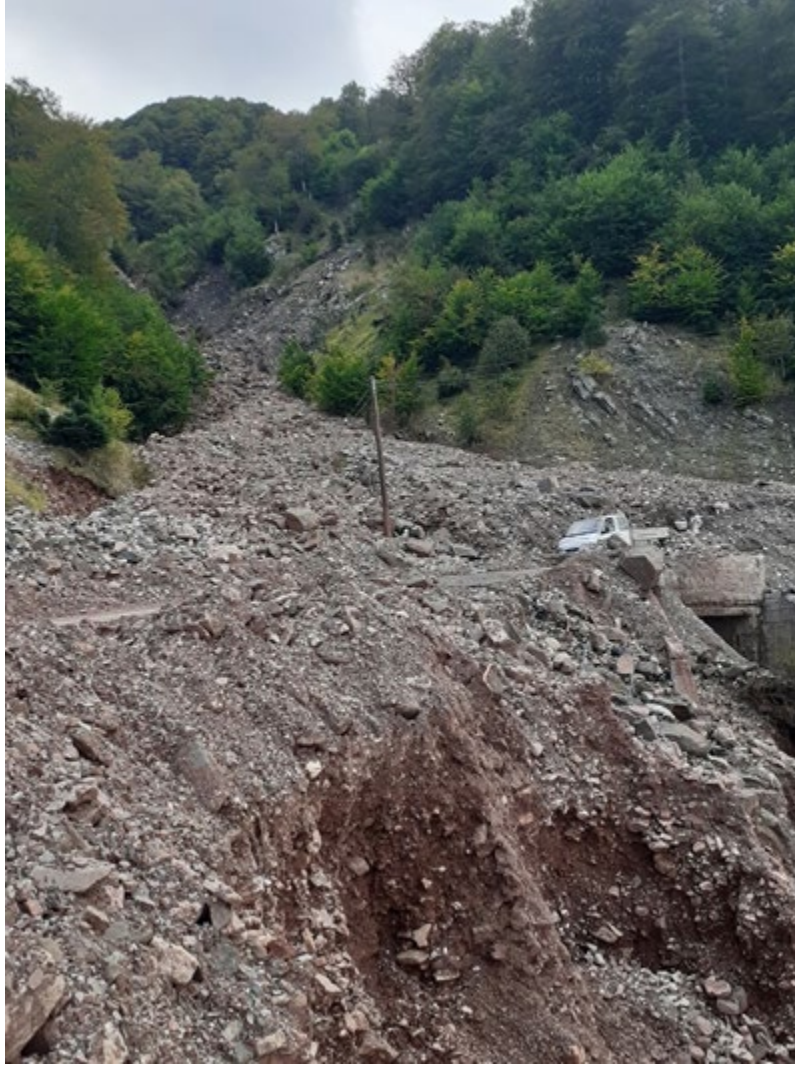
Figure 6.50. Debris flow in gully at Pefkofito area. (39.3296110°N, 21.6094720°E)

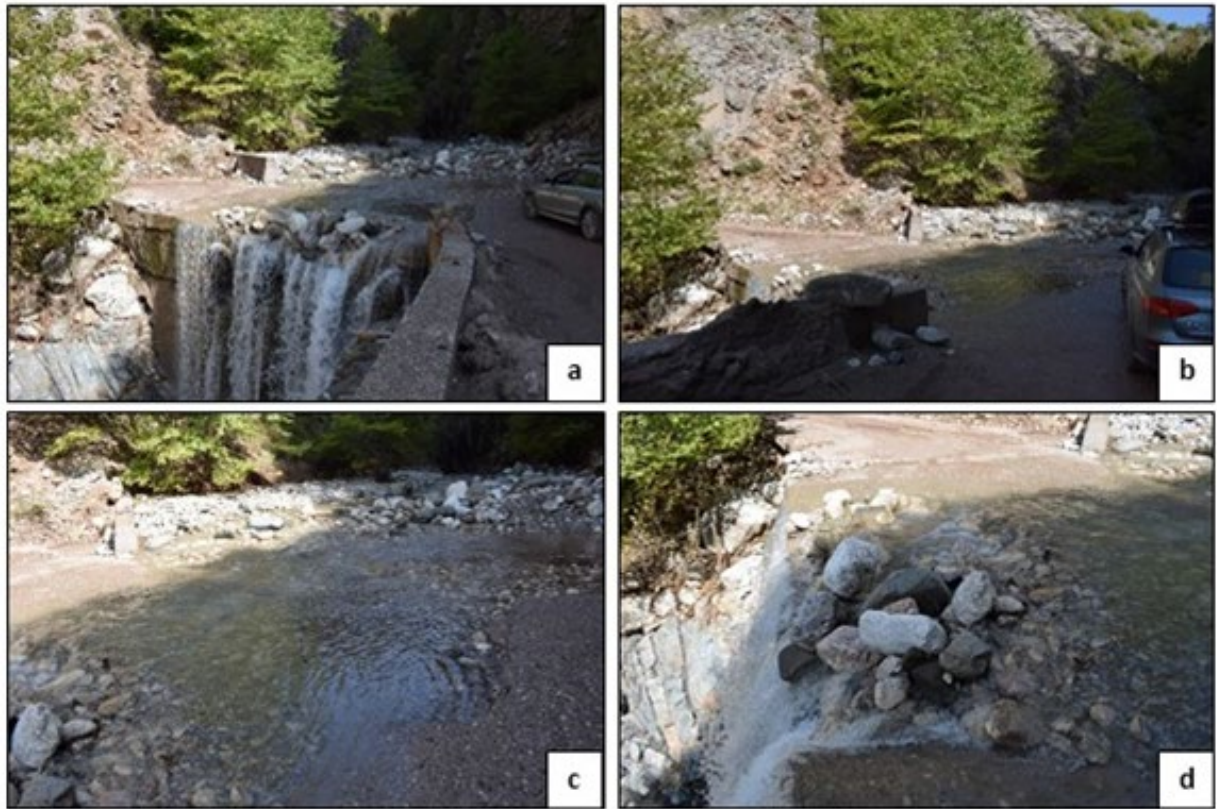
Figure 6.51. Debris flow intercepting a road at the entrance of village Vraggiana

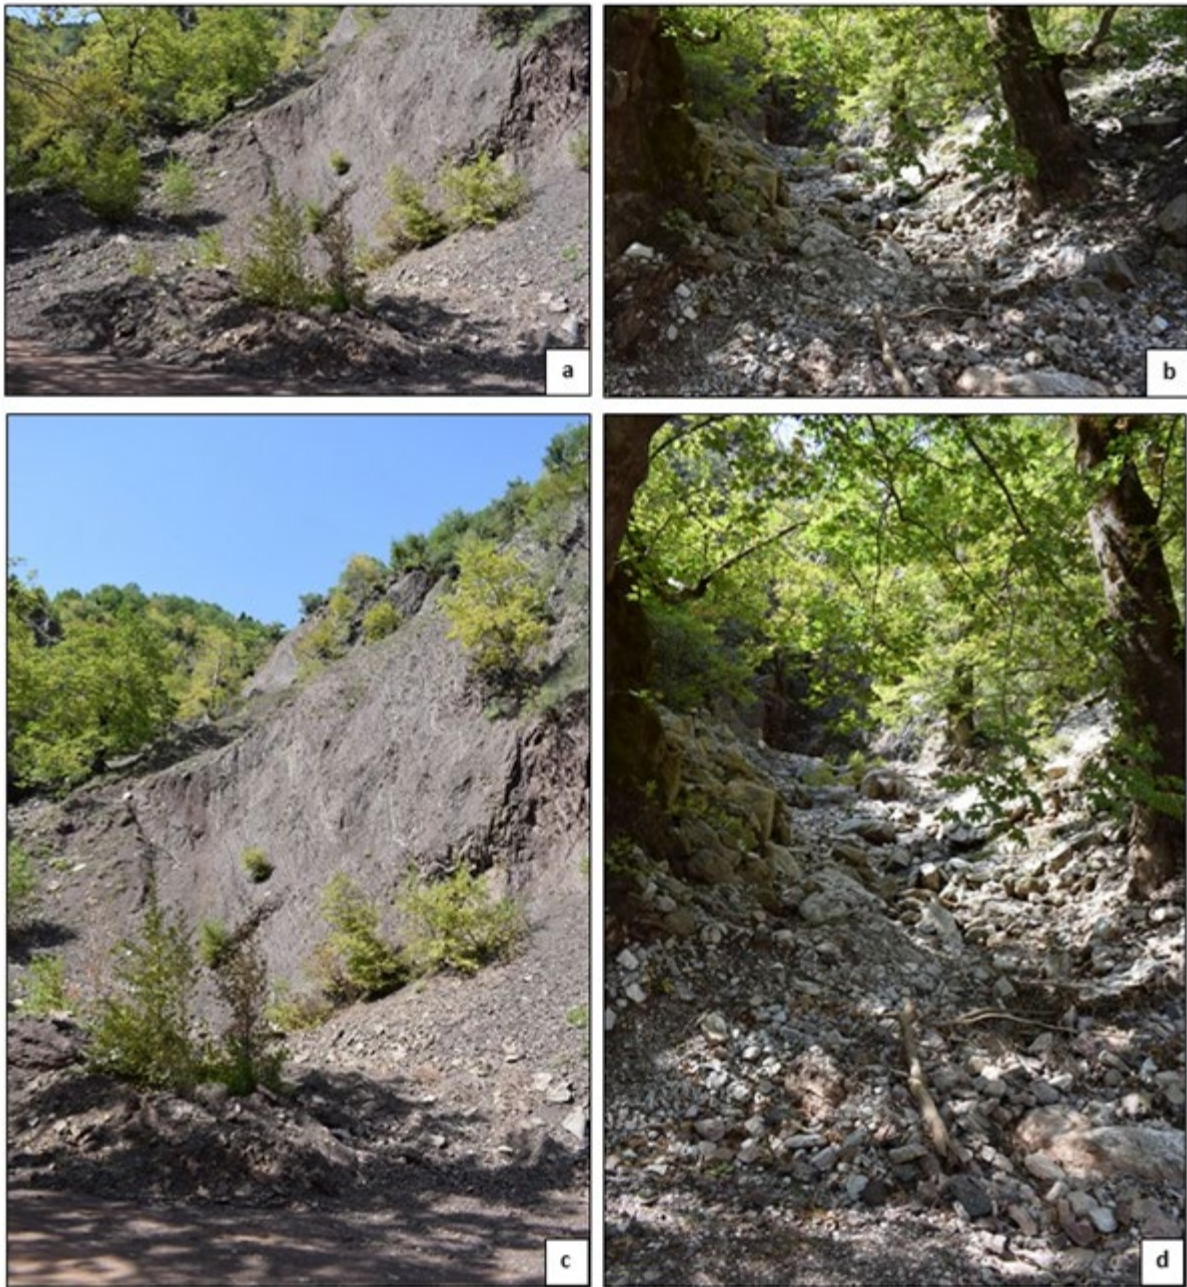
Figure 6.52. Debris flow along the road network of Karpenisi - Agrafa

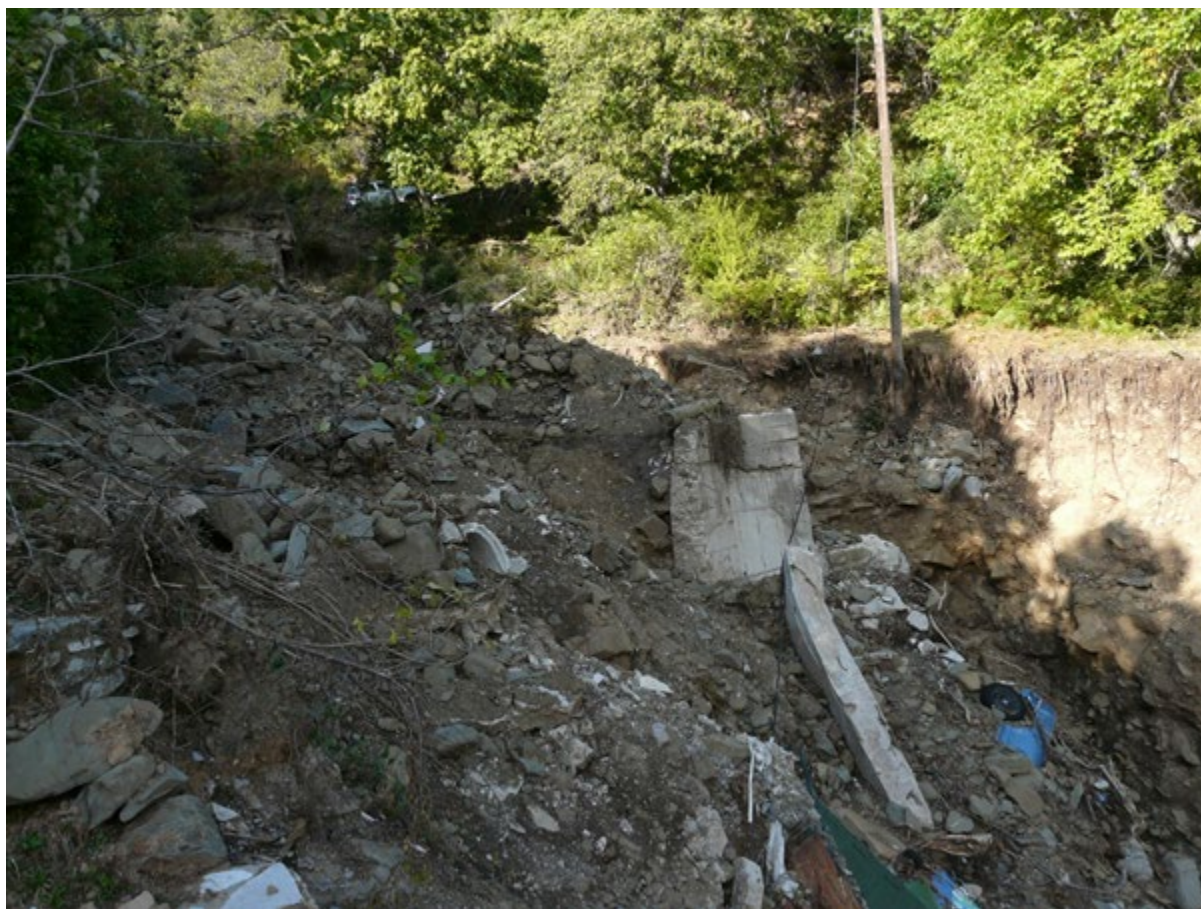
Figure 6.55. Debris flow at the entrance of village Rafina. (39.27220°N, 21.69772°E).

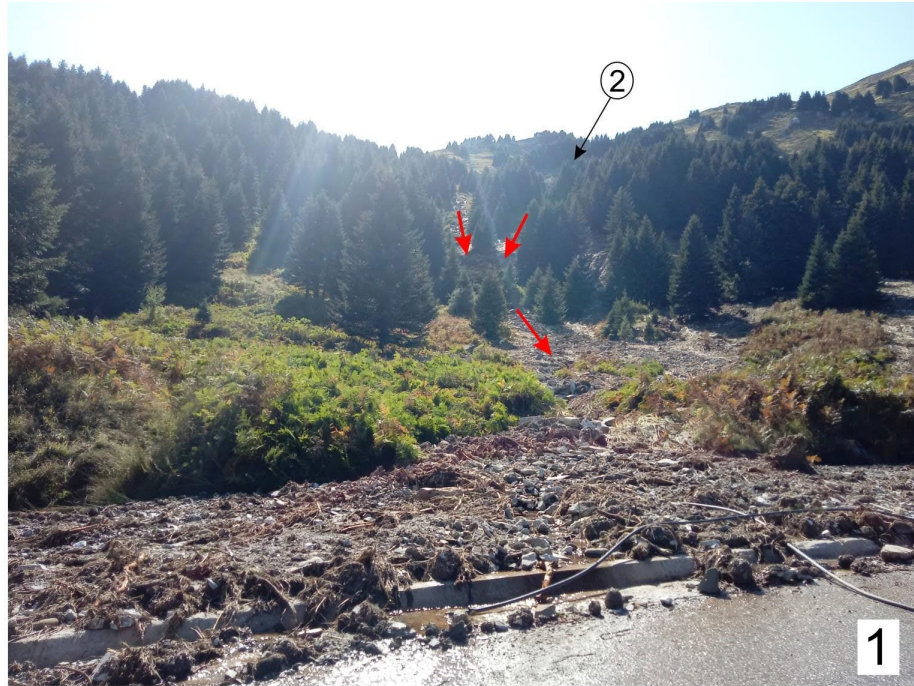
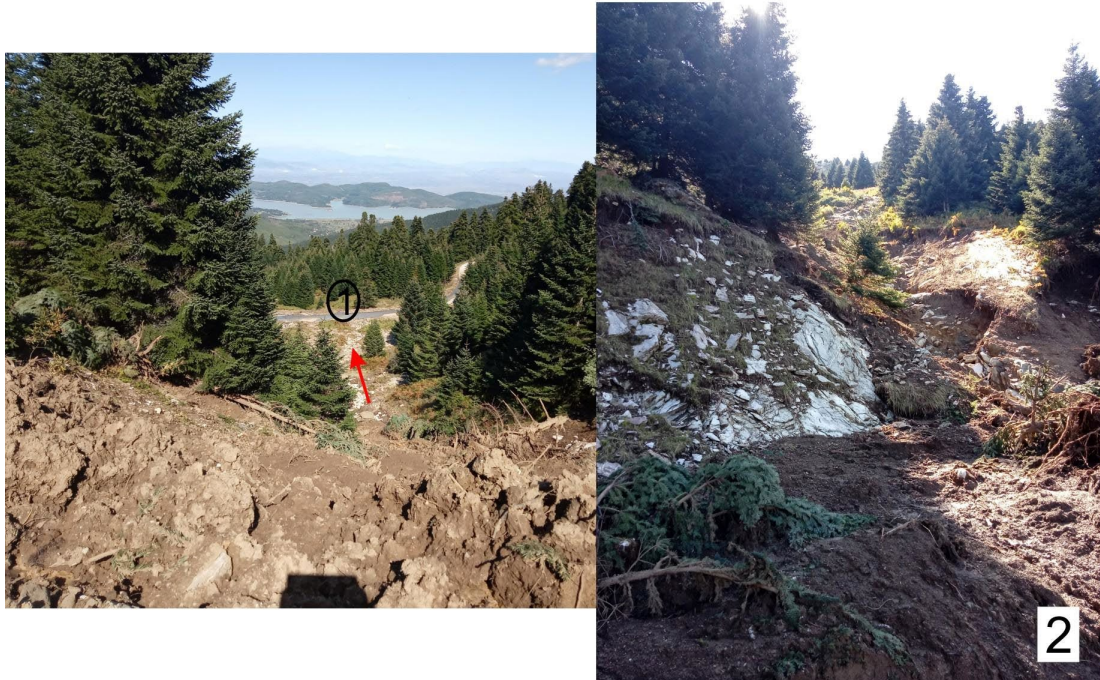
Figure 6.56. Debris flow that intercepted twice the road leading to Agrafa Ski Center, above Plastira Lake: (1) 39.28118°N, 21.67614°E; (2) 39.28013°N, 21.6750°E.

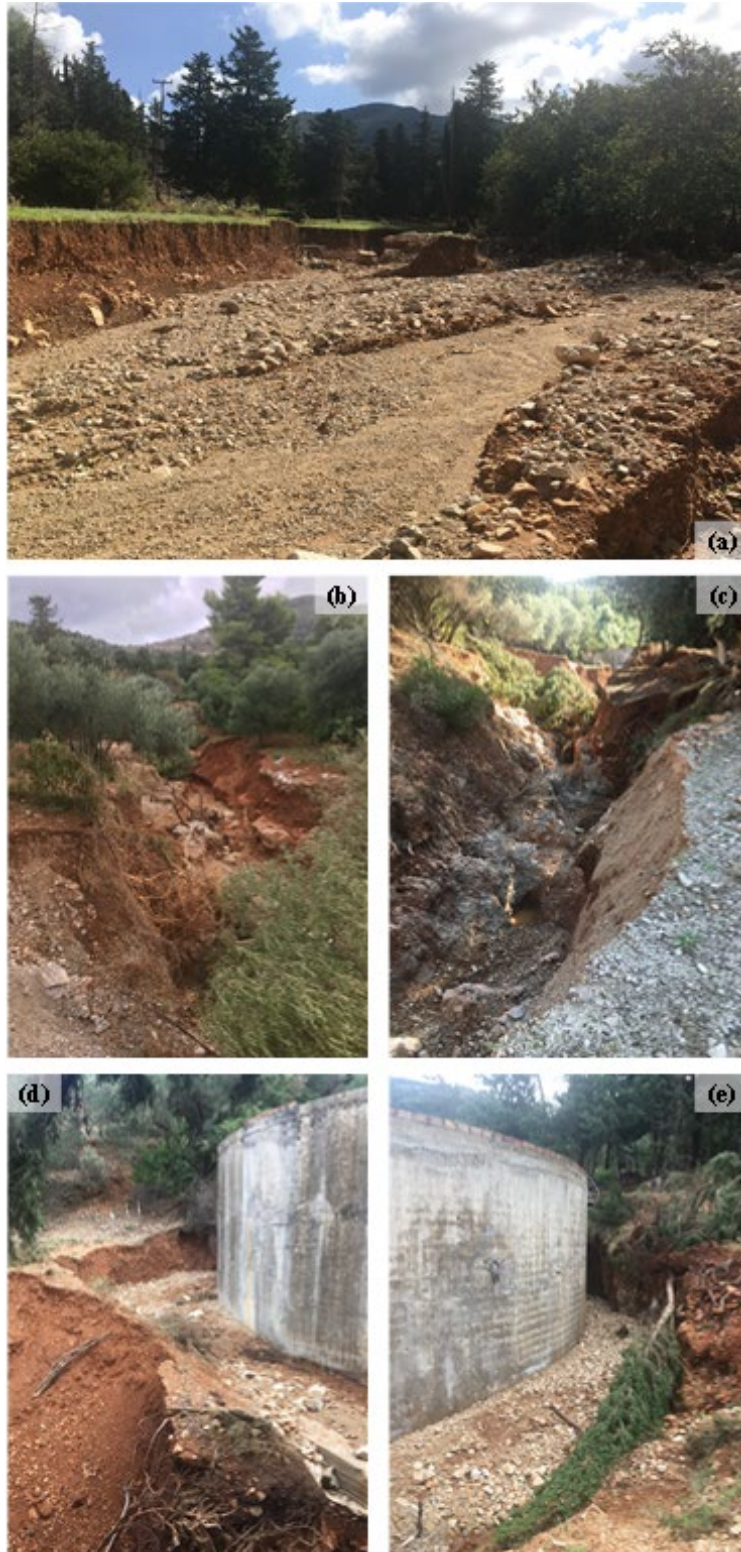
The reconnaissance team found that surface and riverbank erosion and scour was extensive in Cephalonia. The most notable cases were the surface erosion documented outside of the villages of Fiskardo and Assos (Figure 7.1 and 7.2, respectively). In both areas, residual soil and conglomerates were washed away exposing the bedrock formation (Figures 7.1 and 7.2c). The depth of the erosion reached, at places, up to 2 m (Figure 7.1). The eroded material contributed significantly to the debris/earth flows that impacted the nearby communities.

Figure 7.2. Surface erosion outside of Assos village, Cephalonia: a) 38.377188°N, 20.5445722°E; b) 38.3753611°N, 20.5463055°E; c) 38.374833°N, 20.5452722°E, d,e) 38.37619722°N, 20.5511166°E

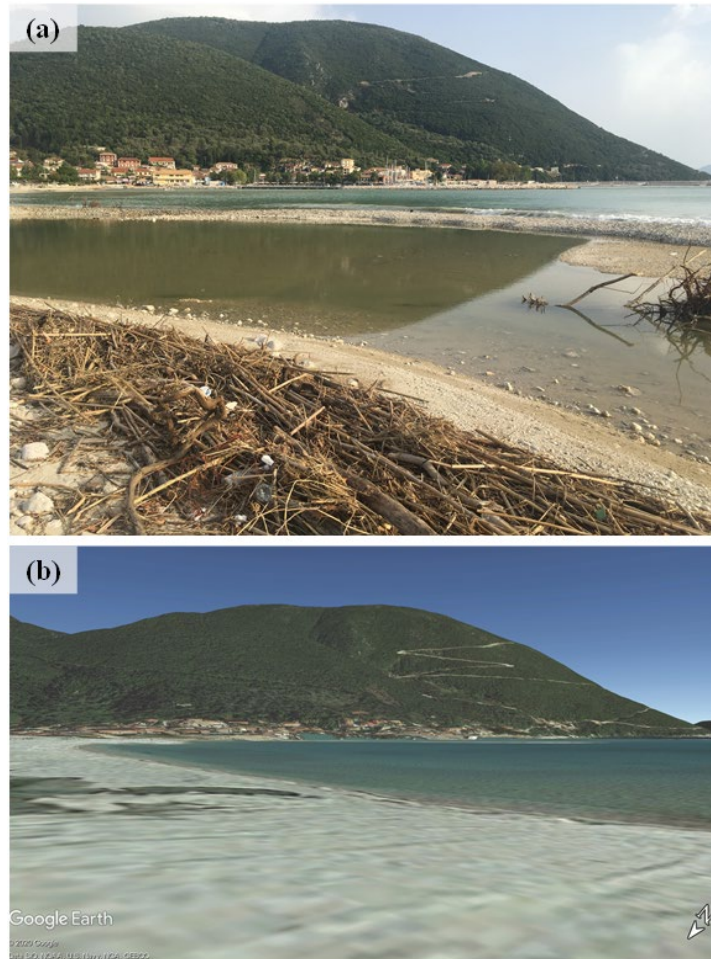
Figure 7.6. a) Photo from Vasiliki beach ($38.629816^{\circ}\text{N}$, $20.603735^{\circ}\text{E}$), showing that the shoreline has receded due to debris deposited by the river. (b) Location the photo was taken from appears to be in shallow water according to Google Earth street view, corroborating this.

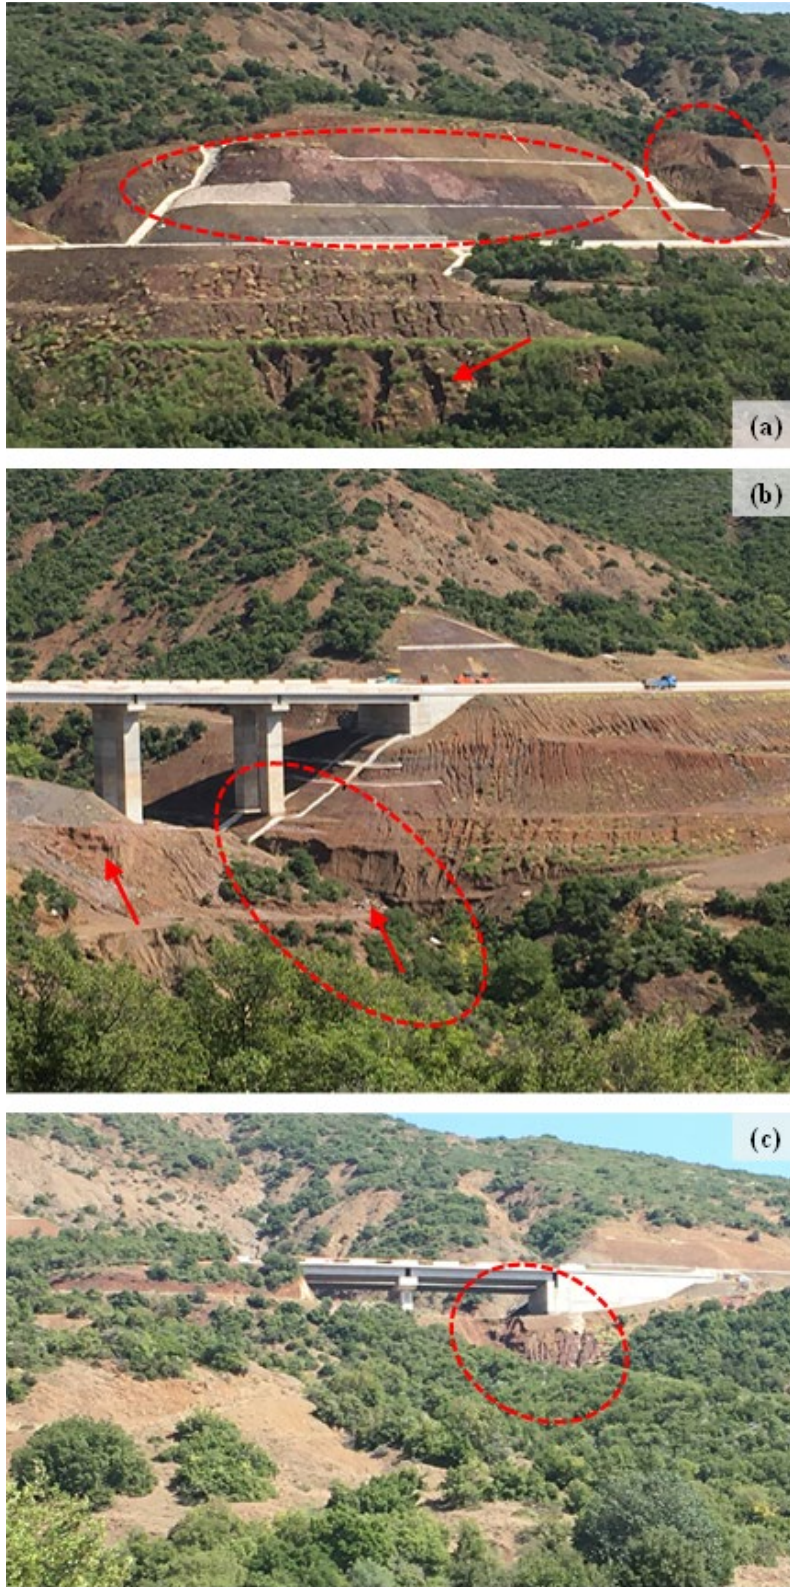
Figure 7.8. Evidence of erosion on embankments and slopes along the construction site of highway E65, north of Stirfaka village. Photos taken from: a) 38.97244167°N, 22.29606945°E; b) 38.97348055°N, 22.2946056°E; c) 38.96774722°N, 22.2956834°E, facing eastwards.

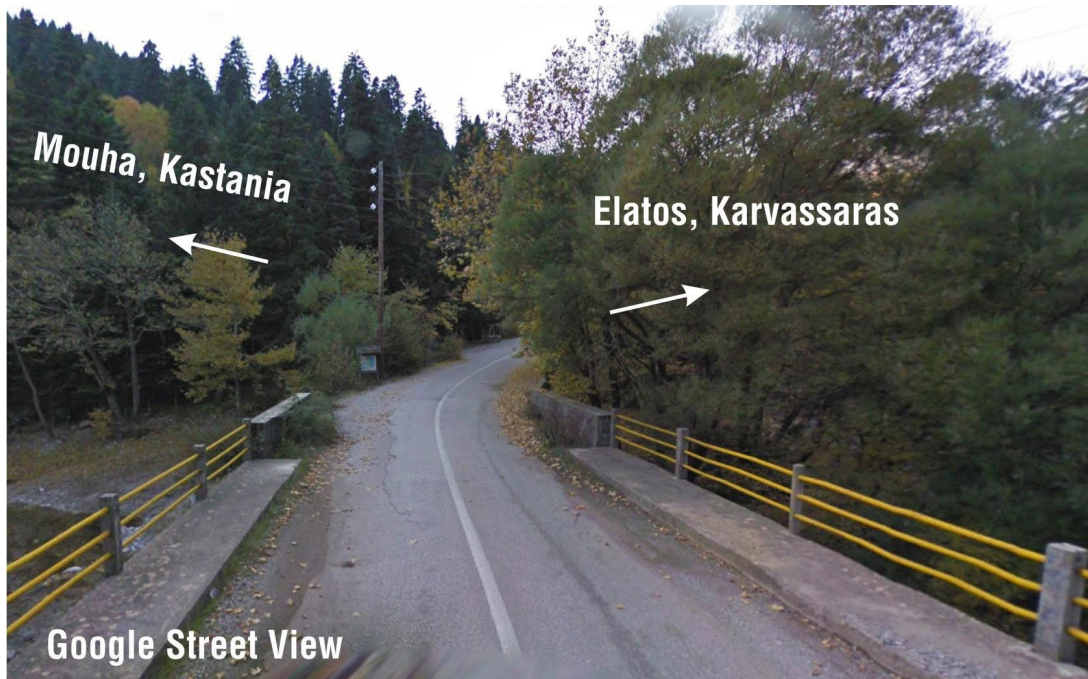
Figure 7.17. View towards south-west from the remaining Karitsiotis river bridge, south of Belokomiti, Plastira Lake. Comparison with Street View image. (39.2538°N, 21.7161°E).

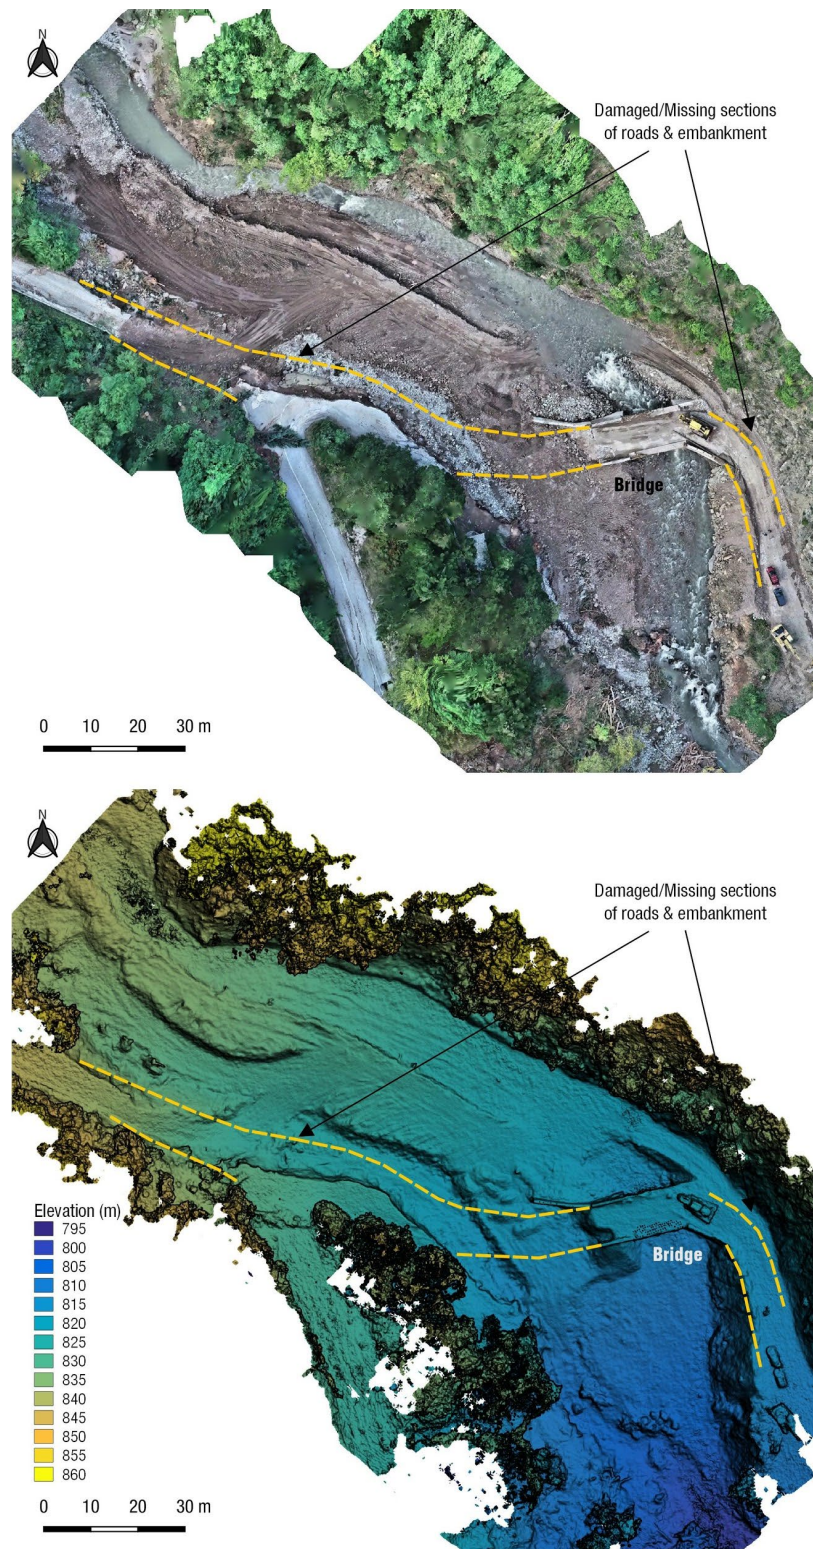
Figure 7.18. UAV survey of Karitsiotis river bridge site, south of Belokomiti, Plastira Lake. (39.25381°N, 21.71591°E). Top: orthophoto. Bottom: DSM shaded relief extracted from point-cloud.

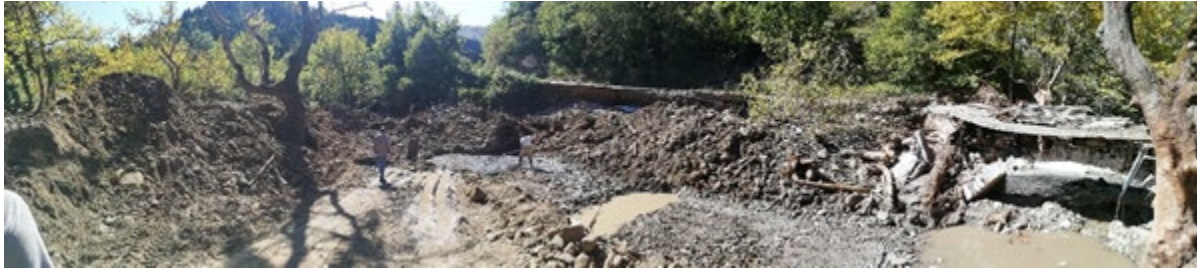
Figure 7.19. Riverbank erosion – slope failure that damaged the road at the village Pezoula. (39.30351°N, 21.6876°E)

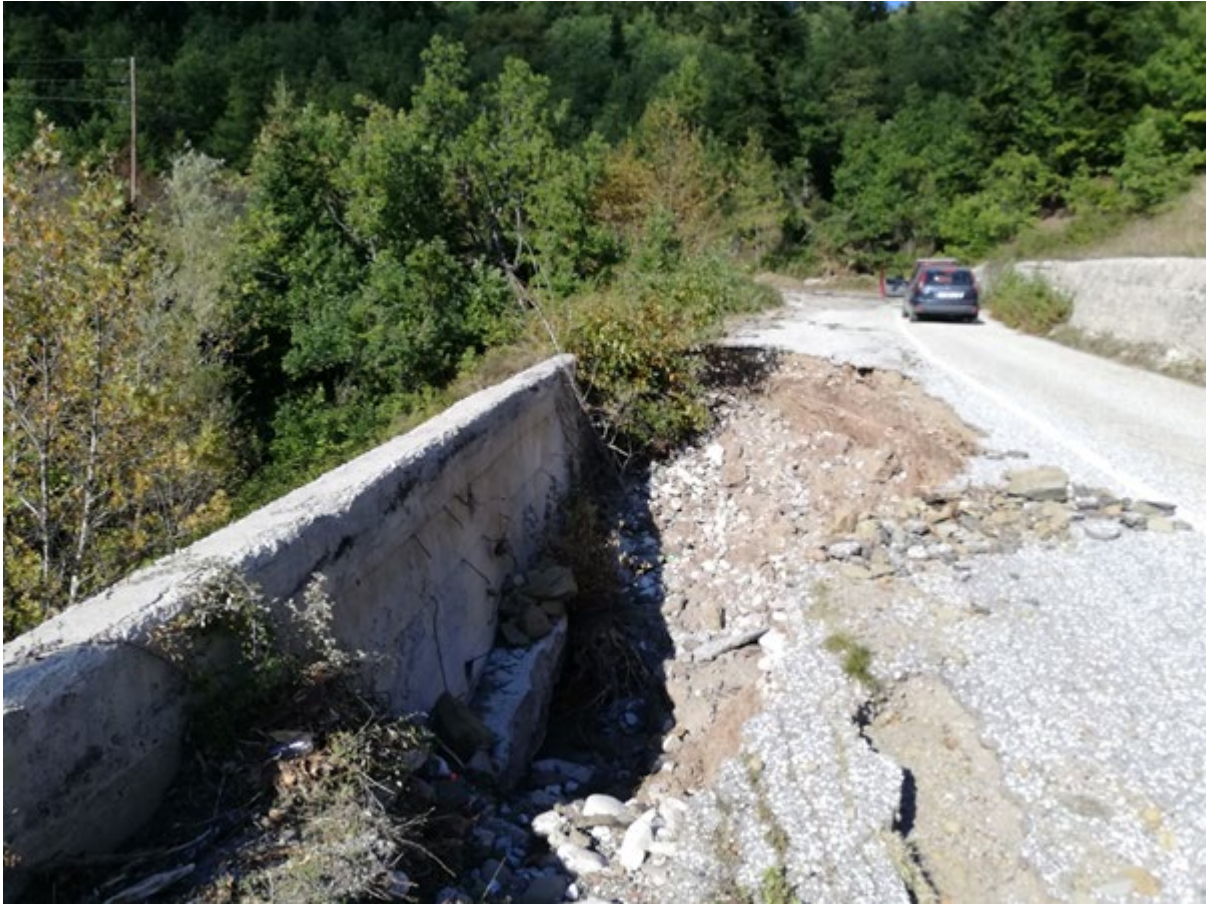
Figure 7.23. Extensive surface erosion on the side of Belokomiti - Karditsa road. (39.26022°N, 21.72556°E).

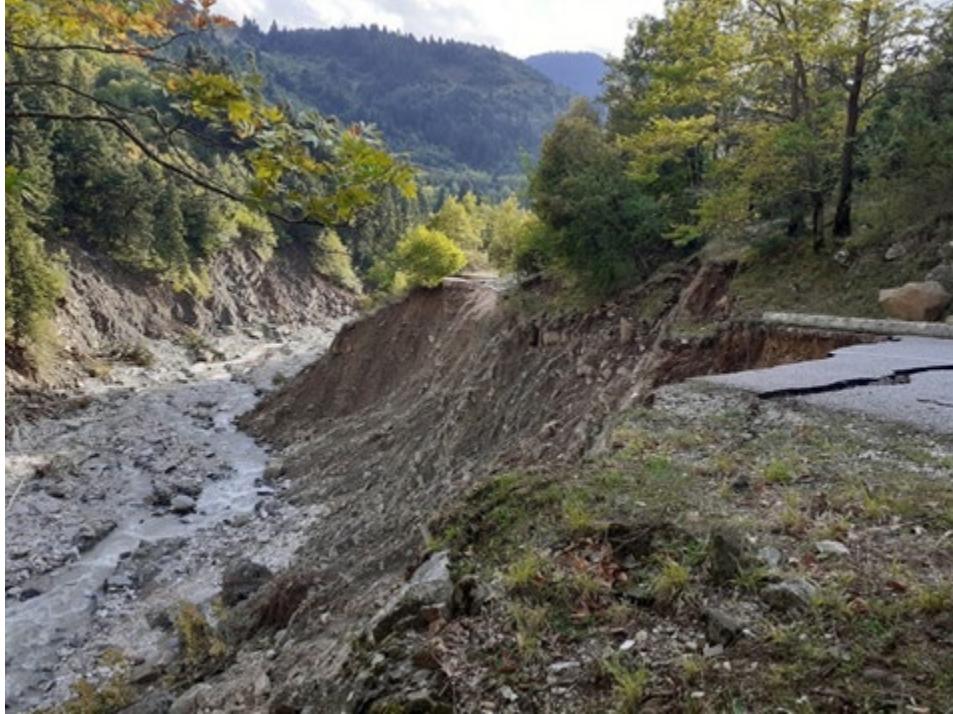
Figure 7.24. Riverbank erosion – slope failure that totally damaged the road at Vlasi village (39.2906260°N, 21.5862230°E).

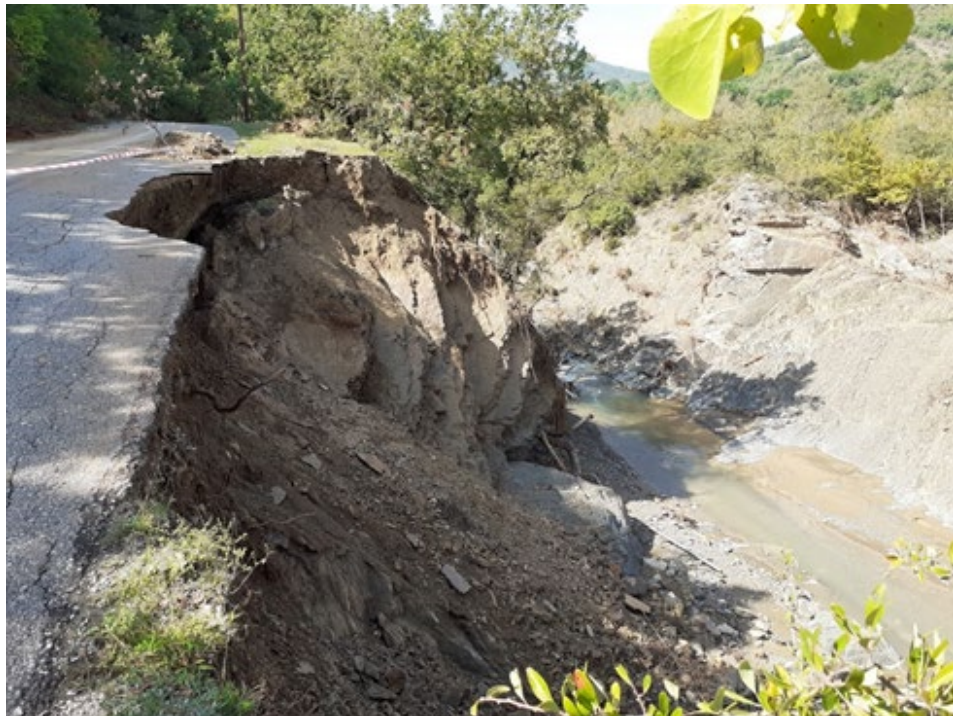
Riverbank erosion also caused several slope failures across the region as shown in Figures 7.19 through 7.26. The flooding of the river caused slope undercutting that resulted in road failures. Example of road embankment failures in weathered mantle of mixed flysch are shown in Figures 7.25 and 7.26. In Figure 7.25, the height and the width of the slope were estimated at 15 and 30 meters respectively, while in Figure 7.26, the surface erosion was extensive reaching a depth of 8-10 meters. A retaining wall that supported the road failed while nearby slopes were intensely eroded.

Figure 7.25. Riverbank erosion – slope failure that partially damaged the road (39.2515460°N, 21.8736180°E).

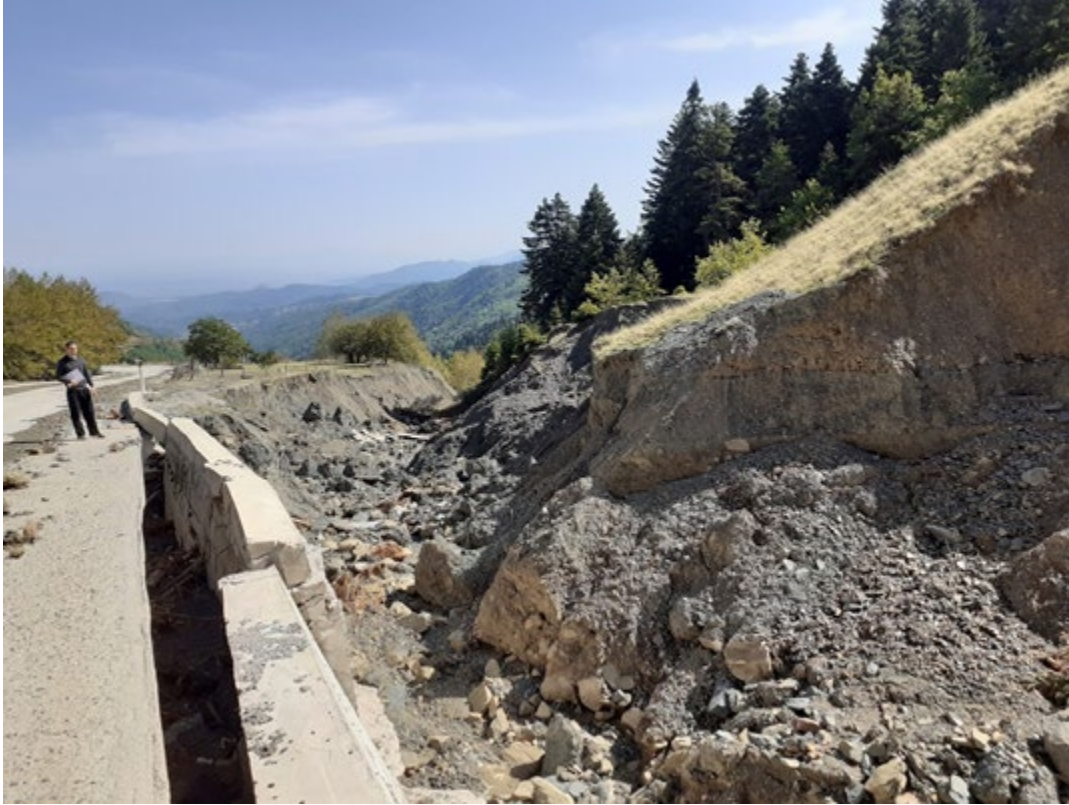
Figure 7.26. Extensive surface erosion on the side of Kastania – Rachoula road. Failure of retaining wall (39.2314830°N, 21.8016040°E).

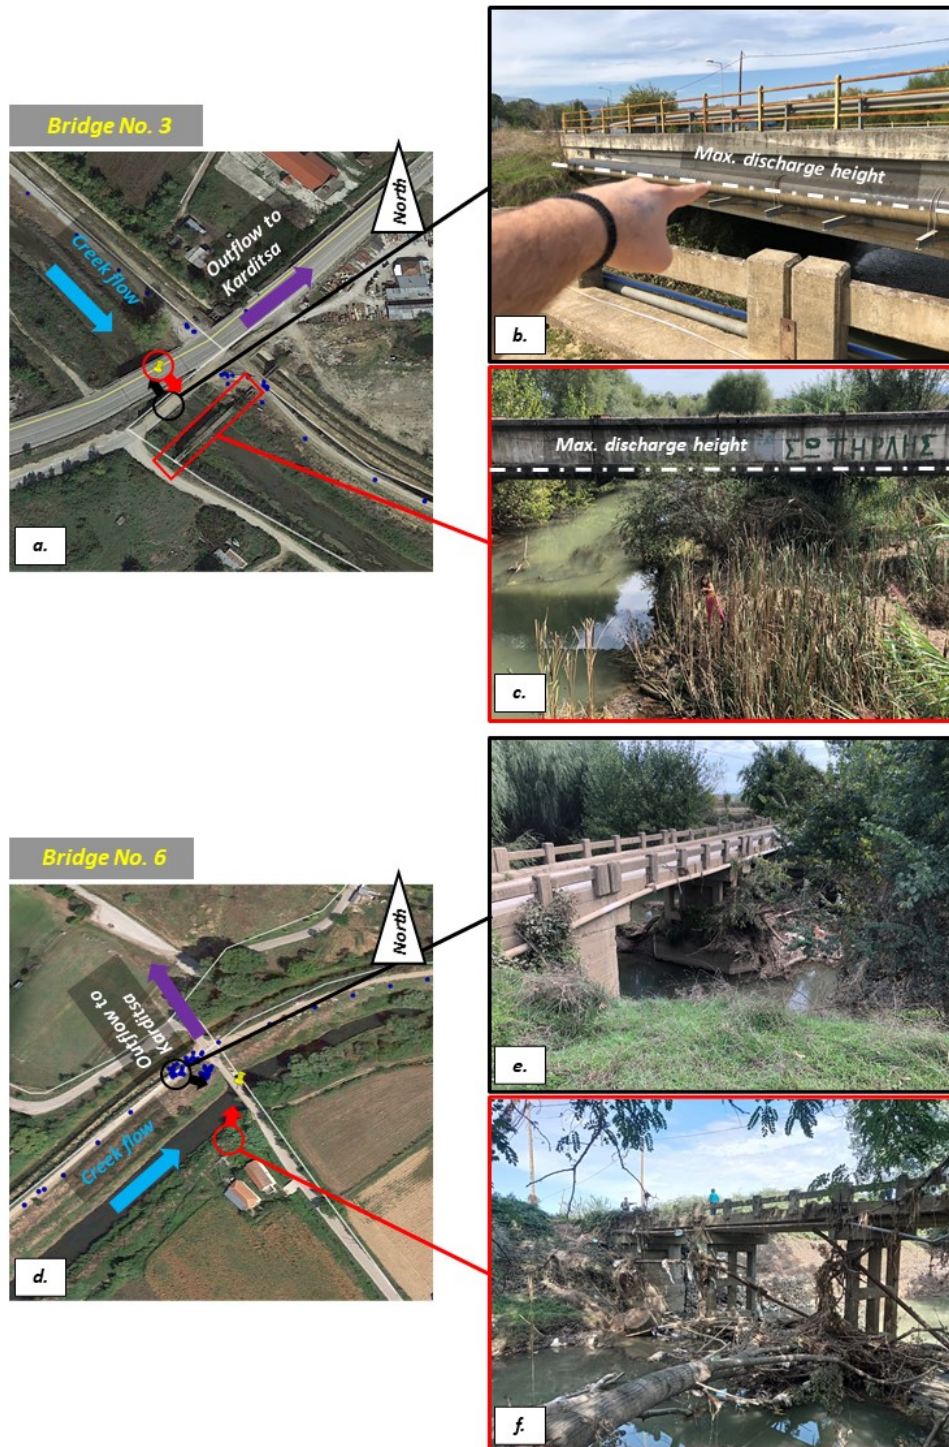
Out of the five bridges inspected, which are both newly constructed, and old with obvious signs of ageing and poor maintenance (e.g. exposed rebar for the case of Bridge No. 6), none had signs of structural damage or abutment distress/ extensive displacement (see also 5.1.3). However, they all had signs of overflowing by the flood discharge of the Gavria Creek, which hints to poor hydraulic design, since their hydraulic sections were proven inadequate for this flood event. More specifically, Bridge No. 3 (Figure 8.2a, 8.2b, and 8.2c) is built next to an old and obsolete bridge, which apparently exacerbated the flood discharge, by reducing further the already insufficient hydraulic section. Bridge No. 3, as well as a utility bridge right across the flow of the creek (Figure 8.2c), have clear marking of the maximum height of the water, leading to the conclusion that the flooded waters overtopped the old bridge, whose deck is on a lower elevation. Bridge No. 6 (Figure 8.2d, 8.2e, and 8.2f), Bridge No. 5 (Figure 8.2a; 8.2b, and 7.27c), and Bridge No. 4 (Figure 8.3d, 8.3e, and 8.3f) also contributed to the flooding of Karditsa by “blocking” the creek flow. Poor maintenance of the riverbed was also an issue, further reducing the effective hydraulic sections beneath the bridges. Tree trunks, mud, debris, even corpses of animals from livestock facilities upstream were found in the riverbed (Figure 8.3f). Figure 8.3e shows the lower elevation of the Bridge No. 4 deck compared to the crest of the flood protection levee. The waters merely overtopped the bridge and flooded the area to the north. Railway Bridge No. 1 (Figure 8.4) is an out-of-use old railway steel bridge, which had a clear mud line, indicative of the maximum discharge height. Notably, a permanent concrete dam with temporary lags is placed slightly upstream this bridge (Figure 8.4c). The lags are used in the summer months, to confine the river flow and create a small-scale reservoir for irrigation purposes. As per local narratives, the lags were not placed in the dam during the flood, thus did not further constrain the flow.

Figure 8.2. (a; b; c) Bridge No. 3 ($39.34458922^{\circ}\text{N}$; $21.89418983^{\circ}\text{E}$): (a) location, (b) evidence of overflow from the horizontal mudline (photo taken from the old bridge on the SE of Bridge No. 3), (c) evidence of overflow on an old utilities bridge (on the SE of Bridge No. 3); (d; e; f) Bridge No. 6 ($39.34506944^{\circ}\text{N}$; $21.92634722^{\circ}\text{E}$): (d) location, (e) section that failed to discharge the flow during the flood event, (f) debris leftovers on the riverbed.

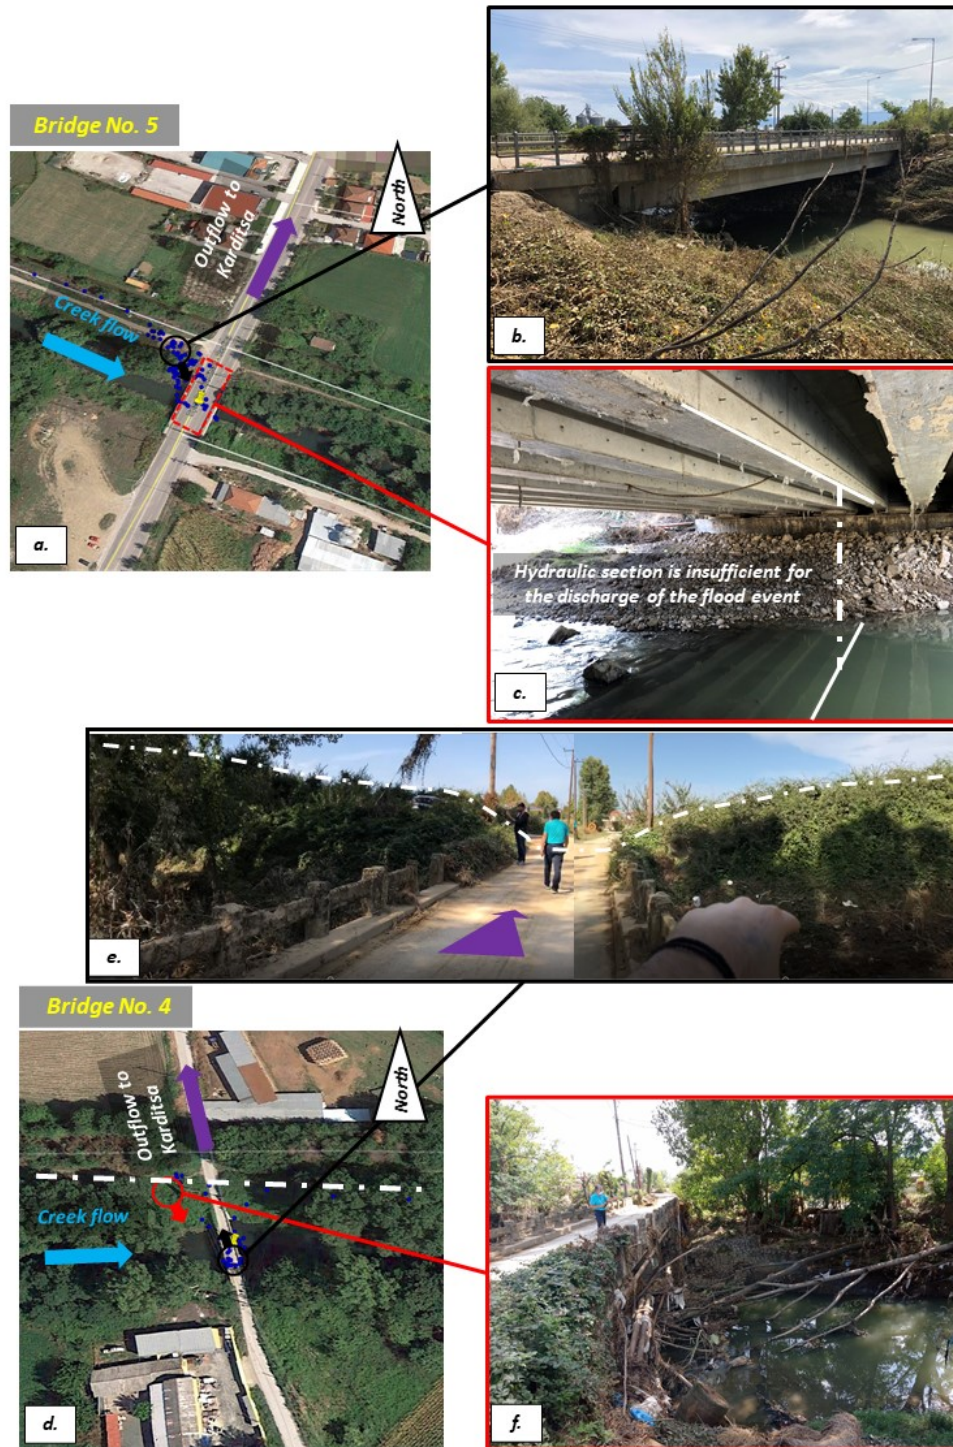
Figure 8.3. (a; b; c) Bridge No. 5 (39.34652222°N; 21.92067222°E): (a) location, (b) section that failed to discharge the flow during the flood event, (c) debris leftovers on the bridge girders (photo taken below the bridge); (d; e; f) Bridge No. 4 (39.348575°N; 21.90459167°E): (d) location, (e) the Flood Protection Levee is lowered at the location of Bridge No. 4, hence leaving a free pass to the flooded water to the north, (f) debris leftovers on the riverbed.

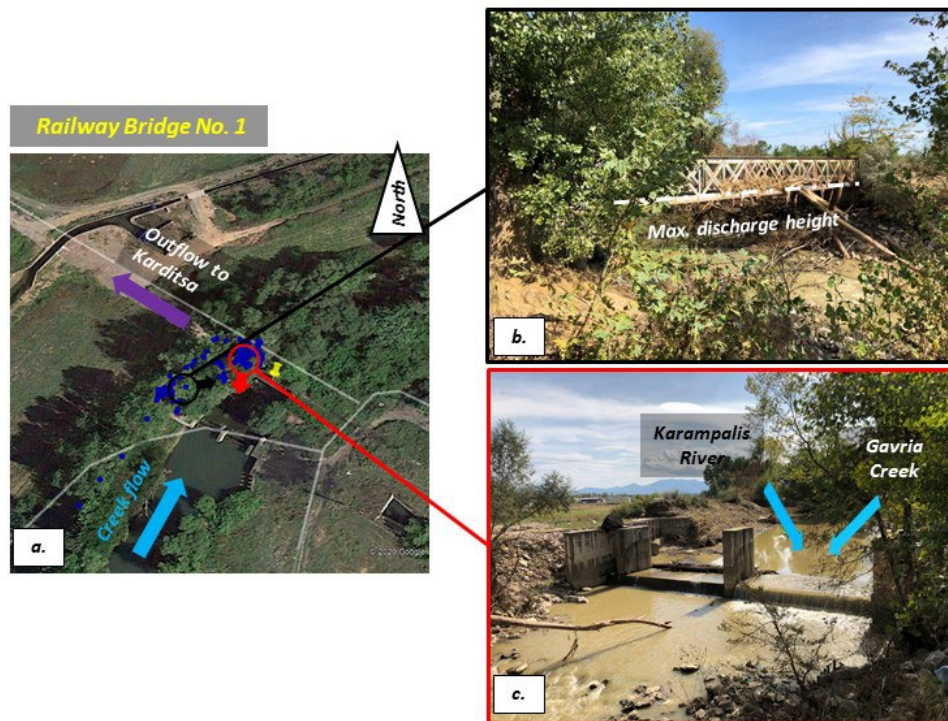
Figure 8.4. Railway Bridge 01 (a) location (39.346627°N; 21.935205°E), (b) photo of the railway Bridge 05 (the max. discharge height is estimated from the horizontal mud line on the bridge); (c) permanent concrete dam with temporary horizontal lags upstream Railway bridge No. 5 – the dam is placed at the intersection of the Gavria Creek with the Karampalis River.

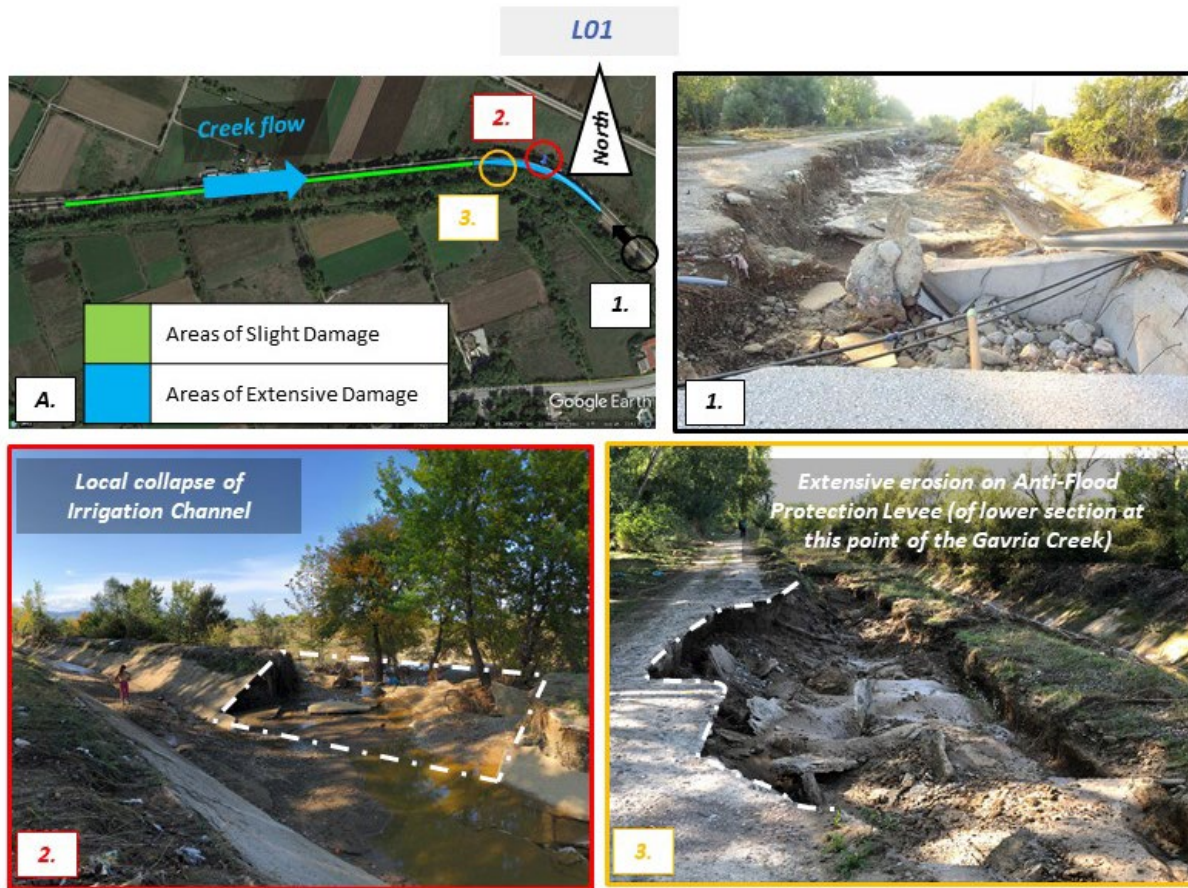
More specifically, Levee 01 had signs of extensive erosion, and the irrigation channel had collapsed locally, allowing the flooded waters to flow to the north uninterruptedly (Figure 8.6). A light green and a light blue zone can be seen in Figure 8.6a, indicative of slight and extensive damage zones, respectively. Increased water velocity due to reduced hydraulic section, circular longitudinal segments of the channel, or the presence of obstacles, such as the water-gate a few

hundred meters downstream the blue zone (close to point 1 of Figure 8.6a) could have led to the extensive erosion and the local failure of the irrigation channel concrete section at this specific location, while the flow upstream caused less severe distortion. Levee 02 (Figure 8.7) had minute damage, and the surface erosion may be irrelevant to the flood event, as no other indications exist suggesting that the irrigation channel was flooded at this point. On the contrary, at the location of Levee 03 (Figure 8.8), the irrigation channel was fraught with mud debris depositions, and extensive erosion was observed. What is more, by the arrival of the reconnaissance team (October 2, 2020), part of the levee had already been restored with layers of compacted soil, suggesting that (1) the traffic on the crest would have been imperiled by the degree of section loss due to erosion, and (2) the local authorities wanted to fix the levee quickly, for preparedness against a new flood event in the near future.

Figure 8.6. (A) location of Flood Protection Levee 01 ($39.347550^{\circ}\text{N}$; $21.890664^{\circ}\text{E}$) – the Flood Protection Levee sustained extensive damages over an area of $\sim 2,500 \text{ m}^2$ (light blue) and slight damage over an area of $\sim 5,500 \text{ m}^2$ (light green); (1) extensive damage with bottom-up erosion of the levee (courtesy of *Mr. Apostolos Vergis*); (2) local collapse of the irrigation channel section, (3) extensive erosion of the levee downstream the irrigation channel failure.

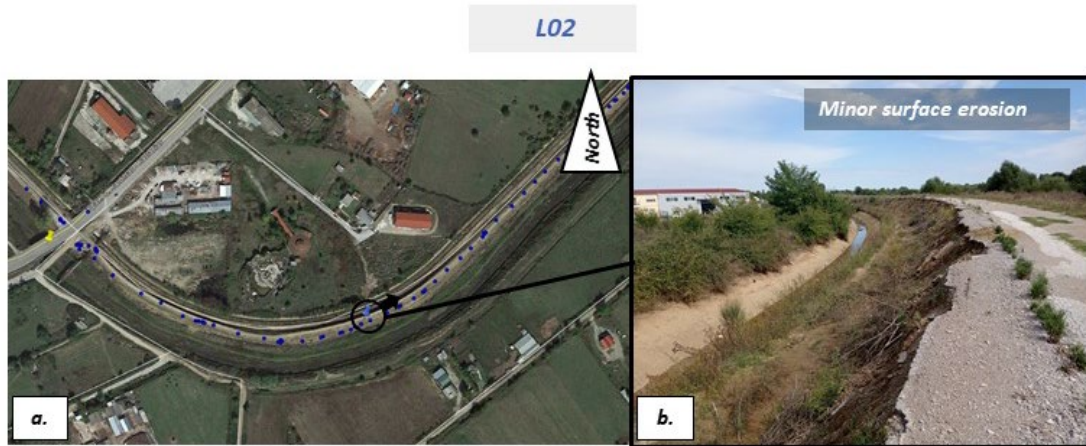
Figure 8.7. (a) location of Flood Protection Levee 02 (39.343994°N; 21.898058 E); (b) minor surface erosion on the crest of the levee.
