The September 18-20 2020 Medicane Ianos Impact on Greece

Phase I Reconnaissance Report

Geotechnical Extreme Events Reconnaissance Association

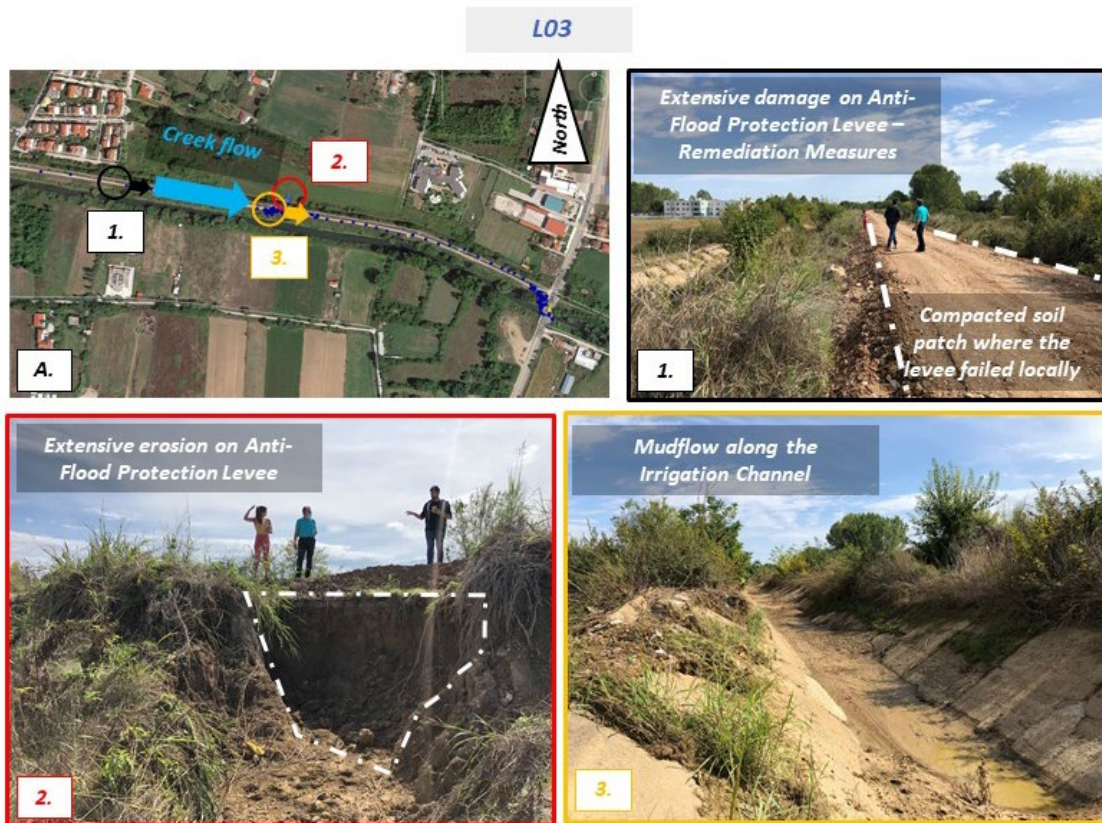
Figure 8.8. (A) location of Flood Protection Levee 03 (39.348173°N; 21.915506°E); (1) extensive damage with loss of a significant part of the levee section (was compacted when we arrived there on October 2, 2020); (2) extensive erosion caused most probably by vortices of the flooded irrigation channel; (3) debris build up on the irrigation channel (photo looking downstream).
